## Loss of nose wheel on takeoff, Airbus A320-214, G-BXKD

**Micro-summary:** The left nose wheel detached from this A320 during takeoff.

**Event Date:** 2005-01-15 at 1635 UTC

**Investigative Body:** Aircraft Accident Investigation Board (AAIB), United Kingdom

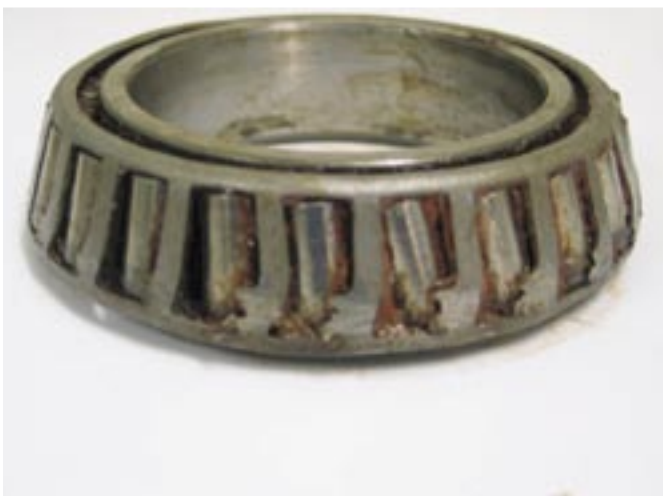
**Figure 5**

The outer bearing assembly, on the recovered left nose wheel, had been correctly fitted and the circlip was still in place; the quantity of grease in the bearing was considered to be adequate. The bearing cup was removed and grease samples were taken at a number of positions through the hub. It was noted that the colour of the grease gradually changed from the chocolate brown at the outside face of the bearing towards the more normal reddish colour on the inner face of the bearing. Fitters experienced in handling this type of wheel indicated that the grease was normally chocolate brown on returned wheels. From the bearing (Figure 5) it could be seen that the rollers had been forced under the bearing cage and that the softer cage had been distorted, with metal transfer having occurred between the cage and bearing cup. Metal smearing was discovered around the circumference of the bearing cone in a position consistent with the distortion and damage to the bearing cage. Apart from localised bluing at the large end of the bearing rollers and a light straw colour on part of the cone, there was no indication that the hub, axle or other wheel components had been subjected to high temperatures. Because of distortion to the outer bearing seal it was not possible to check the

Left hand wheel outer bearing

dimension of the seal using the seal gauge. The inner bearing cone was removed, inspected and found to be in a good condition.

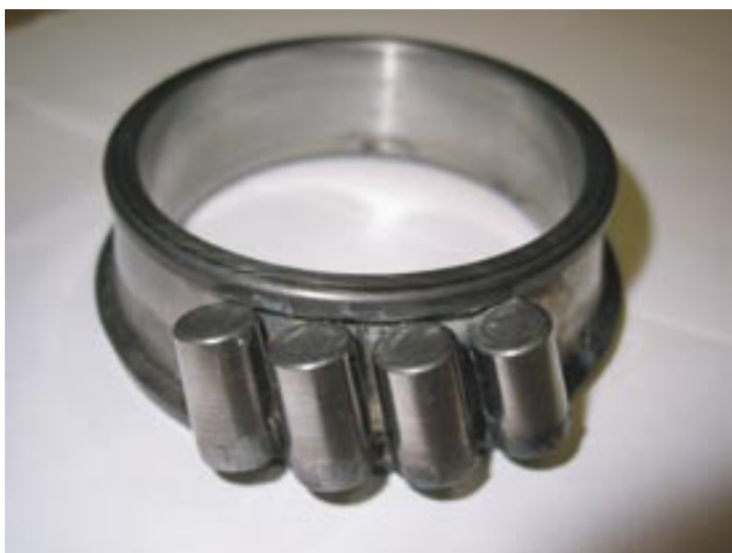
The cage, which was distorted, was cut open to allow the bearing to be inspected. (Figures 6 and 7) The cage pockets were skewed and metal transfer had occurred between the cage and cup, approximately 5 to 10 mm from the roller large end. Four of the rollers were welded to the race at an angle of approximately 16° and there were marks around the remainder of the circumference indicating that the remaining rollers had

been spot welded to the cone race. The roller large ends were slightly deformed with metal smearing and signs of bluing, which indicates temperatures above 815°C. A number of the rollers also exhibited metal smearing and a flat spot within 10 mm of the roller large end, which indicates that the rollers had skidded for a short period. The cone large rib face exhibited signs of plastic deformation and bluing around its circumference. The cup displayed evidence of light straw discolouration, indicating temperatures of approximately 238°C, and metal smearing 5 mm deep around the circumference of the race, which matched the metal smearing on the cage.

**Figure 6 (left)**  
Rollers welded to cone

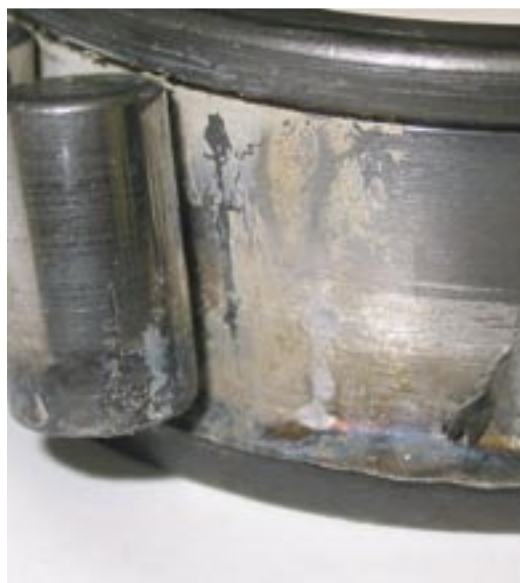
**Figure 7 (right)**  
Distortion of cone large rib  
face

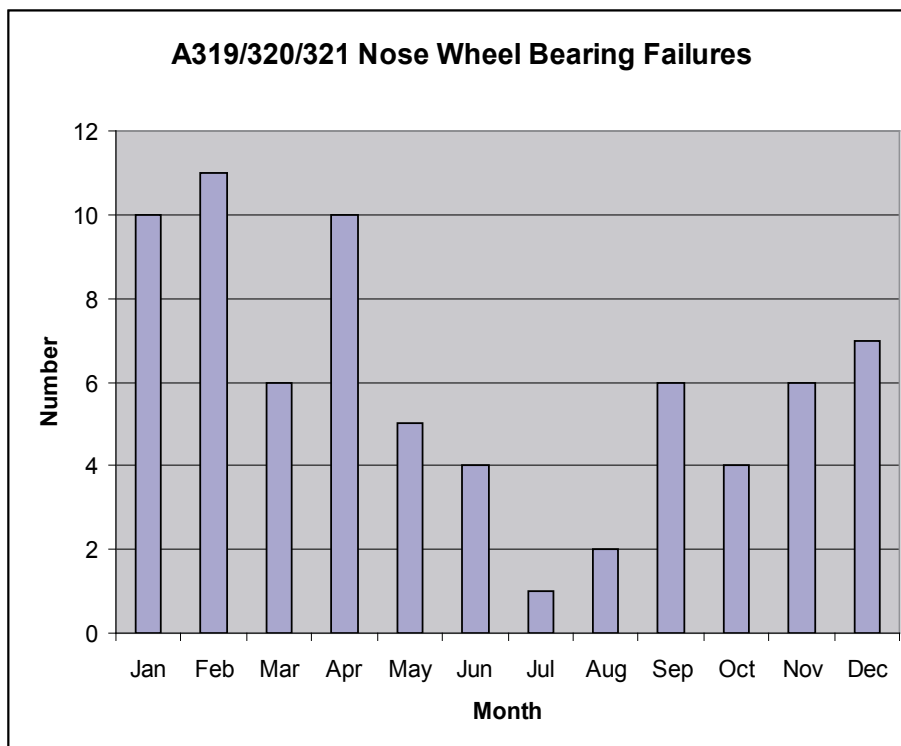
Graph 1

a seasonal connection. However, given the size of the fleet and the number of cycles flown since 1989 care must be taken in how this relatively small number of occurrences is interpreted. (See Graph 1.)

Following the early failures an investigation was undertaken by the aircraft, wheel and bearing manufacturers who determined that the failure mode of the bearing was roller end scoring, resulting from excessive rib stress. In the subsequent years a number of measures were introduced such as increasing the bearing preload and reducing the aircraft speed when undertaking

Data provided by the aircraft manufacturer indicated that there had been 74 reported occurrences of problems with the nose wheel bearings on the A319/320/321 family of aircraft since 1989, which resulted in seven nose wheels coming off aircraft operated by six different airlines. Four of the incidents involved the left wheel. Approximately 44% of the occurrences involved the new wheel assembly (3-1531), of which 28% involved the outer bearing. The majority of the airlines that have reported problems operate in the Northern Hemisphere and it would appear from the data that there might be

sharp turning manoeuvres. A number of modifications to the wheel assembly were also made including the introduction of a new improved wheel (PN 3-1531), which featured bigger bearings and improved spacers and grease retainers. A new grease seal inspection criteria was also introduced, by a Service Bulletin, in July 2004, which the wheel manufacturer believed would help ensure that fully worn grease seals were not refitted in nose wheel assemblies. Since this incident the wheel manufacturer has introduced an improved grease seal, which they believe makes the ingress of contaminants and the leakage of grease more difficult.

Not only did the last three occurrences of wheels coming off aircraft involve the improved wheel, but the manufacturer's tests did not demonstrate that the new seal is any more effective at keeping out water than the seal fitted to the incident wheel. This suggests that the fundamental causes of the bearing failures might not have been resolved.
