Cargo Bay Fire, Air Canada Boeing 767-300 C-GHML, Toronto/Lester B. Pearson International Airport, Ontario, 13 May 2002

AVIATION INVESTIGATION REPORT

A02O0123

CARGO BAY FIRE

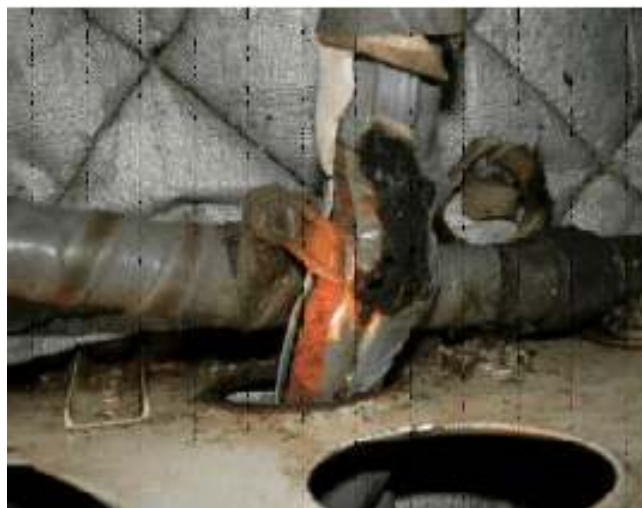
Photo 5. Burned heater ribbon behind aft wall

In addition to the fire damage associated with the occurrence flight, TSB investigators found a burned Cox & Company heater ribbon, protective tape, and Rubatex foam insulation behind the aft wall of the aft cargo area on the occurrence aircraft (see Photo 5). Although a self-propagating fire had not occurred, the area had become hot enough to burn through the Rubatex foam insulation and a nearby plastic clamp.
