## Roll Oscillations on Landing, two Air Canada Airbus 321-s211, C-GJVX and C-GIUF, Toronto/Lester B. Pearson International Airport, Ontario, 07 December 2002

## AVIATION INVESTIGATION REPORT

### ROLL OSCILLATIONS ON LANDING

Report Number A02O0406

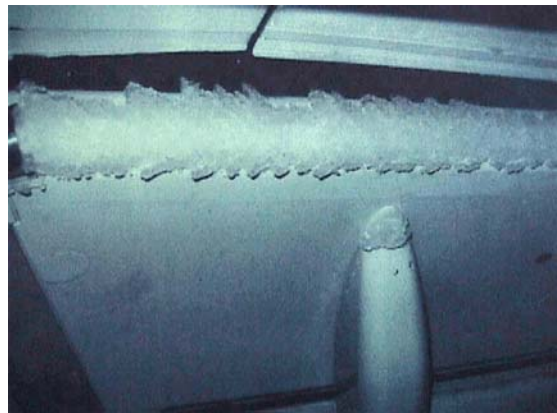
### *Airbus Testing*

**Photo 1.** Ice accretion on main flaps leading edges from a December 1998 A321 event
