Flight into terrain, Final Report of the Aircraft Accident Investigation Bureau on the accident to the Saab 340B aircraft, registration HB-AKK of Crossair flight CRX 498 on 10 January 2000 near Nassenwil/ZH

Final Report of the Aircraft Accident Investigation Bureau

to the Saab 340B aircraft, registration HB-AKK

of Crossair flight CRX 498

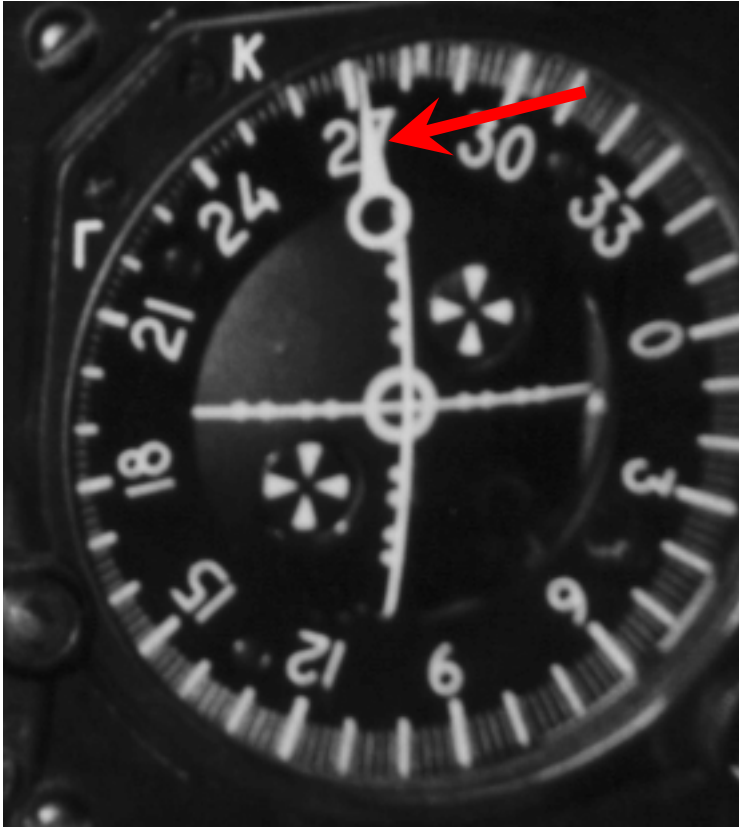
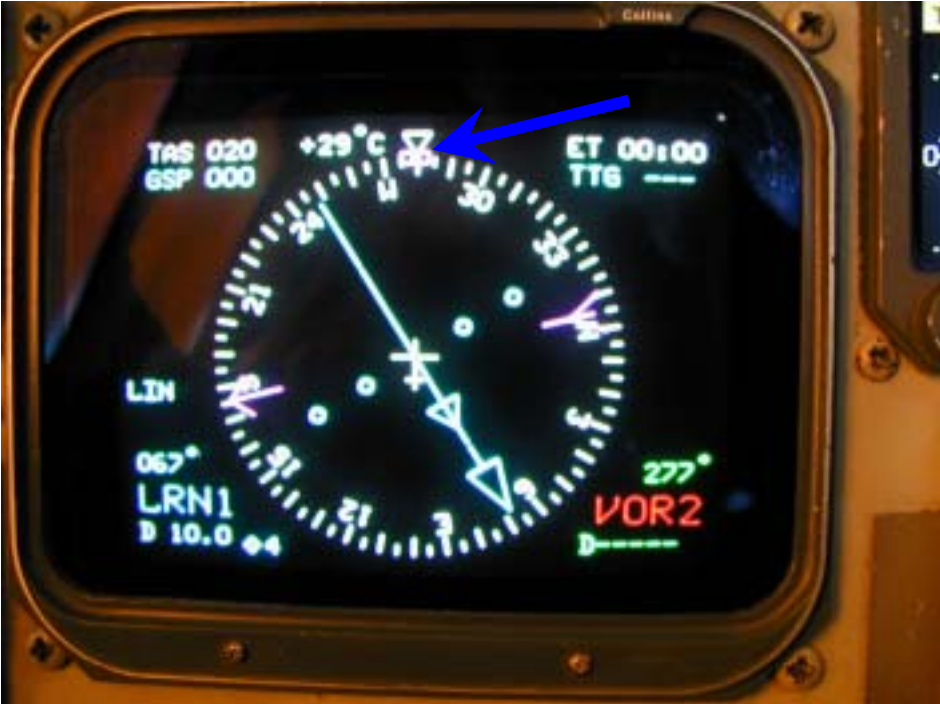
Annex 6

Gyro compass of russian design (above) in comparison with the EHSI of the SF-340 B (below). The pointer (red arrow) rotates with respect to the fixed scale, whereas on instruments of western type, the heading bug (blue arrow) is fixed with respect to the rotating compass card.
