Ground cabin smoke, Final Report of the Aircraft Accident Investigation Bureau concerning the incident of the airplane Mc Donnell Douglas DC-9-83, HB-IUM on 5 June 2000 at Geneva Airport

Final Report of the Aircraft Accident Investigation Bureau

of the airplane Mc Donnell Douglas DC-9-83, HB-IUM
on 5 June 2000
at Geneva Airport

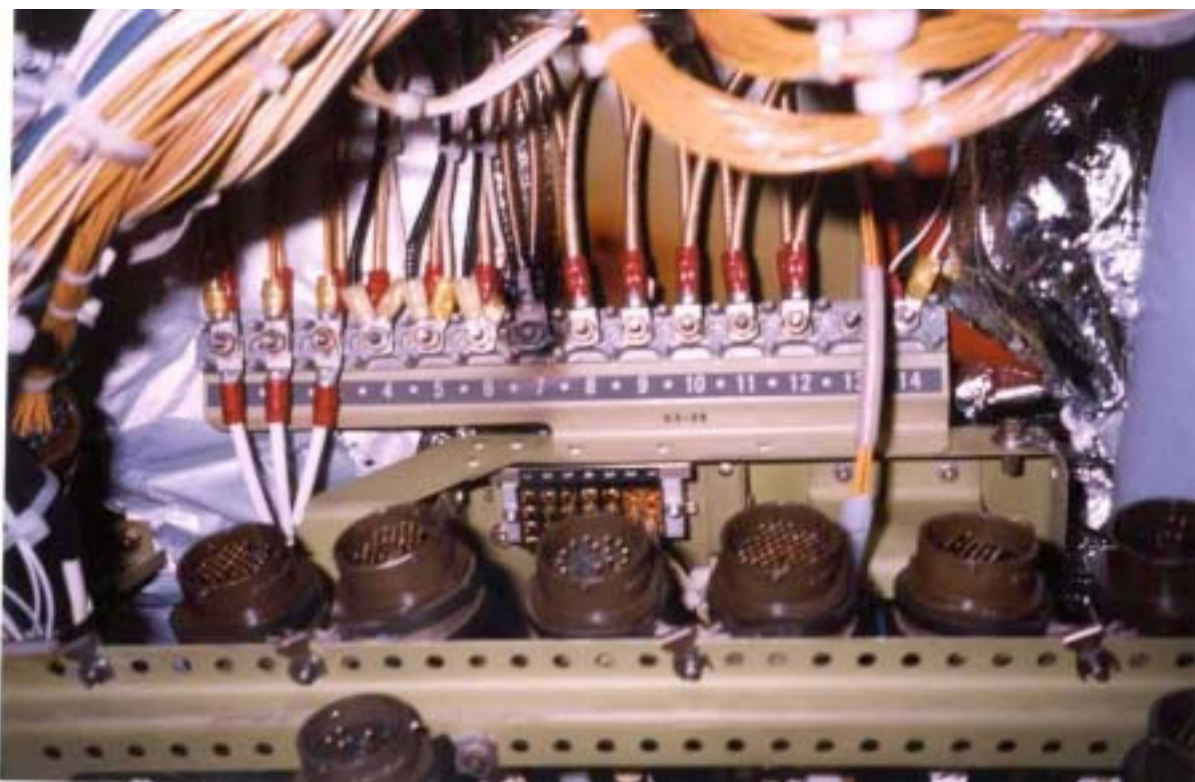
- All crew members held licences.
- The aircraft had no story of smell or smoke.
- The aircraft had undergone a D- and C3- check in December 1999 at Shannon Aerospace together with a modification package.
- After opening the necessary access panels, at STA 218, a burned contact on the terminal board assy S3-25 was located (Fig. 1).
- The terminal board assy and the associated, burned terminals were removed for investigation.
- The terminal Nr. 7 of the terminal board assy P/N MS27212-6-14 showed extensive heat damage (Fig.2).
- The connection between wire and contact did not show thermal damage and had a firm seat.
- The terminals of the attached cables H735L8C and H735M8C showed extensive heat traces (Fig. 3).

Fig. 1 Terminal Board S3-25 in situ

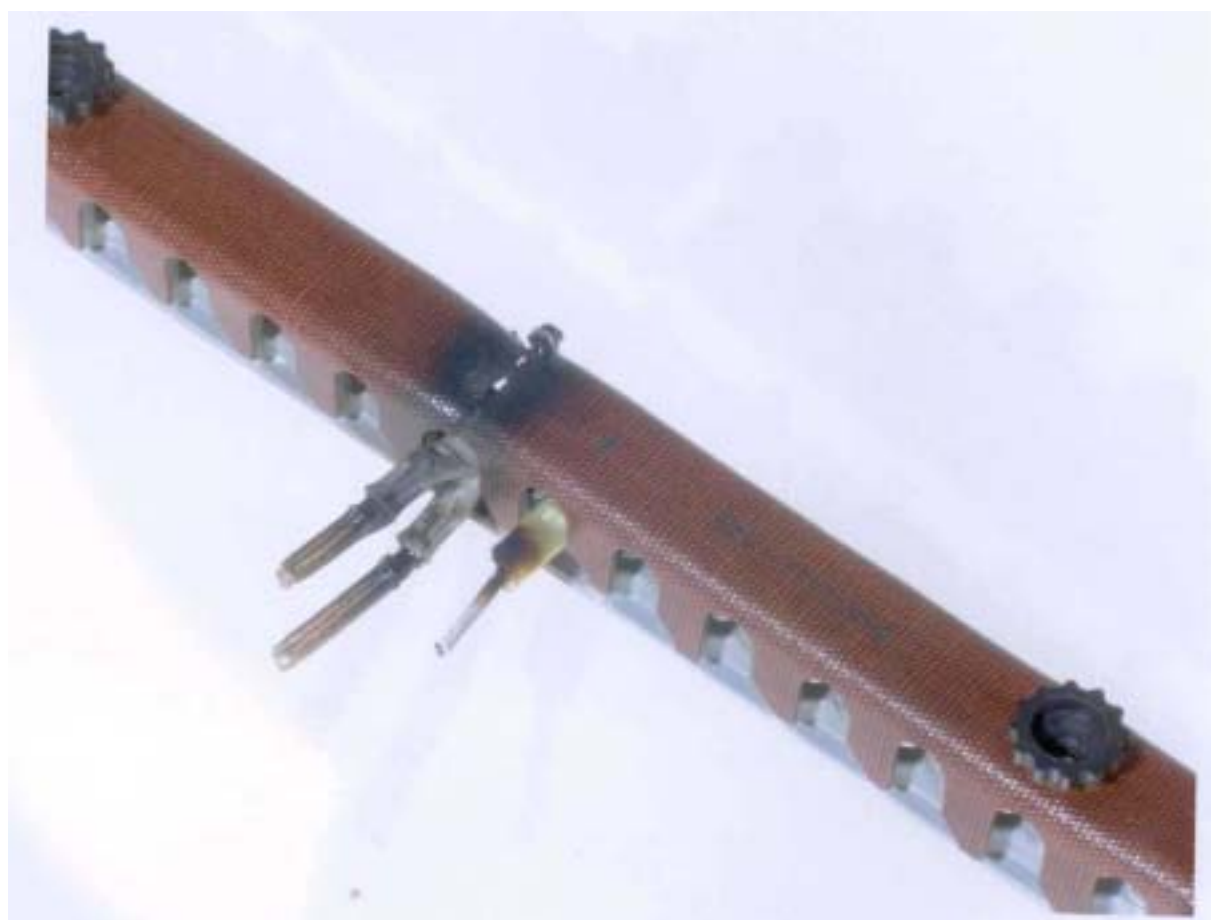
The analysis of the protection cover and wire pieces is stating an increase of temperature due to an insufficient pressure between the terminals. The temperature may have increased to between 800° C and 1000° C. No arcing was observed. The damage to the protection cover and the proximity cable terminal are to be considered as secondary damage.

The incident was caused by an increased electrical resistance due to an insufficient pressure between the terminals on contact 7 of the terminal board assy S3-25.

Fig. 2 Terminal Board with heat damage

If properly torqued and the lock washer in good condition, the connection should remain firm.
