## **In-flight smoke, Final Report by the Aircraft Accident Investigation Bureau concerning the serious incident to the aircraft EMB-145LU, HB-JAU on 16 November 2003 at Zurich Airport**

**Micro-summary: Smoke on climb on this Embraer 145 resulted in a declaration of emergency and return to Zurich.**

# Final Report by the Aircraft Accident Investigation Bureau

to the aircraft EMB-145LU, HB-JAU

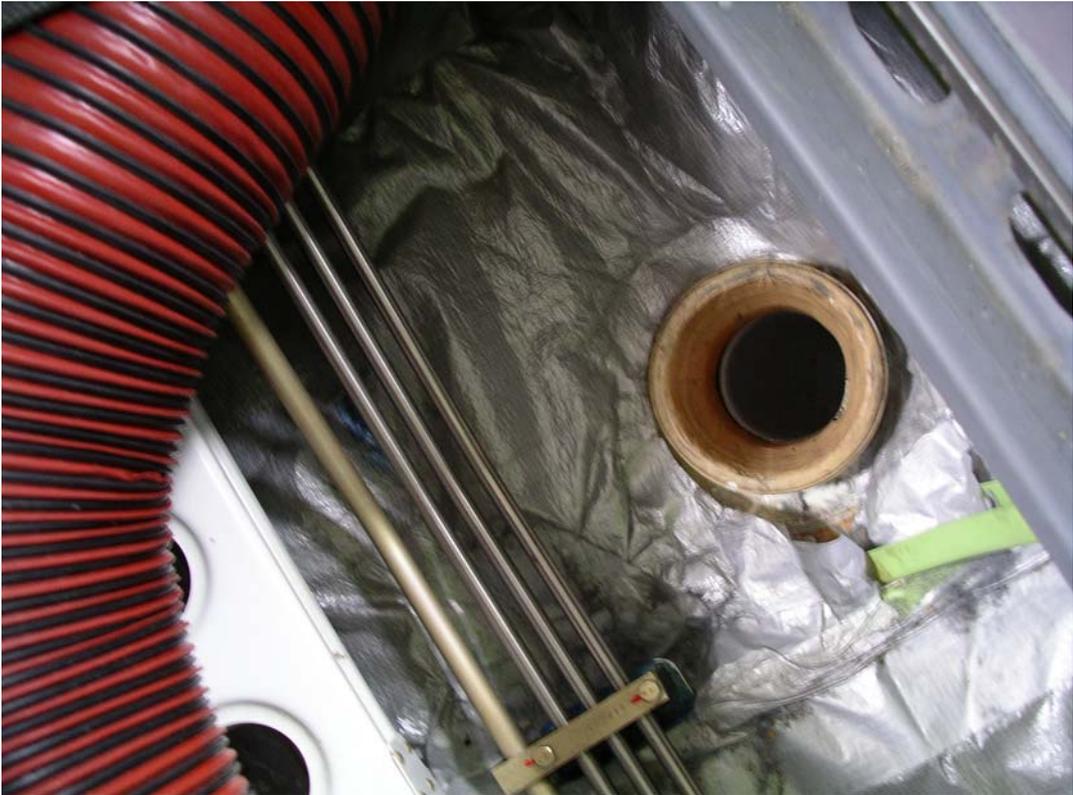
Figure 1

- During a system test of ECS Packs#1 and #2 with engines running (high power test), a very loud noise was heard in the area of seat row 8. The cabin floor was opened in this area (Annex 1 figure 2) and it was found that the hose leading from recirculation fan #1 to ECS Pack#1 had separated near the cabin entry point (Annex 1 figure 1). The hose was reconnected.

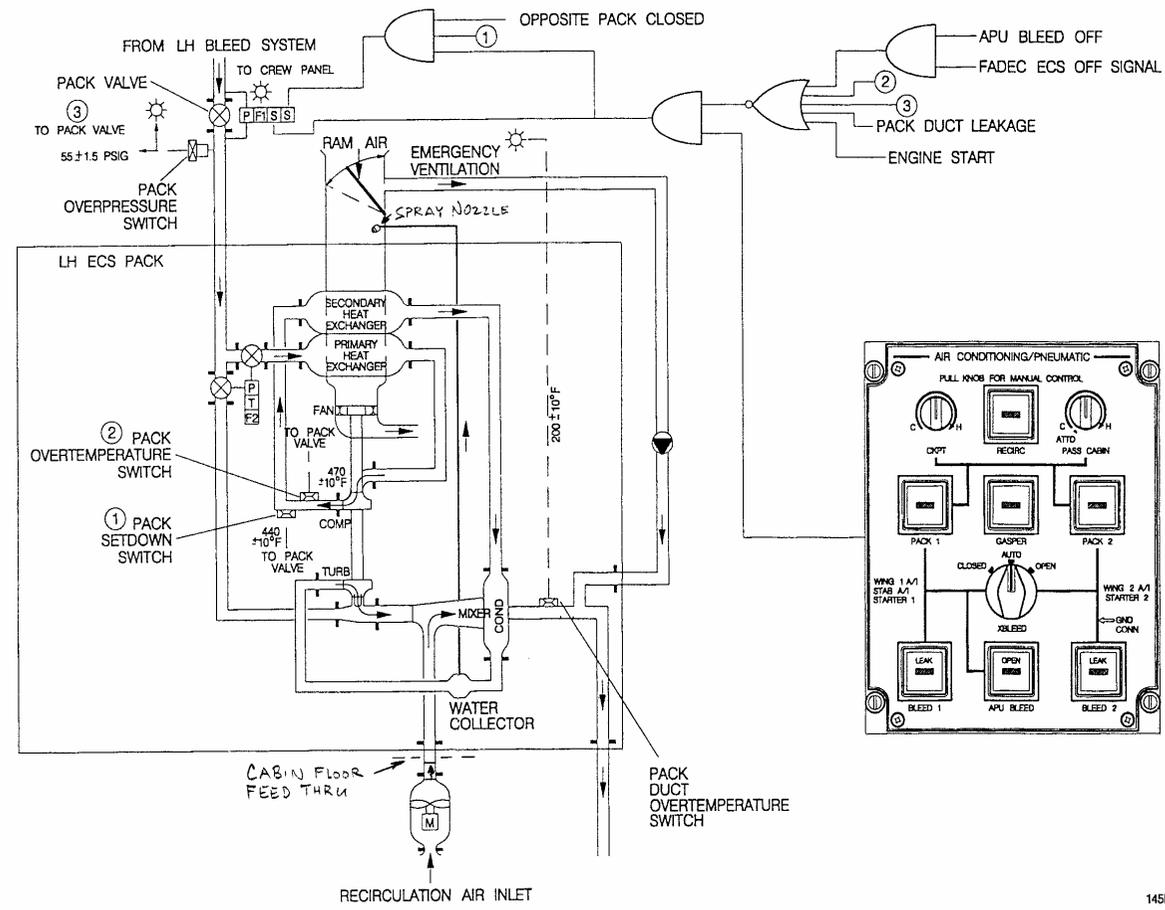
EMB 145 Aircraft Maintenance Manual (PART 1)  
COOLING PACK SYSTEM - SCHEMATIC DIAGRAM , S eet 1

- The spray nozzle, which carries water away from the water collector to the ram air duct, was examined to see if it was clear. In the process, a foreign body was found in the spray nozzle. This was a small piece of solder residue, which had presumably found its way from the condenser via the water collector into the spray nozzle and in the process had blocked it.

The occurrence of fumes and frost can be explained as follows (cf. Annex 2): as a result of the blocked spray nozzle, the water which had accumulated in the water collector could no longer be carried away. This now reached the turbine, where ice crystals were then formed. These in turn blocked the condenser and high pressure was created in the direction of the recirculation fan. The non-return valve fitted at the outlet of the recirculation fan prevented pressure from being released and the hose failed near the cabin entry point. The ice crystals now reached the cabin, formed the fumes in question and led to the drop in the cabin temperature. The situation normalised itself again at low engine power.

The serious incident was caused by a foreign body in the spray nozzle in the left environmental control system (ECS).

1. A check to ensure that the spray nozzles are clear every 500 flying hours (1A check).
2. Cleaning of the spray nozzles every 2000 flying hours (4A check).
