Uncommanded roll, Serious incident on March 20, 2001 at Frankfurt/Main, to Airbus Industrie A320-200

Investigative Body: Federal Bureau of Aircraft Accidents Investigation (BFU), Germany

Investigation Report

5X004-0/01
April 2003

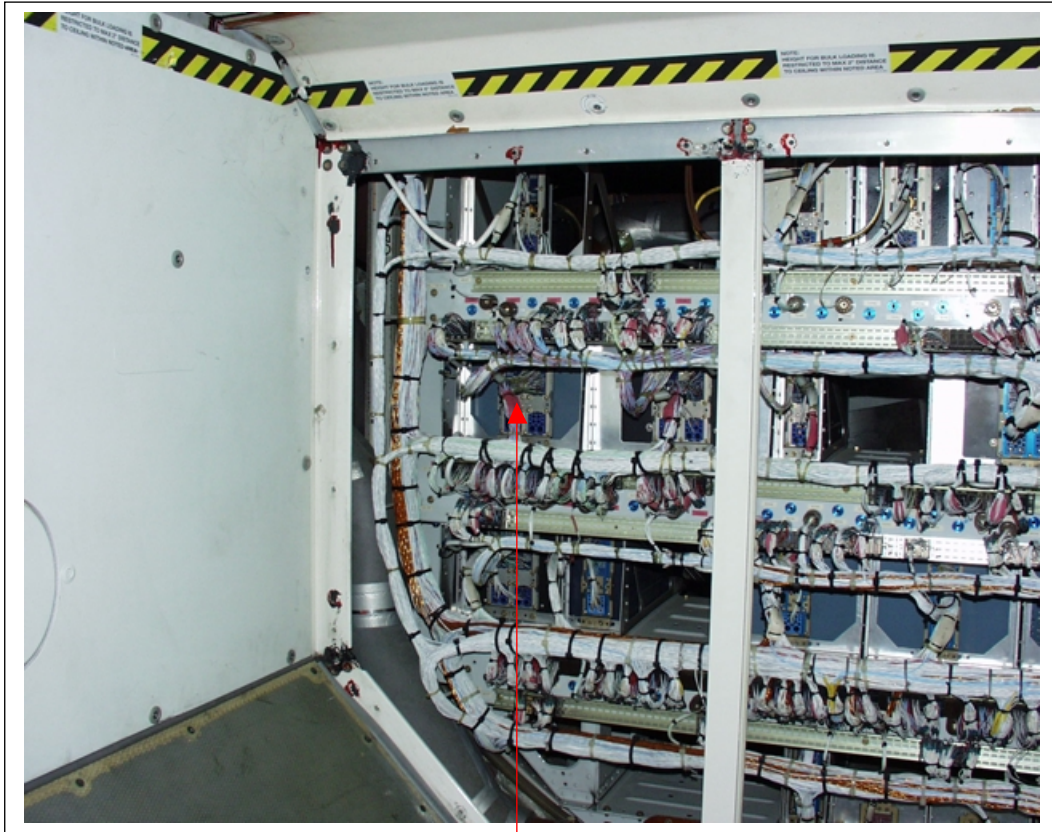
During the error search, which was accomplished during the night shift from 18th to 19th March 2001 a defect in the X-TALK-BUS between ELAC no. 1 and ELAC no. 2 could be localized. It was caused by a bent connection pin (Pin 6K) in the plug segment AE of the socket for the ELAC no. 1.

Location of the ELAC no. 1 in the Avionic Bay

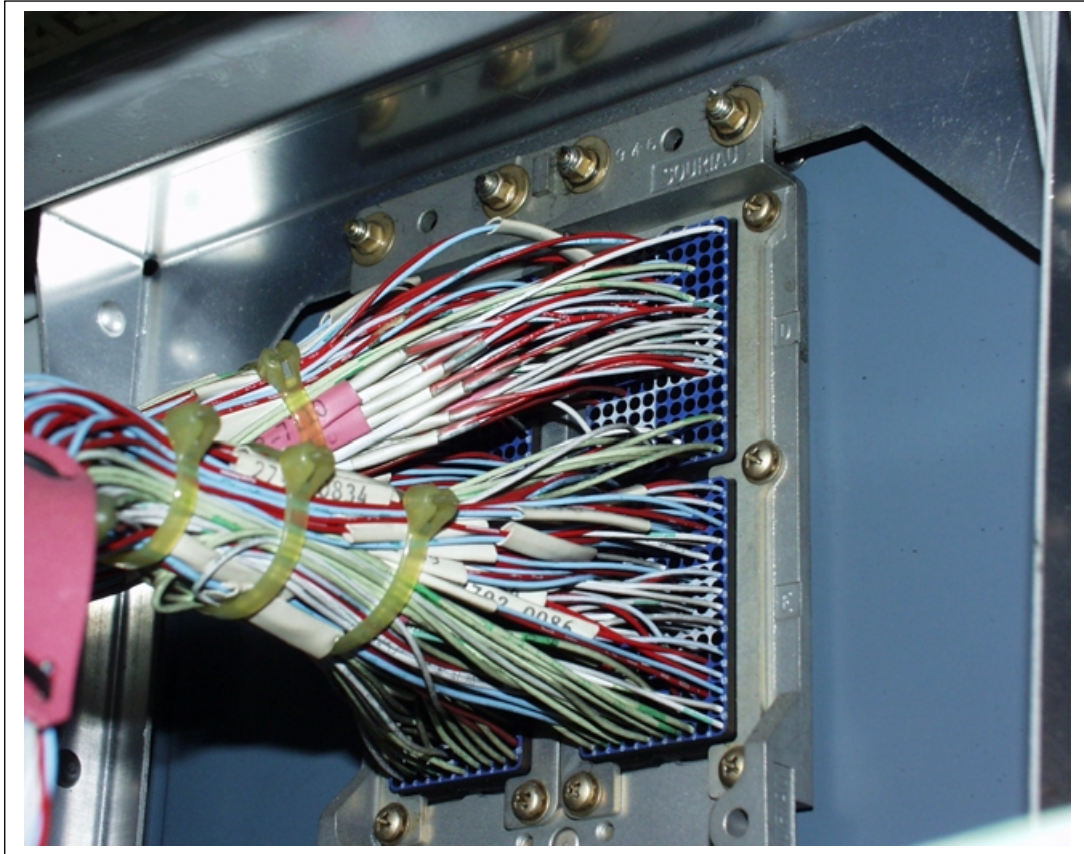
The attempt to replace the connection pin without replacing the whole plug segment was not successful. A safety spring of the connector pin had come out and could not be inserted again. Therefore it was decided to replace the plug segment AE, but there was a problem, it was no suitable spare plug segment for this series of airplane on stock. Consequently it was decided to replace all four plug segments AA, AB, AD and AE. This meant that in a most confined space approx. 420 assigned connector pins had to be reconnected. As this repair work would take a longer period of time, the aeroplane was taken out of flight operations.

Rear of the plug with its four segments

It was decided to apply the "ONE TO ONE" method, i.e. the wires were disconnected one after the other from the old plug and immediately connected to the new one. The work started on 19.03.2001 in the morning shift with the replacement of the plug segments AA, AD und AE. The fourth plug segment AB was replaced in the subsequent late shift. The work was accomplished by adequately qualified aircraft electronic technicians with company internal ratings, so-called B1 and B2 qualifications.

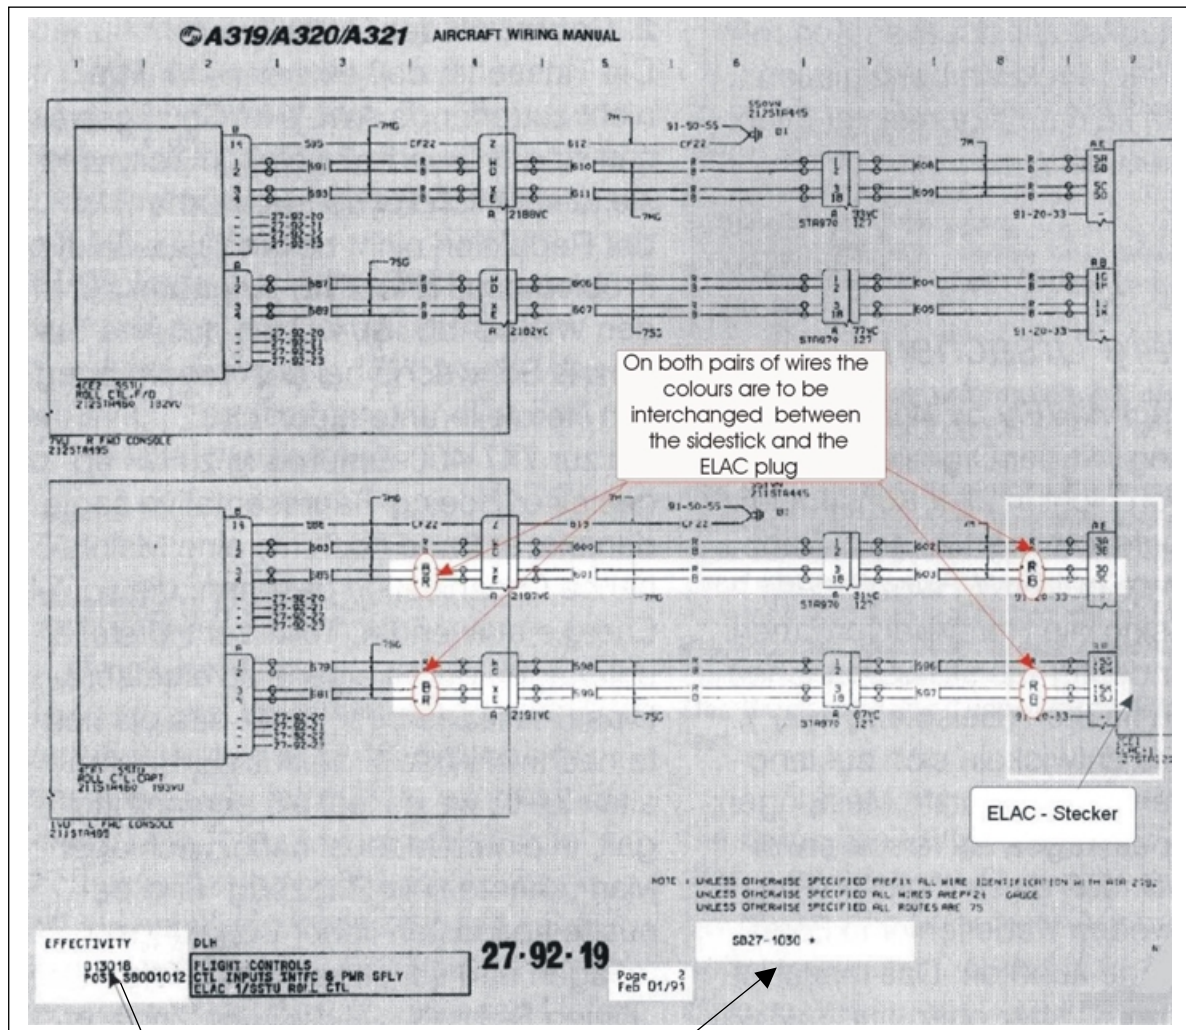
Page 2 of the AWM 27-92-19, Feb. 01/91 shows an effectivity range of 013 up to 018 (bottom left). The designation **POST SB001012** below the effectivity range **013018** on the bottom left means that this WD applies only to aeroplanes whose effectivity is within the range of **001 to 012**, if the **SB27-**

1030 has been accomplished; the accomplishment being indicated on the bottom right. The aeroplane concerned had the effectivity 017 and the SB 27-1030 had not been accomplished, therefore page 2 was applicable.

This page is applicable to all aeroplanes with an effectivity range of 013 to 018 and 001 to 012, provided on the latter the SB27-1030 has been accomplished.

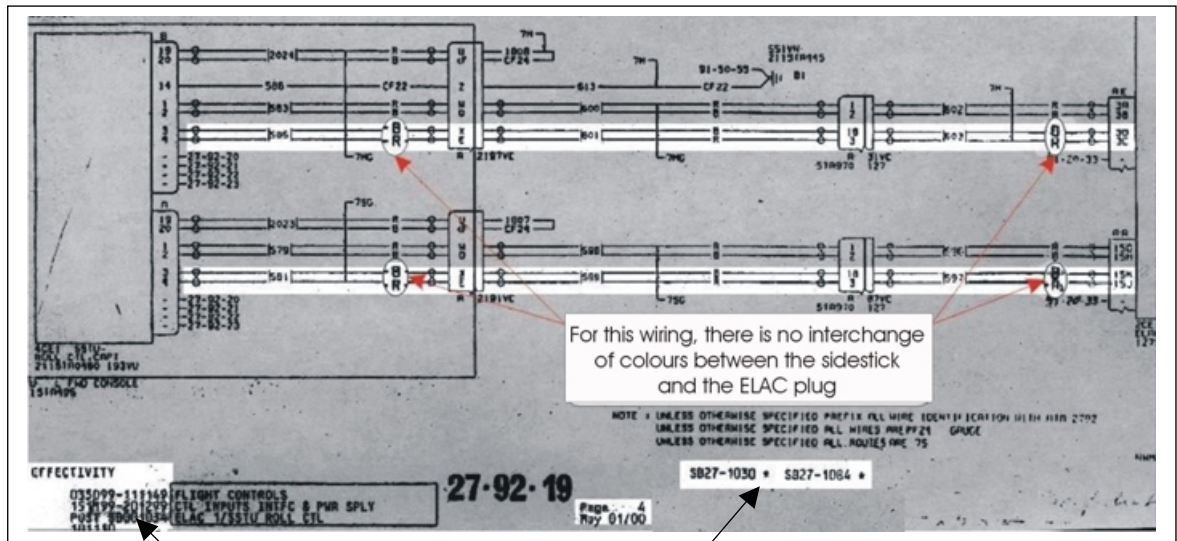
This page is applicable among other things to aeroplanes within an effectivity range POST SB from 001 to 034, provided the SBs listed on the right-hand side have been accomplished.

Page 4 shows the effectivity range from **001 to 034** following the designation **POST SB**, this means that this range applies only to aeroplanes on which the SBs indicated on this page on the bottom right have been accomplished. Although the aeroplane concerned was within this range, only the **SB27-1084** had been accomplished, but not the **SB27-1030**, thus the page was not applicable to this aeroplane. Erroneously the mechanics thought page 4 to be applicable as the SB 27-1084 had been accomplished on this aeroplane.

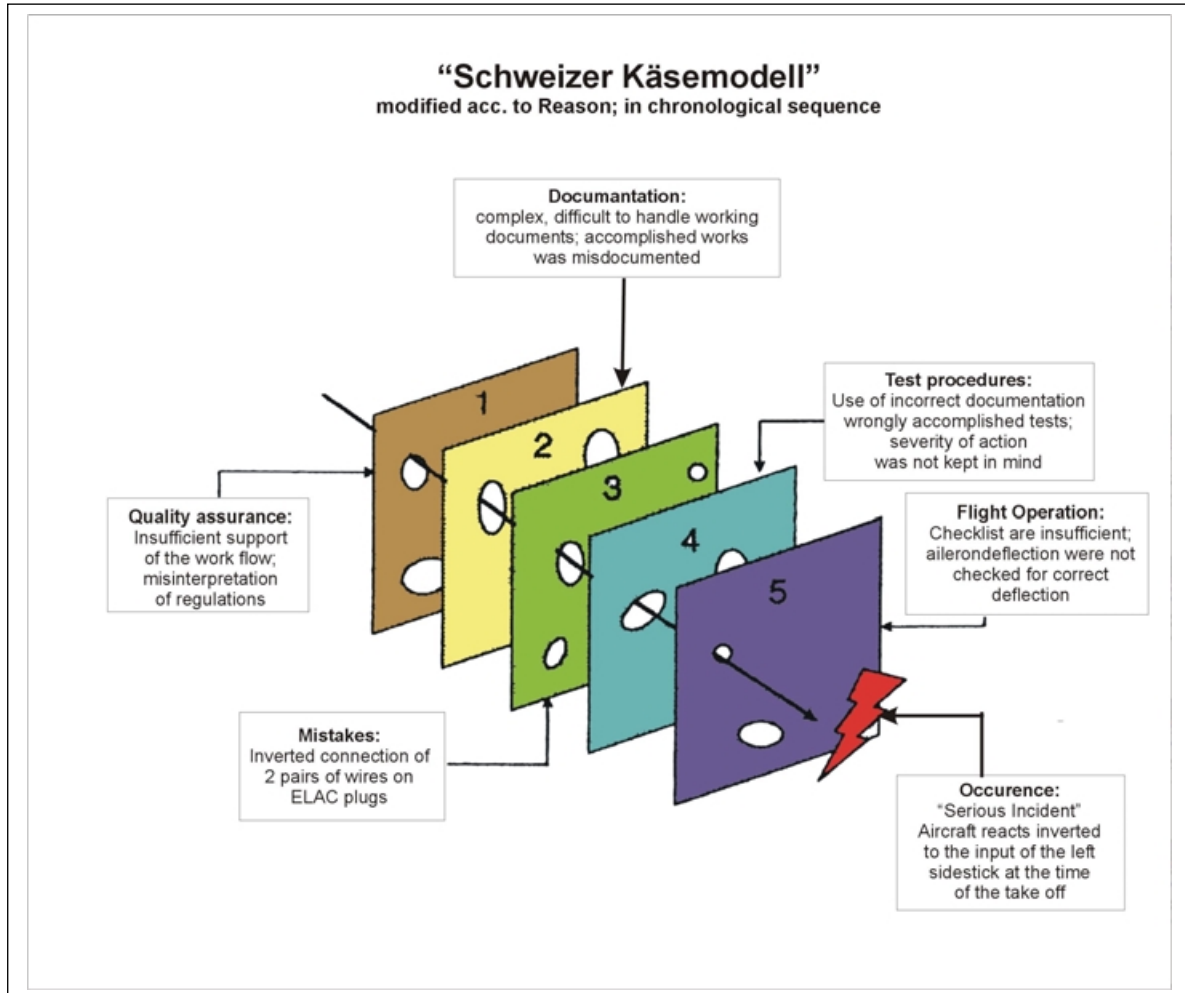
2.5 Illustration of the causal chain

The investigation has revealed that numerous factors have contributed to this occurrence. The causal chain was never interrupted. In order to illustrate this the Swiss Cheese Model according to Reason was modified in to a chronological sequence.
