Midair collision, Accident occurring July 1, 2002 involving a Boeing 757-200 and Tupolev Tu-154M

Investigative Body: Federal Bureau of Aircraft Accidents Investigation (BFU), Germany

Investigation Report

AX001-1-2/02
May 2004

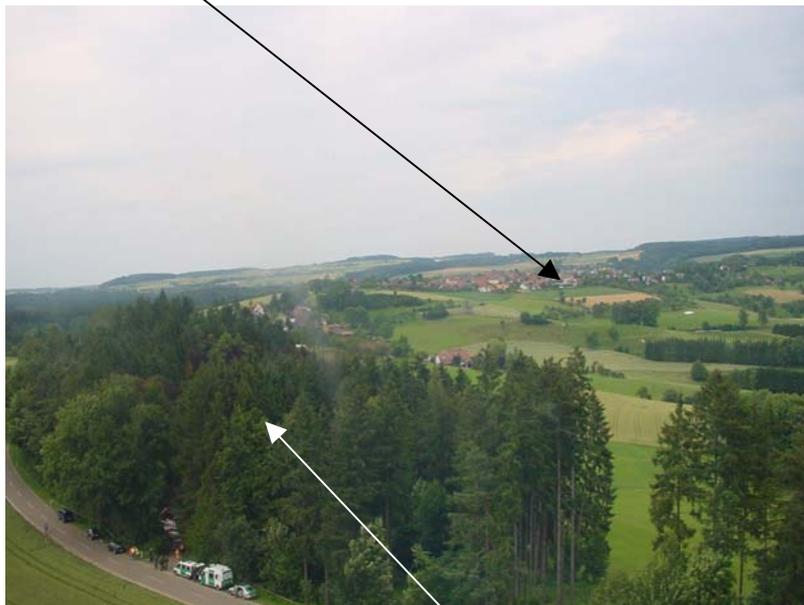
Main wreckage

The main wreckage of the B757-200 was found approximately 1 km west-south-west of the village of Taisersdorf, eastward of the street K 7788 in a mixed forest. The accident site covered an area of 110 m x 30 m.

The B757-200 had crashed with a negative pitch of about 70° into a mixed forest. The cockpit stuck about 2 m deep in the loamy soil of the forest. The airplane's longitudinal axis pointed to the east-north-east. The crash and the fire had destroyed most of the fuselage except for the empennage and about 2 m of fuselage. The cargo had been stored in cargo shipment containers. These were now only identifiable as fragments and were scattered over the whole crash site of the fuselage.

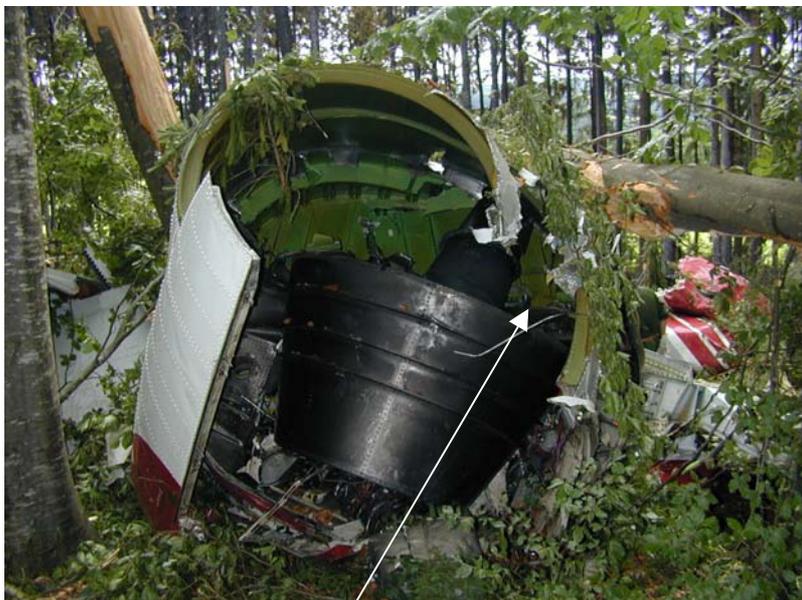
exhaust of APU

The APU access doors were present. The APU was torn off its bracings.

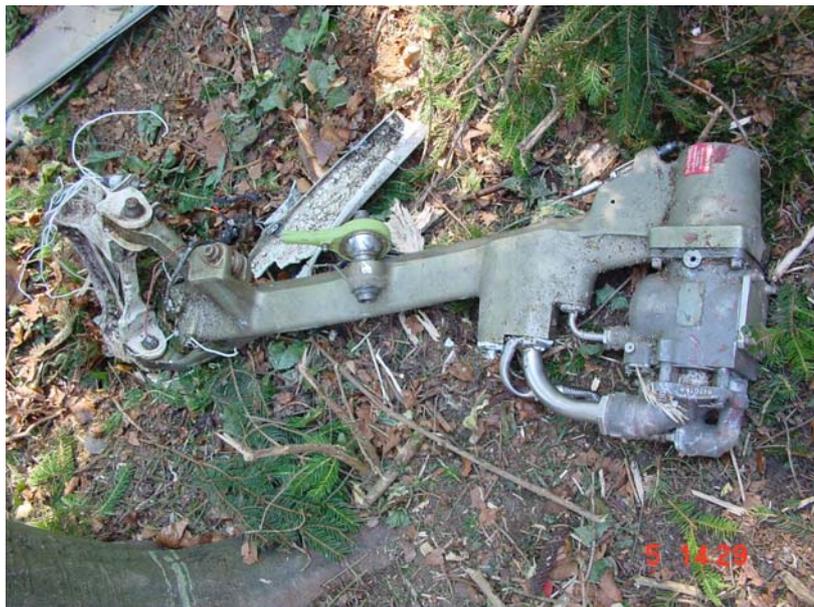
ram air turbine without propeller

The ram air turbine (RAT) was found almost undamaged and without any traces of fire.

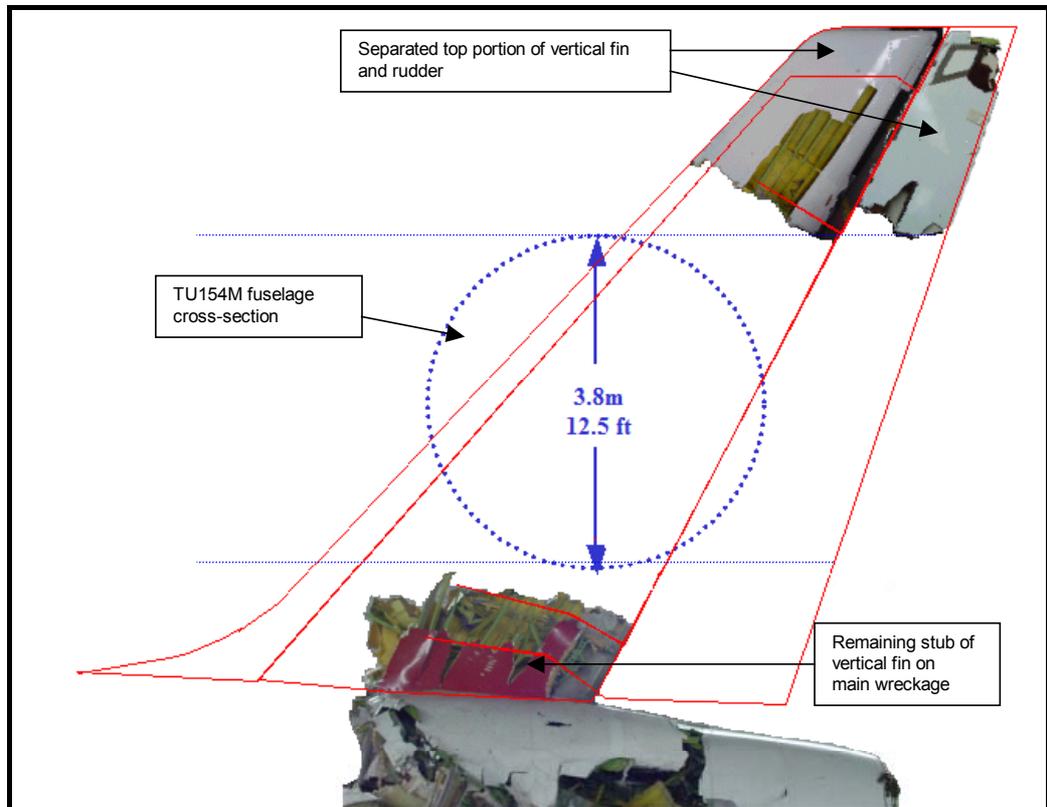
- On collision, the airplane lost about 80% of the vertical tail. The manufacturer stated that the loss caused the airplane to become aerodynamically unstable in the yaw axis.

B757-200 damage on vertical tail in relation to cross-section of TU154M

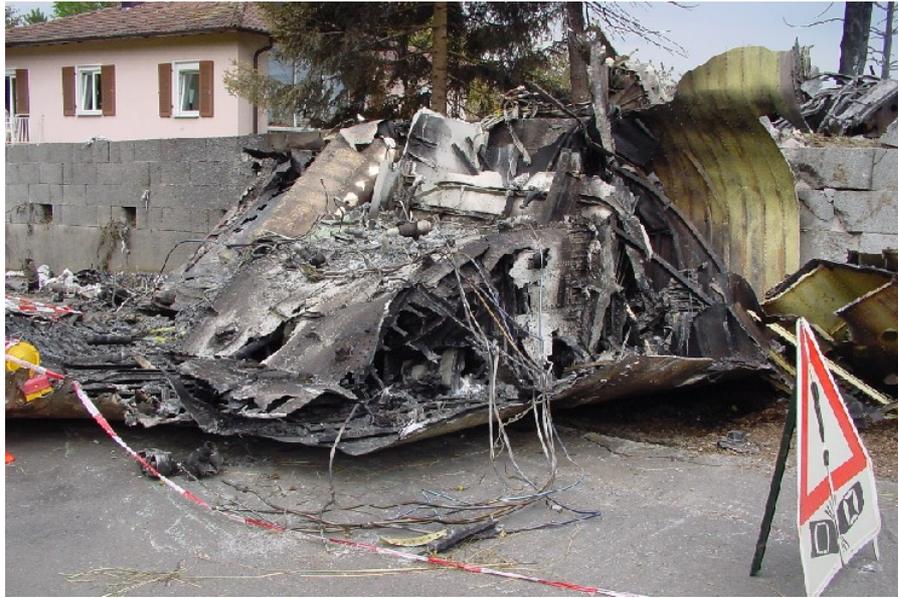
The centre wing section was found on the paved access road in front of a wall. The wreckage part itself had burnt. The fire had affected the road very little. The right wing had separated from the centre wing section at the area of the wing root.

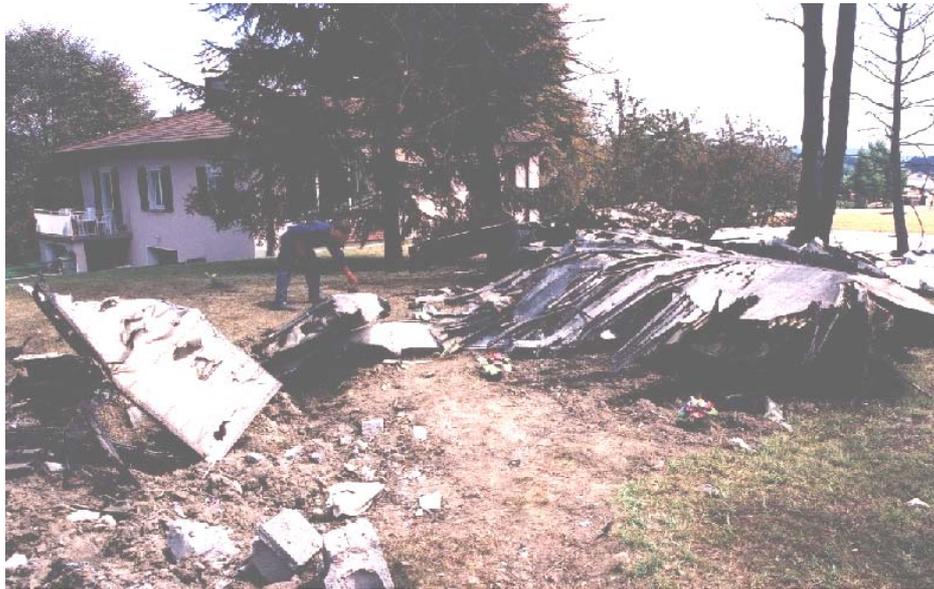
Left wing

The connection of left wing and centre wing section consisted of the trailing edge in the area of the inboard flap and hydraulic lines. The wing was found at a residential garden at a level higher than and at a distance of about 10 m from the house. The wing had been separated from the leading edge in a transversal line in the direction of the fuselage. The point of rupture is located between wing root and inboard slat. Some parts of this wing area were not present.

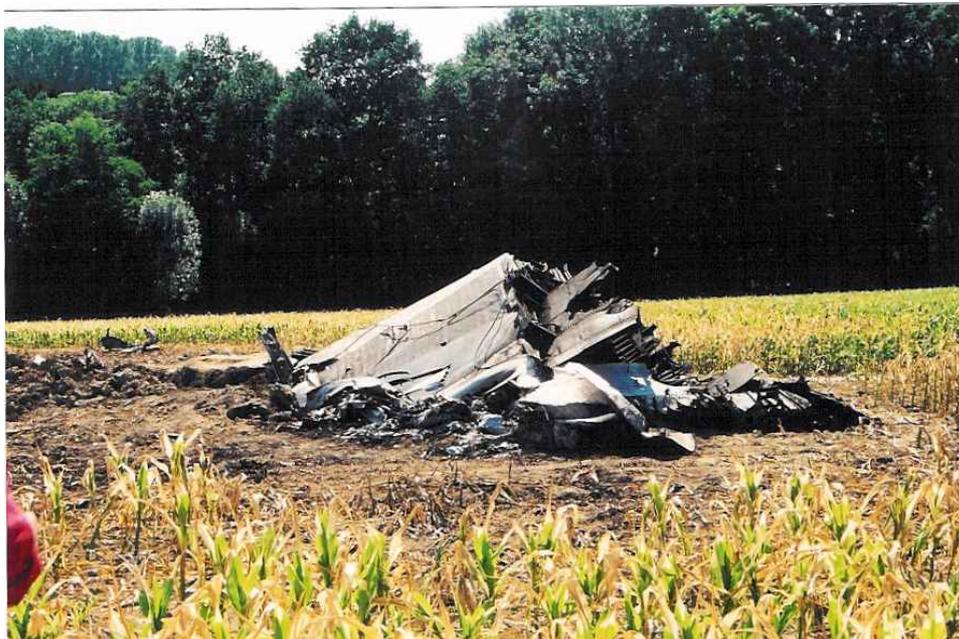
overall view – right wing

The wreckage part was found in a corn field some 800 m south of the accident site of the fuselage and some 30 m west of the district road 7786 north of the village Aufkirch. Leaking and burning fuel affected the plants in a radius of 15-20 m around the crash site. The plants showed a brownish colour.

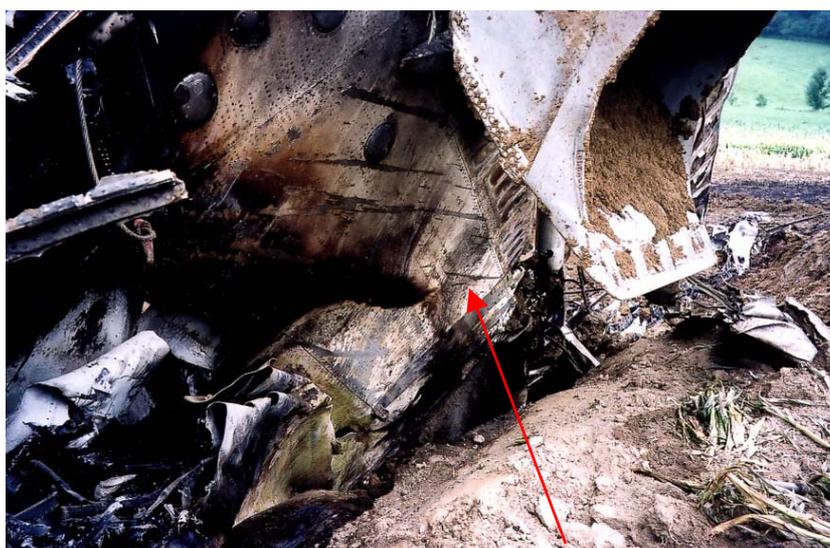
The ditch caused by the impact had a length of about 18 m and pointed into the direction of 228°. The inner section of the wing from the wing root to the main landing gear stuck 3.5 m deep in the earth. Most of the outer section of the right wing from the main landing gear to the wing tip had been destroyed by the fire except for the leading edge and the slats. A 6 m long wreckage part of the right wing's upper surface including the remains of the registration marks was found some 20 m from the wing's crash site. On the wing's lower surface between the wing root and the main landing gear scratch marks of about 3.6 m length and 0.9 m width and red paint transfer were found. The flap track and carriage of the inner flap, one landing gear door and the rear part of the main landing gear fairing were missing.

lower surface of the right wing with scratch marks

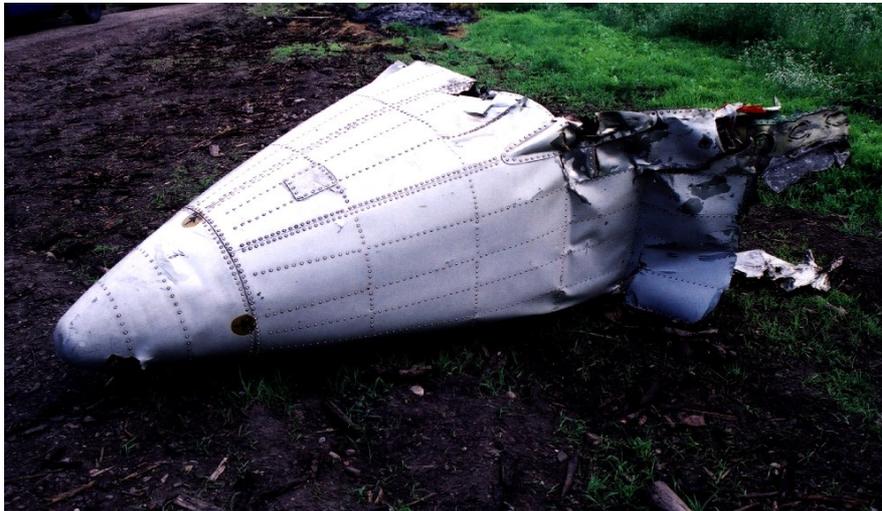
Fairing of right main landing gear

A 2.80 m long part of the TU154M's fairing of the right main landing gear was found 1 kilometre west of Steinhöfe. It showed traces of red paint and remains of the honeycomb structure of the B757-200.

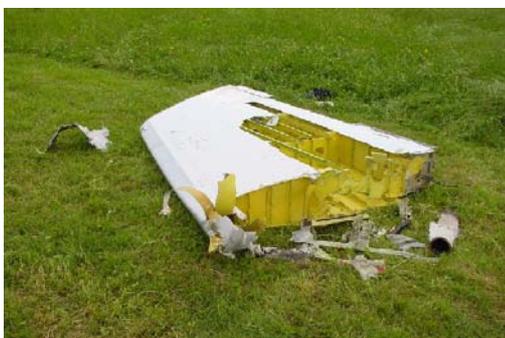
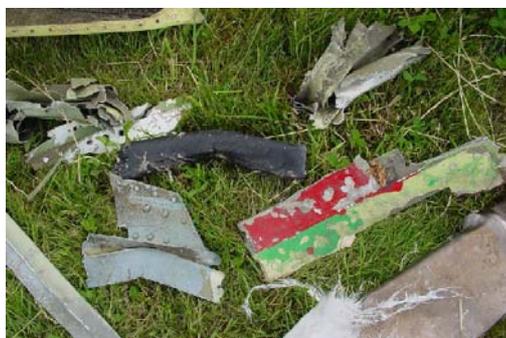
West of Altheim, debris of both airplanes was found on an area of about 4 km². The top part of the B757-200's vertical stabilizer was found in the immediate vicinity of two parts of the Tu-154's left wing leading edge of about 30 cm in width each.

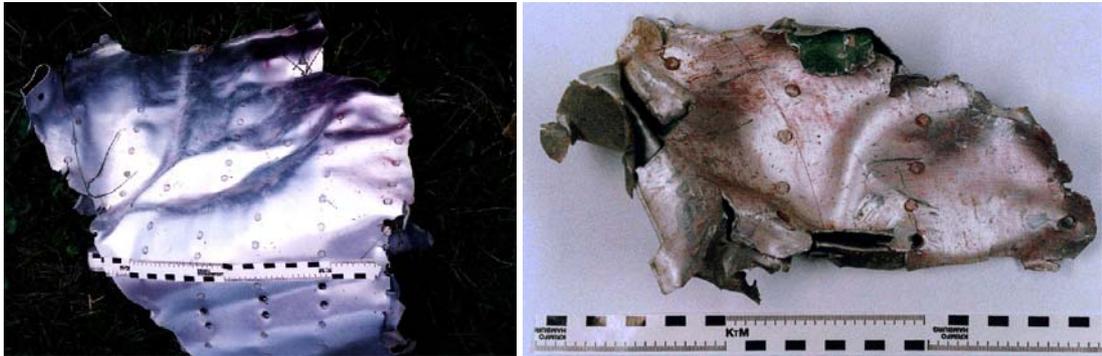
On the left wing collision traces between the wing root and the inboard slat were found. The fragments of the wing leading edge showed traces of red paint.
