Failure of braking, Accident occurred on 21 May 1998 to Aircraft Airbus A-320-212 Registration G-UKLL At Ibiza Airport, Balearic Islands

Investigative Body: Civil Aviation Accident and Incident Investigation Commission (CIAIAC), Spain

TECHNICAL REPORT

A - 19/98

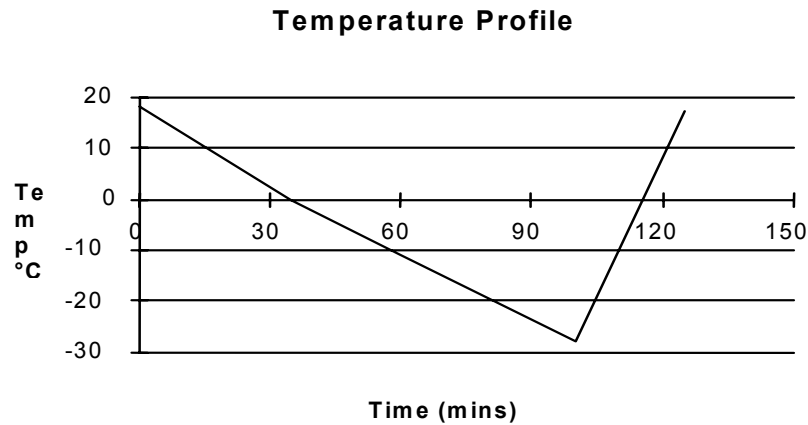
The initial test roughly followed the total air temperature profile for the accident flight, as derived from the FDR. Thus the valve was cooled at a near-constant rate to the lowest value of -28°C before being warmed up again to +17°C, as shown below:

The BDDV function was tested after one hour, at which point the temperature was -11°C , with the hydraulic fluid temperature at -3°C . A satisfactory pressure output was obtained in response to brake pedal input. However, when the test was repeated after 1 hr 25 min elapsed time, with the test chamber and fluid temperatures at -20°C and -12°C respectively, no output was obtained, thus reproducing the failure condition. This condition persisted at the lowest temperature of -28°C . The ensuing warming-up process was intended to simulate the descent and landing on the accident flight. After reaching $+17^{\circ}\text{C}$ the fluid reservoir temperature was still at -16.8°C , although its temperature at the input to the BDDV was $+12.9^{\circ}\text{C}$. The left and right brake functions were tested in turn by applying the maximum input pressure of 12 bar, and maintaining it for one minute. No brake output pressure was obtained on either side. After waiting an additional minute, the tests were repeated, and it was found that normal operation had been restored.

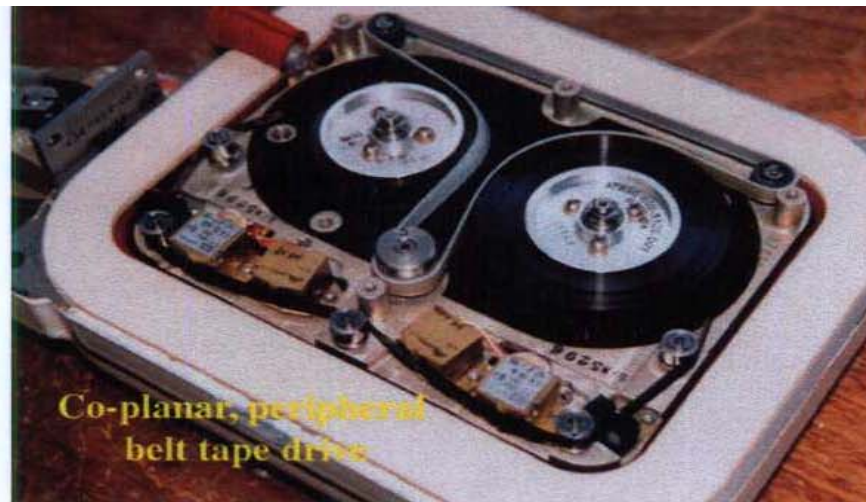
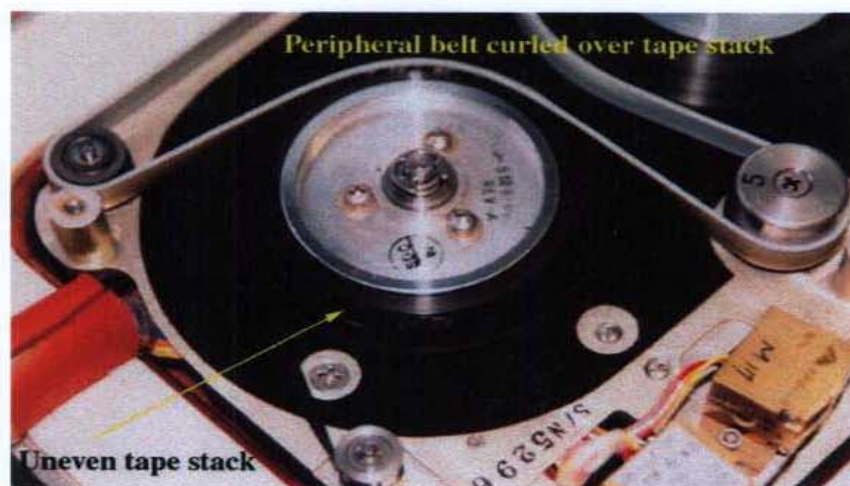
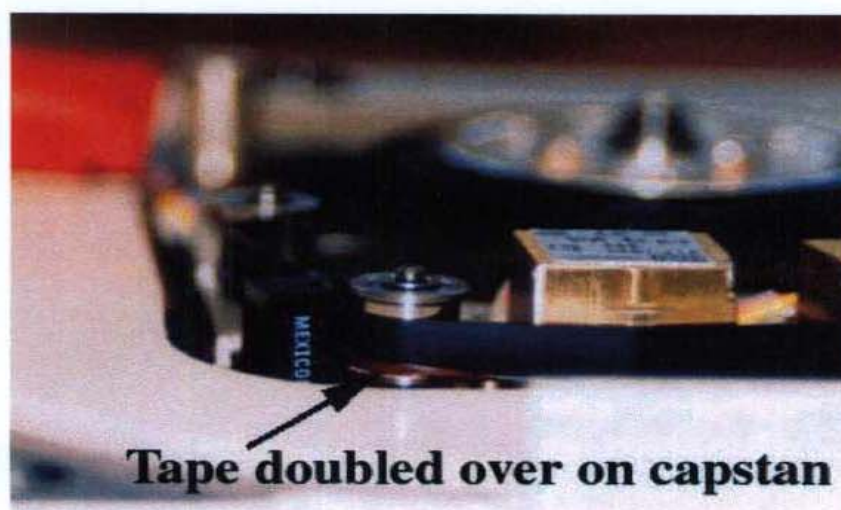
DFDR internal fault photographs.

The unit was then examined in Madrid at the airline workshops. The tape enclosure was opened and the tape found to be damaged such that the unit would not run. The supply and take up reels are driven by a peripheral belt. As found, the peripheral belt was curled over the reel and the tape stack was uneven. The tape path from the supply reel to the take up reel, over the record heads, passes over a number of tape guides. At one of these tape guides, the tape had actually become doubled over causing damage to the tape.

During replay the FDR runs continuously and the most frequently reported failure mode in this condition is tape 'coning', where the flat disk appearance of a normal tape pack is distorted. When this occurs the tape becomes misaligned with the heads and no signal is obtained from the tape. In

this case the tape probably ‘coned’ during the initial replay by standard means, and continuing to run the recorder caused the damage seen in the tape assembly (see Appendix C).

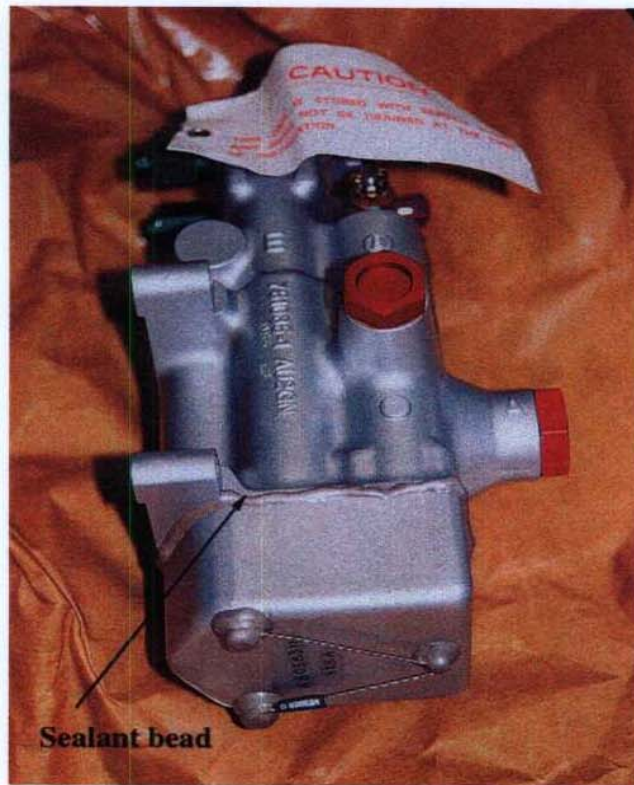
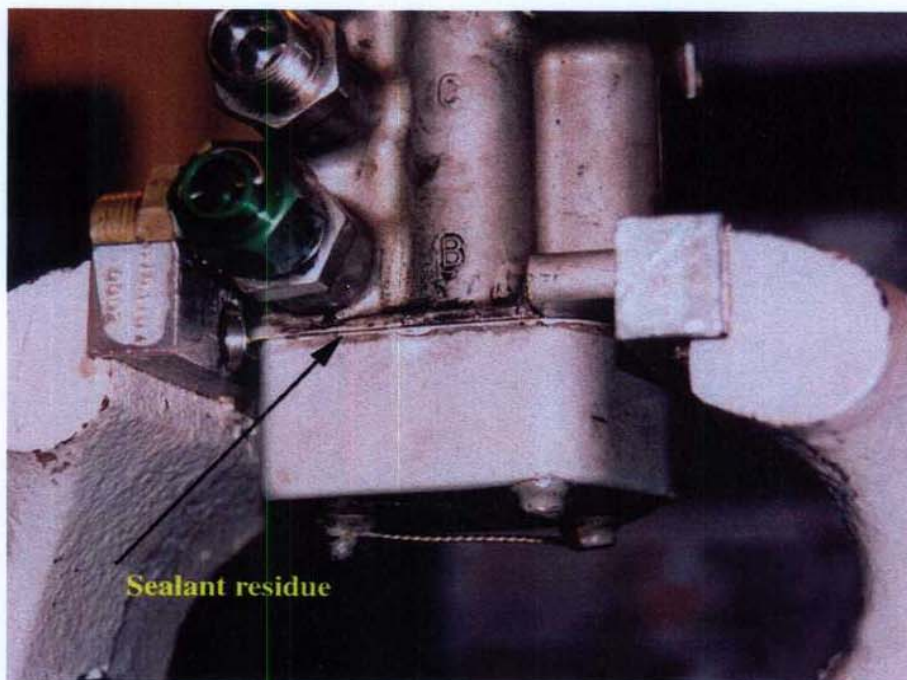
FIGURE 1. VIEW OF NEW BDDV TOGETHER WITH UNIT FROM G-UKLL

After the chamber had been force-warmed to ambient temperature, the BDDV was subjected to a further test to confirm that it was fully functional again, before being removed from the test rig. The cup-shaped cover at the base of the valve body was removed and found to contain a quantity of fluid. This consisted of 30 ml of dirty water and 3.5 ml of what appeared to be a mixture of hydraulic fluid and grease. This was later analysed by the Fuels and Lubricants laboratories at DERA, Pyestock, United Kingdom, along with the samples of hydraulic fluid taken from the BDDV prior to its installation in the environmental test rig.

The moving parts of the valve had been assembled with silicone grease and it was apparent that emulsification had occurred as result of contact with the water. However, there was no visible corrosion that may have impeded the operation of the valve. As a final check, the BDDV was reinstalled, with its cover, in the test chamber and cooled to

Following the discovery of the water in the BDDV, and the BSCU internal disagree condition highlighted by this event, Airbus Industrie issued an All Operators Telex (AOT) No 32-19 dated 07 July 1998 and an accompanying Flight Operations Telex (FOT). The AOT was mandated by four Airworthiness Directives (AD), ref. 34, 35, 36 and 37/98 issued by Certification Authority, on 8 July 1998.

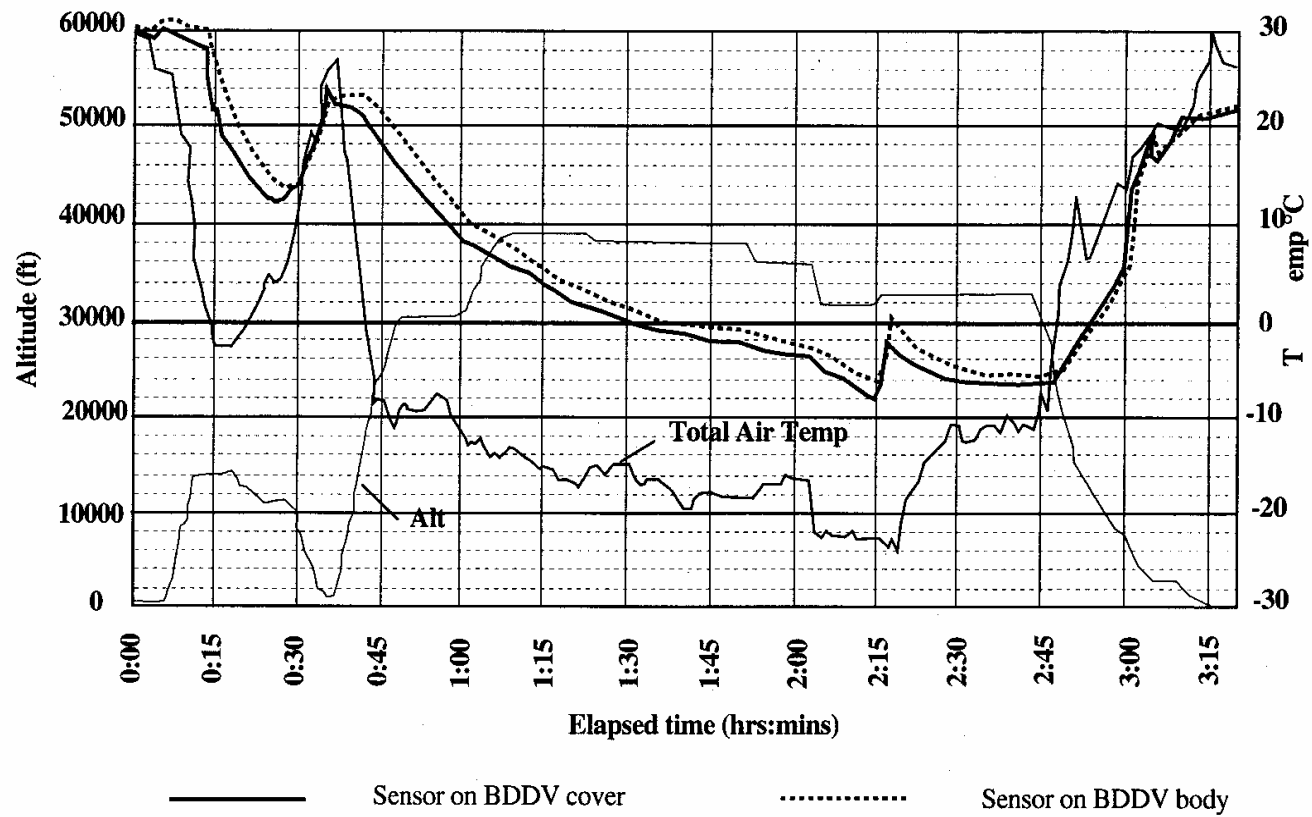
FIGURE 3. A320 BDDV TEMPERATURE MEASUREMENT TESTS

None of these tests showed any abnormality with Alternate brake operation, and so they were repeated with dry ice packed around the brake system hydraulic components in the right hand landing gear bay. This time the accident flight condition was reproduced in that there was no brake pressure in response to brake pedal deflection. Additional pressure transducers that had been installed in the hydraulic system showed that the automatic selector, the Park Brake valve and the operated valve had been functioning as expected, and that Yellow system pressure was available to the BDDV. However no BDDV output pressure was apparent, which thus indicated a problem with this component.

The tests were repeated in order to demonstrate the consistency of the failure condition, and it was found that after the BDDV had been cooled to -40°C and the ice pack removed, then brake function was not recovered until the temperature had risen to an indicated +15°C. However, it must be appreciated that these temperature values cannot be regarded as accurate, as measurement was by means of a probe attached to the valve body, which was therefore not capable of assessing the internal temperature.

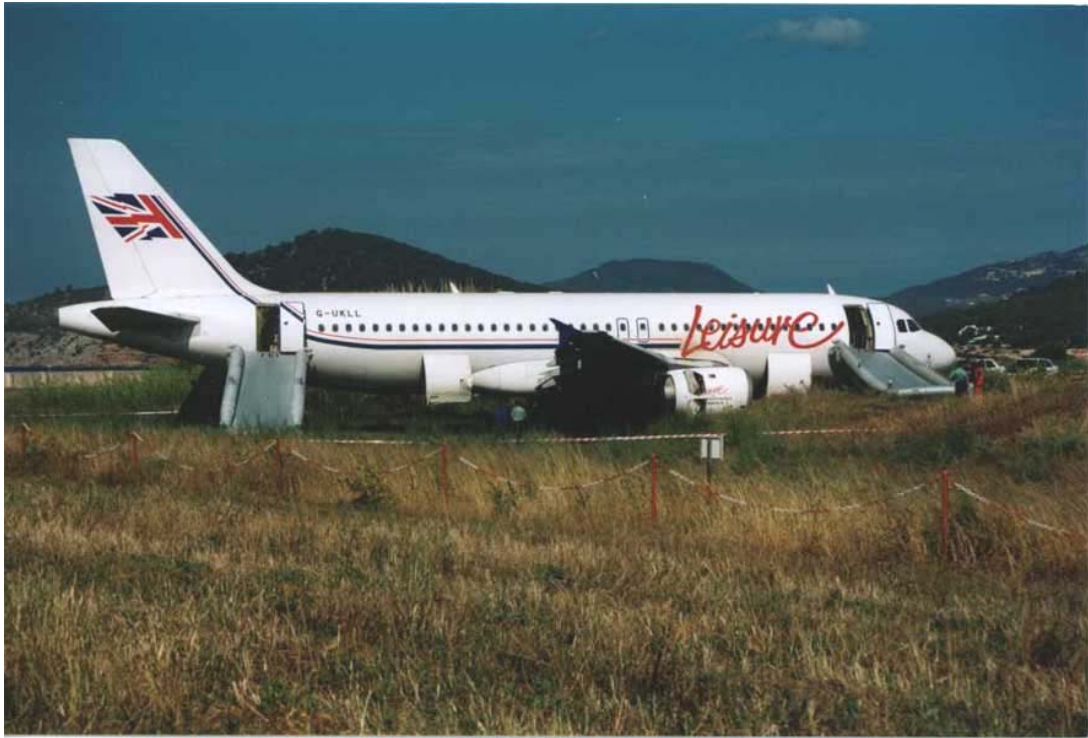
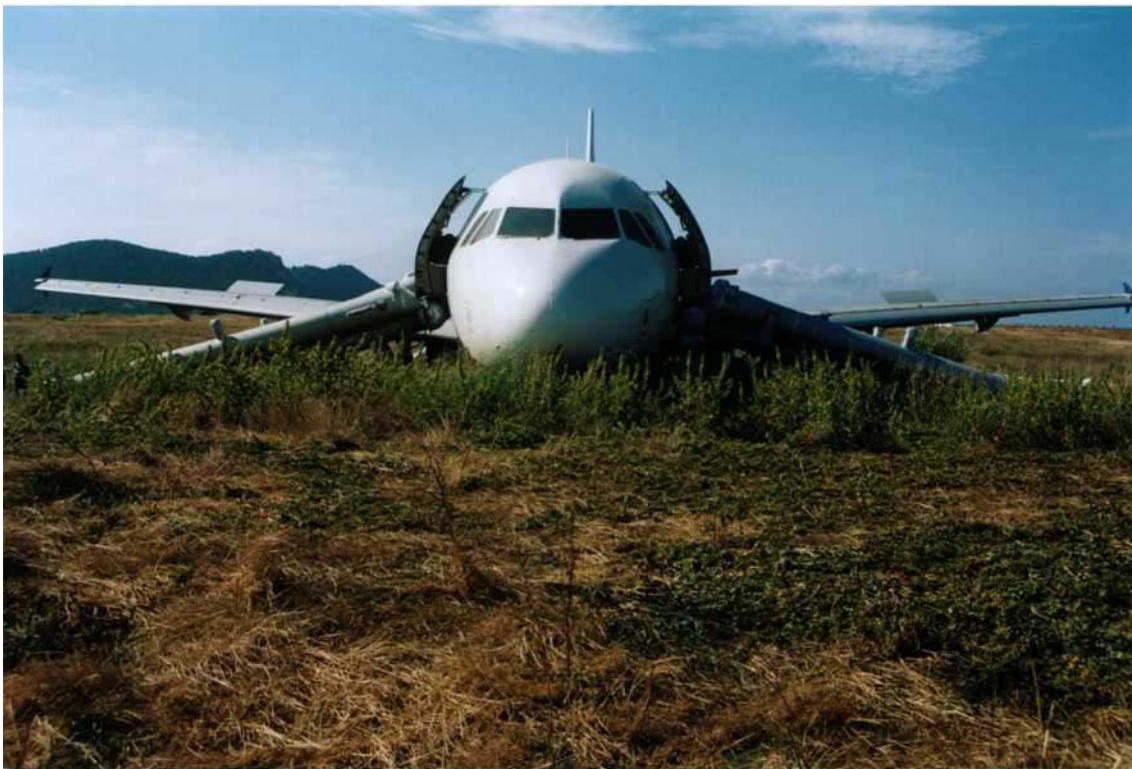
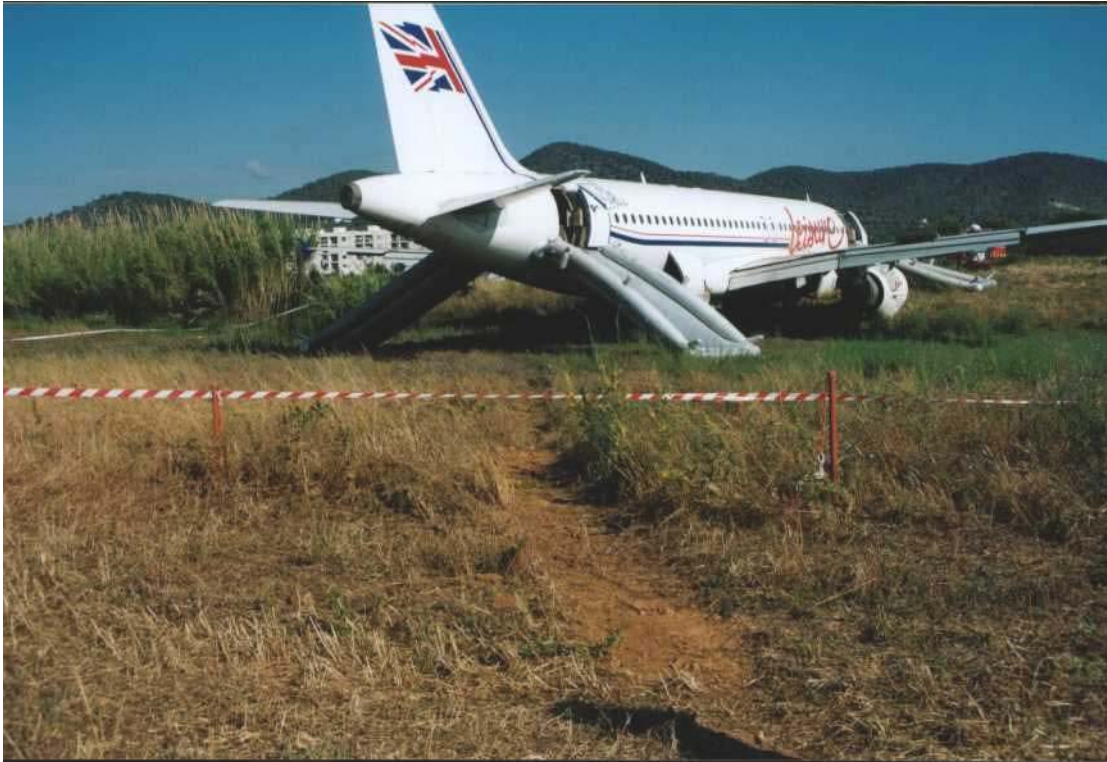
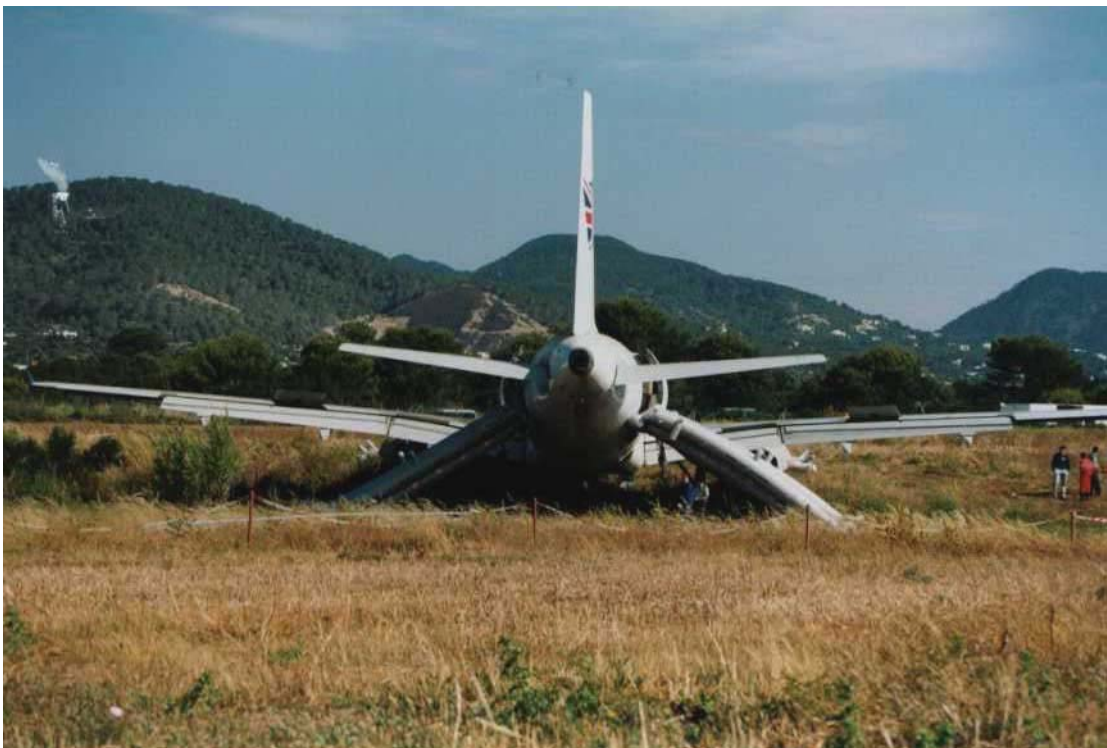
The nose landing gear had collapsed rearwards and was broken. It was found between the two main landing gear doors, which were open.

Both engine nacelles were distorted at the bottom and were partially embedded in an earth embankment. Both engines suffered damage from ingress of earth and stones. Both engine reverses were deployed. The flaps and slats were extended to the landing position.

- Nr. 1.- GENERAL VIEW.-- Right side.
- Nr. 2.- FRONT VIEW.-- Nose above a low earth bank.
- Nr. 3.- PATH ONROUGH TERRAIN.
- Nr. 4.- REAR VIEW.
- Nr. 5.-A/C PATH AND AIRFIELD LIGHTS BROKEN.
- Nr. 6.- RUBBER MARKS ON RWY 24.
- Nr. 7.- LEFT ENGINE.-- Embedded in ground.
- Nr. 8.- NOSE LANDING GEAR.-- Collapsed and broken.
- Nr. 9.- BRAKE CONTROL PANEL.
- Nr. 10.- COCPIT CENTRAL INSTRUMENT PANEL.
- Nr. 11.- RIGHT HAND LANDING GEAR. BAY.-- BDDV place.
- Nr. 12.- BSCU computer.
- Nr. 13.- Water an detergent found into BDDV lower cover.
- Nr. 14.- Lower part of BDDV jammed by presence of frozen water in its lower cover.
