Botched landing, Accident to Boeing 757-200 G-BYAG at Girona Airport on 14 september 1999

TECHNICAL REPORT

A-054/1999

Accident to Boeing
757-200 G-BYAG
at Girona Airport
on 14 september 1999

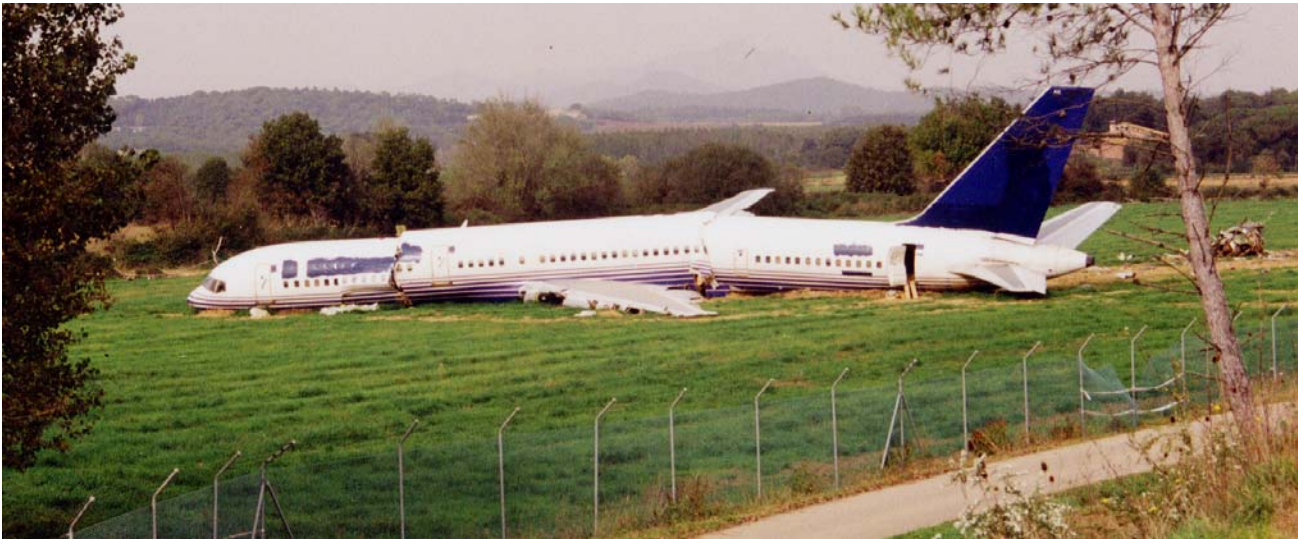
Figure 3.2 – Main Wreckage looking North-West

The aircraft came to rest, with the fuselage broken in two places, in a field outside the airport boundary and lying approximately 10 metres below the runway surface elevation. The commander was unconscious when the aircraft first came to a halt; he recovered consciousness shortly thereafter. The FO carried out the recall actions for a passenger evacuation. His seat had been displaced as a result of cockpit floor deformation and he had some difficulty in locating the required switches in the darkness.

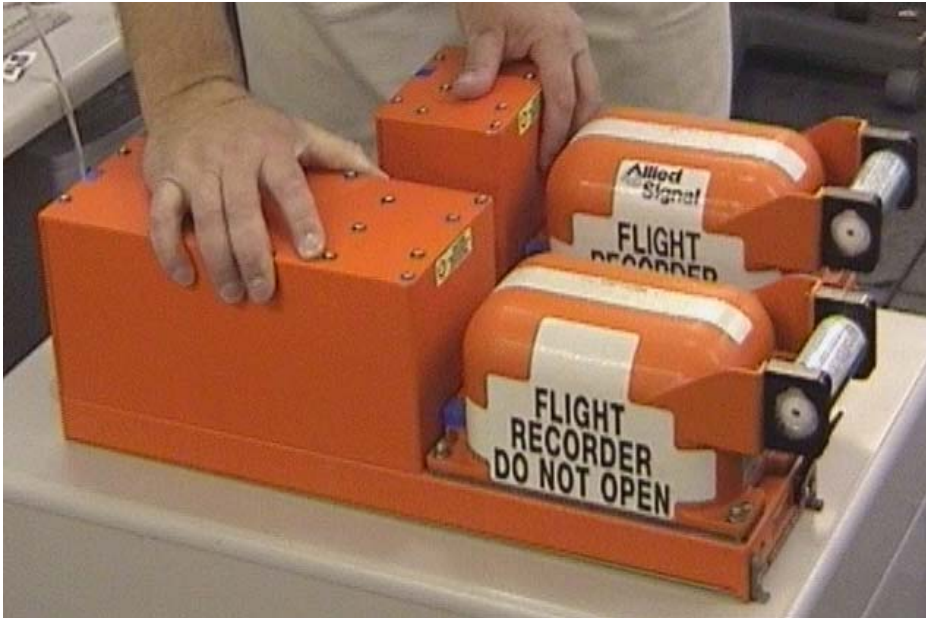
Figure 11.1 – Flight Data Recorder and Cockpit Voice Recorder

Both flight recorders had been installed in the rear of the aircraft and neither showed signs of having been damaged during the accident. A photograph of the units is shown in Figure 11.1.

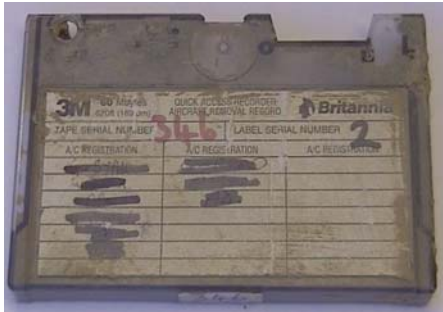
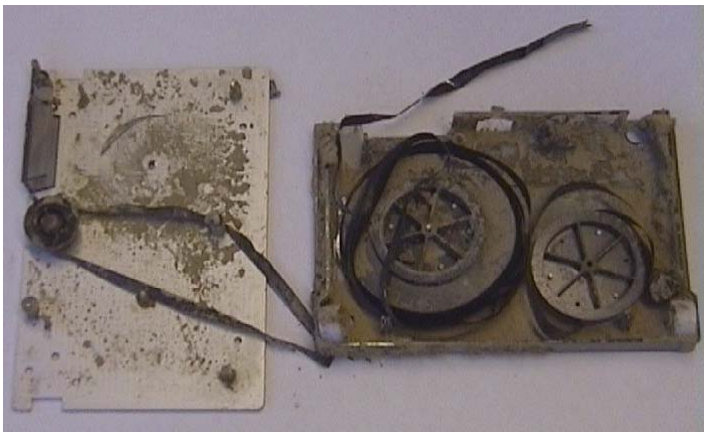
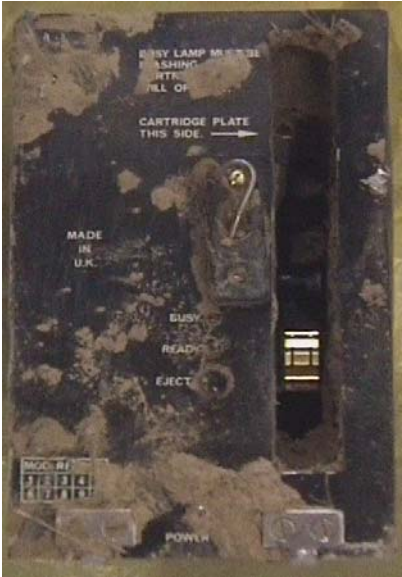
A damaged Quick Access Recorder (QAR) cassette tape was sent to the AAIB for analysis during the course of the investigation. The tape had been found at the accident site near to the QAR itself. The QAR and a small stowage locker for a spare tape had been located in the main equipment centre of the aircraft, just aft of the nose gear bay. Photographs of the recorder and damaged cassette are shown in Figures 11.2 to 11.4.

The tape was spliced at the break and wound into an undamaged cassette. Upon replay it was found that the tape was full of data but was from the period of 7 August to 8 August 1999. Technical records from the operator indicated that this may have been the last data recorded on the QAR as there were no tapes available from a later period. The presence of a quantity of mud within the cassette aperture of the QAR would also seem to indicate that no cassette was present at the time of the accident.

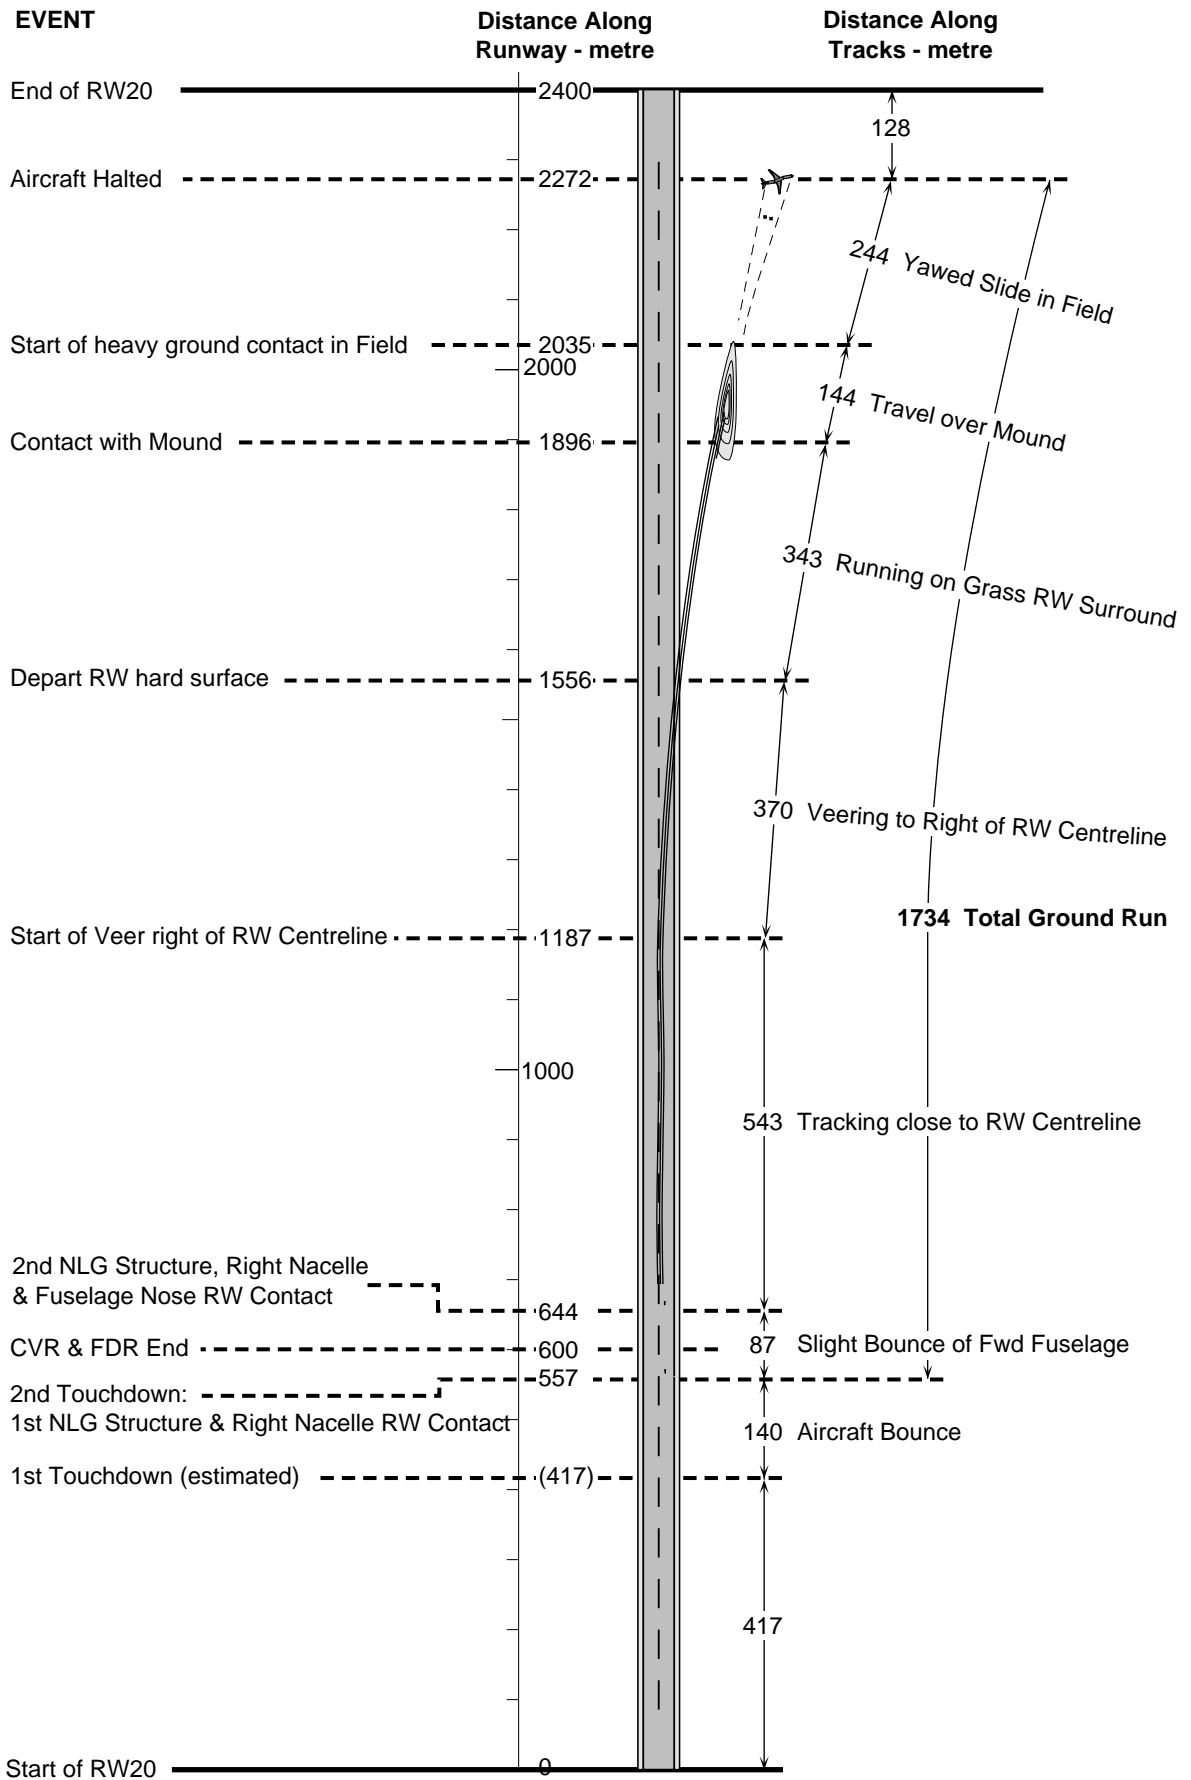
Figure 20

The aircraft electrical power failed and the emergency cabin lighting activated. The FO called out «AUTOBRAKE» (informing the commander that the system was not working) and the commander applied the brakes manually. The evidence found indicated that spoilers and thrust reversers probably did not deploy. After travelling along the runway the aircraft veered to the right and left the paved surface 1000 metres from the second touchdown point (Figure 20, Appendix A).
