Runway departure, Incident of aircraft, Airbus A-340 registration EC-IDF, at Madrid-Barajas Airport (Madrid) on 7 September 2002

TECHNICAL REPORT

IN-062/2002

Incident of aircraft
Airbus A-340
registration EC-IDF,
at Madrid-Barajas
Airport (Madrid) on
7 September 2002

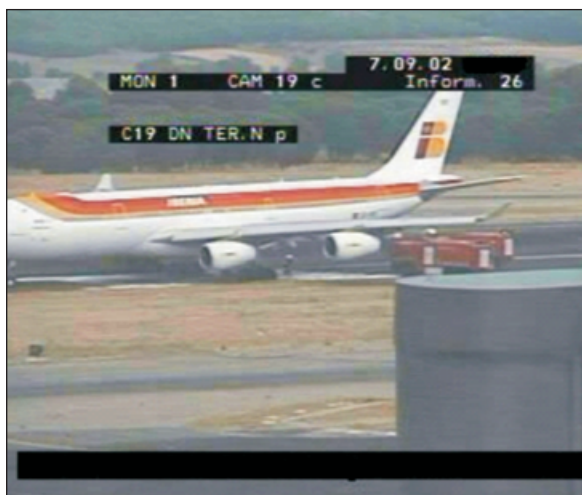
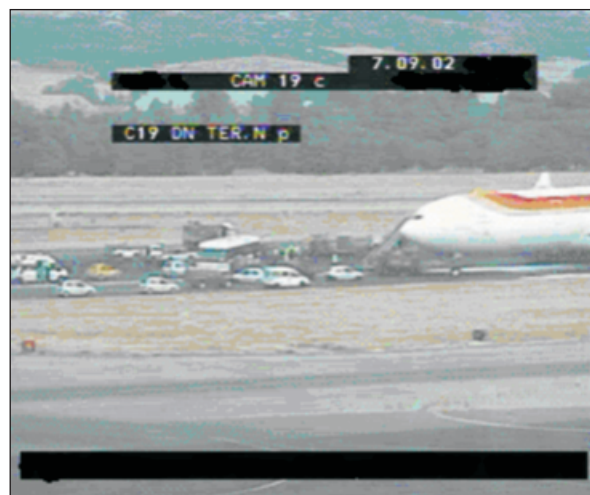
The eight wheels of the left and right MLG burst during the landing roll, and the wheel rims dragged over the runway surface. The lower part of the four left brake assemblies was totally disintegrated as a consequence of the contact with the ground. The eight wheels and their brake assemblies were replaced.

The left leg assembly of the MLG had eventually to be completely replaced, because of the loads suffered during the landing roll once the wheels had burst. There was fire on all the wheels of the left and right MLG, but no other part of the aircraft was affected by that fire.

The maintenance personnel of the operator replaced all the wheels of the left and right MLG and around 18:25 h the aircraft was towed towards the maintenance hangars. The area was cleaned and runway 33 and its lighting system were inspected. At 19:21 h runway 33 was again open for arrival traffic.

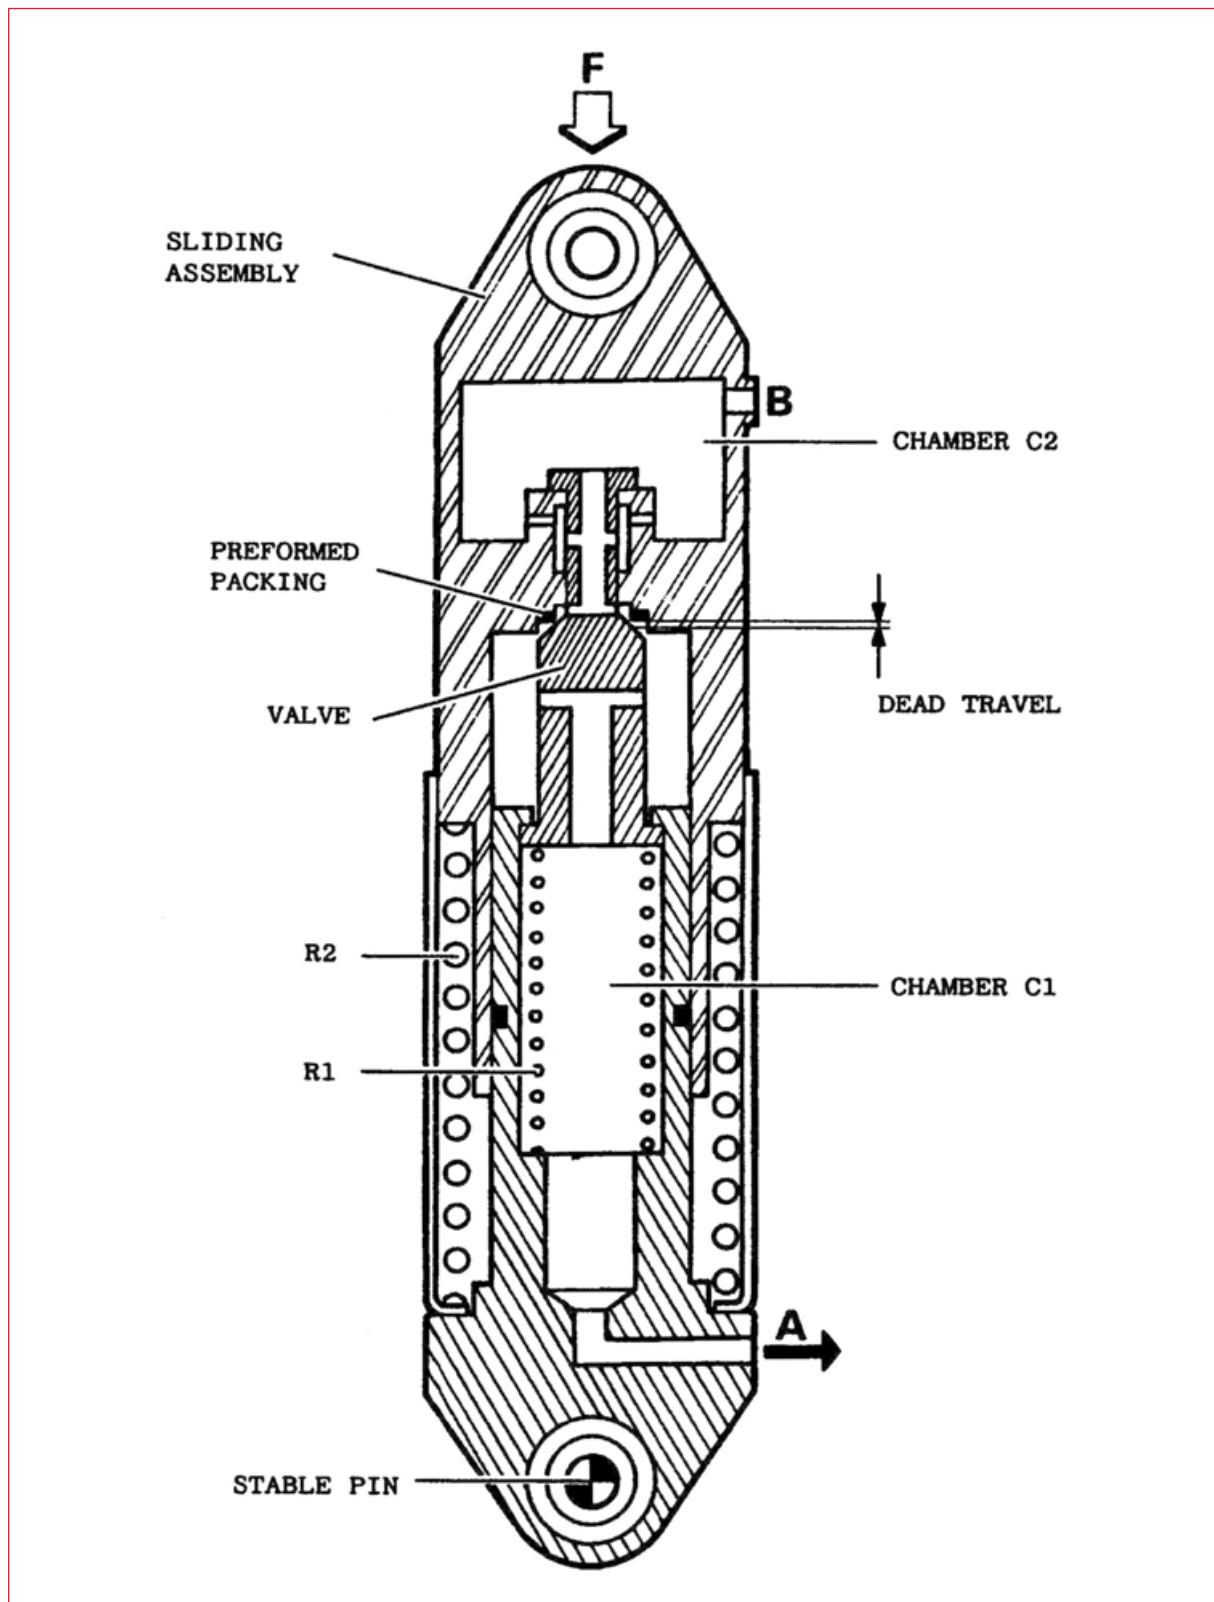
The investigation determined that the cause of the residual pressure in flight was the left master cylinder P/N C24592020 S/N H2121, which had a length and a dead band longer than specified.

Figure 4. Drawing of the master cylinder. When the pedal is pressed, a force F is applied in the upper part of the cylinder

After the incident, following a troubleshooting procedure prepared by Airbus (see 1.16) and before any further flight, the left brake master cylinder P/N C24592020, S/N H2121, was also replaced.

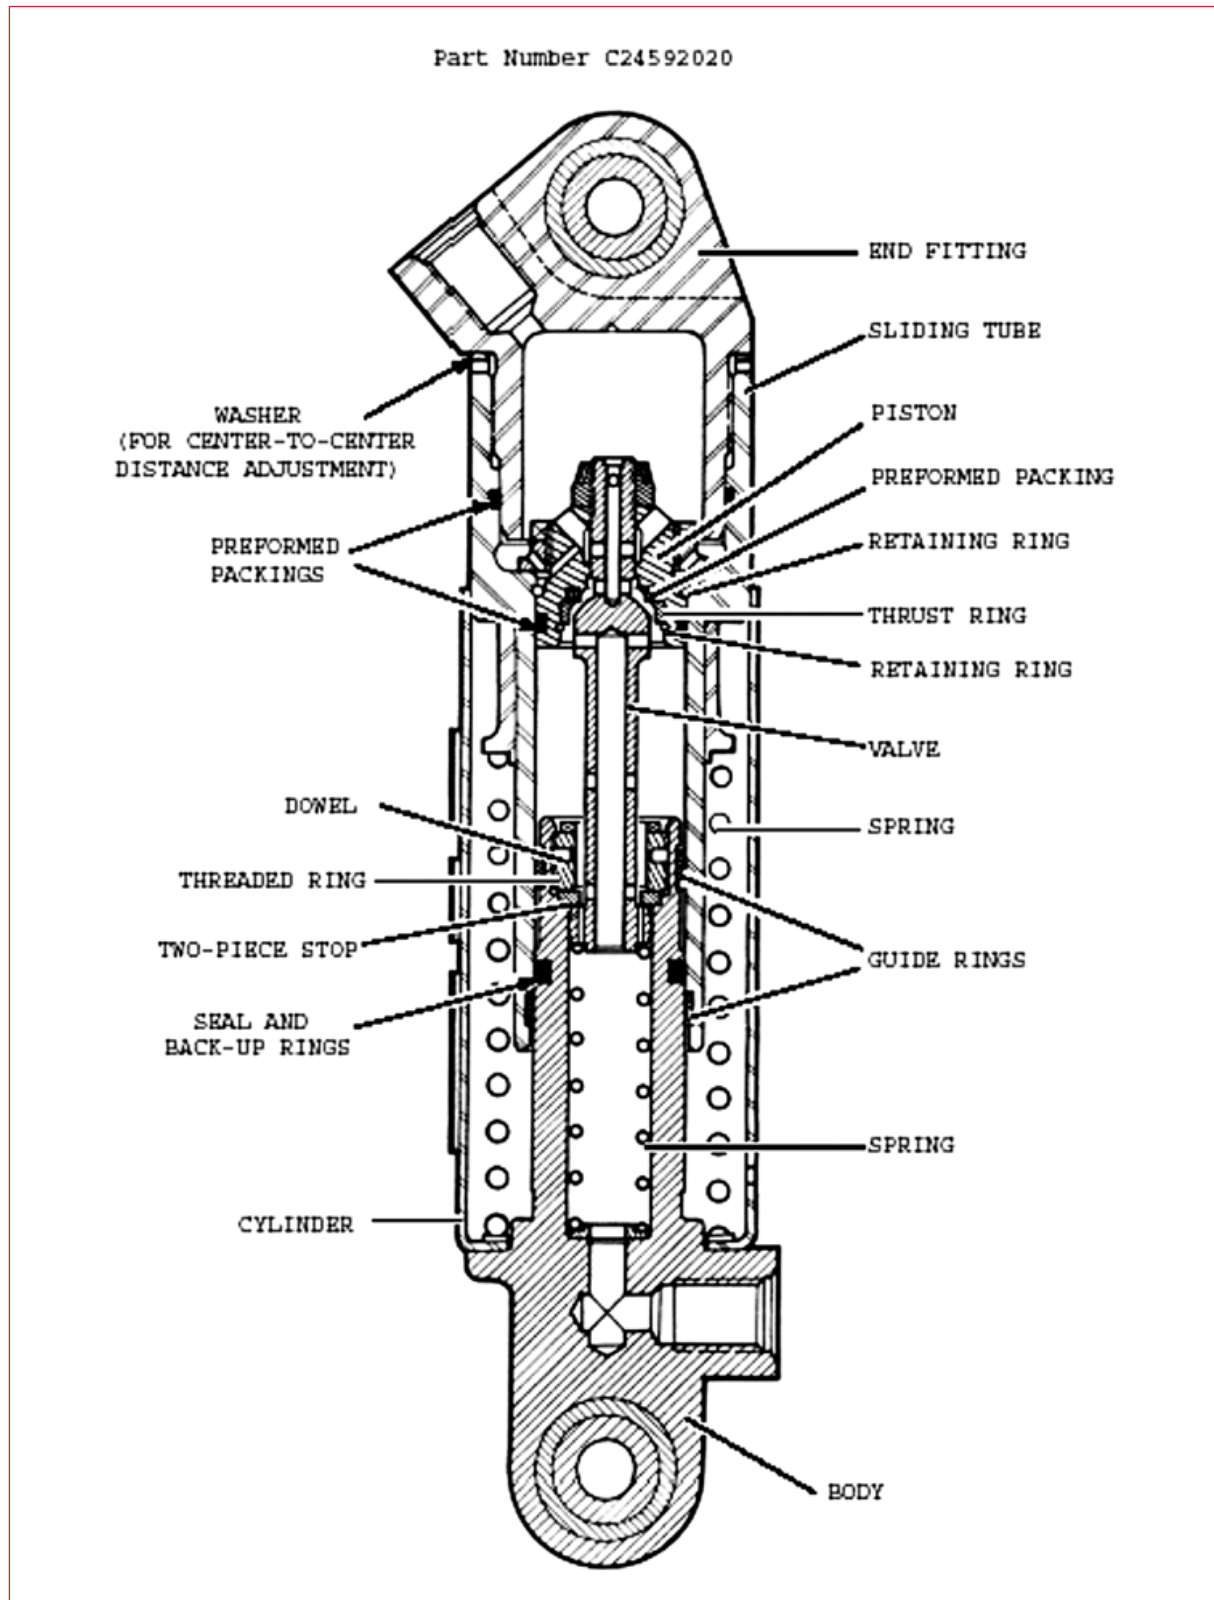
Figure 5. Detailed cutaway of the master cylinder

According to the Component Maintenance Manual (CMM) «Master Cylinder C24592020», dated 31 July 1992, the total length of the cylinder must be between 170.050 mm and 170.100 mm, and the dead band must be between 0.4 mm and 0.5 mm (there was a typo in the CMM, page 703, in which it is mentioned «dead travel 0,4 to 05»).

- The cylinder was disassembled and no noticeable defects were found. The different subcomponents were dimensionally checked and all of them were found inside tolerances except the «small» spring or spring valve (spring R1) that reached the nominal length with a load of 4 Nw instead of the 5 Nw of the specification. The specialists in the system considered this difference was not significant. The preformed packing of the valve was deformed because of the contact with the valve, and had no longer the squared section with which it was manufactured.

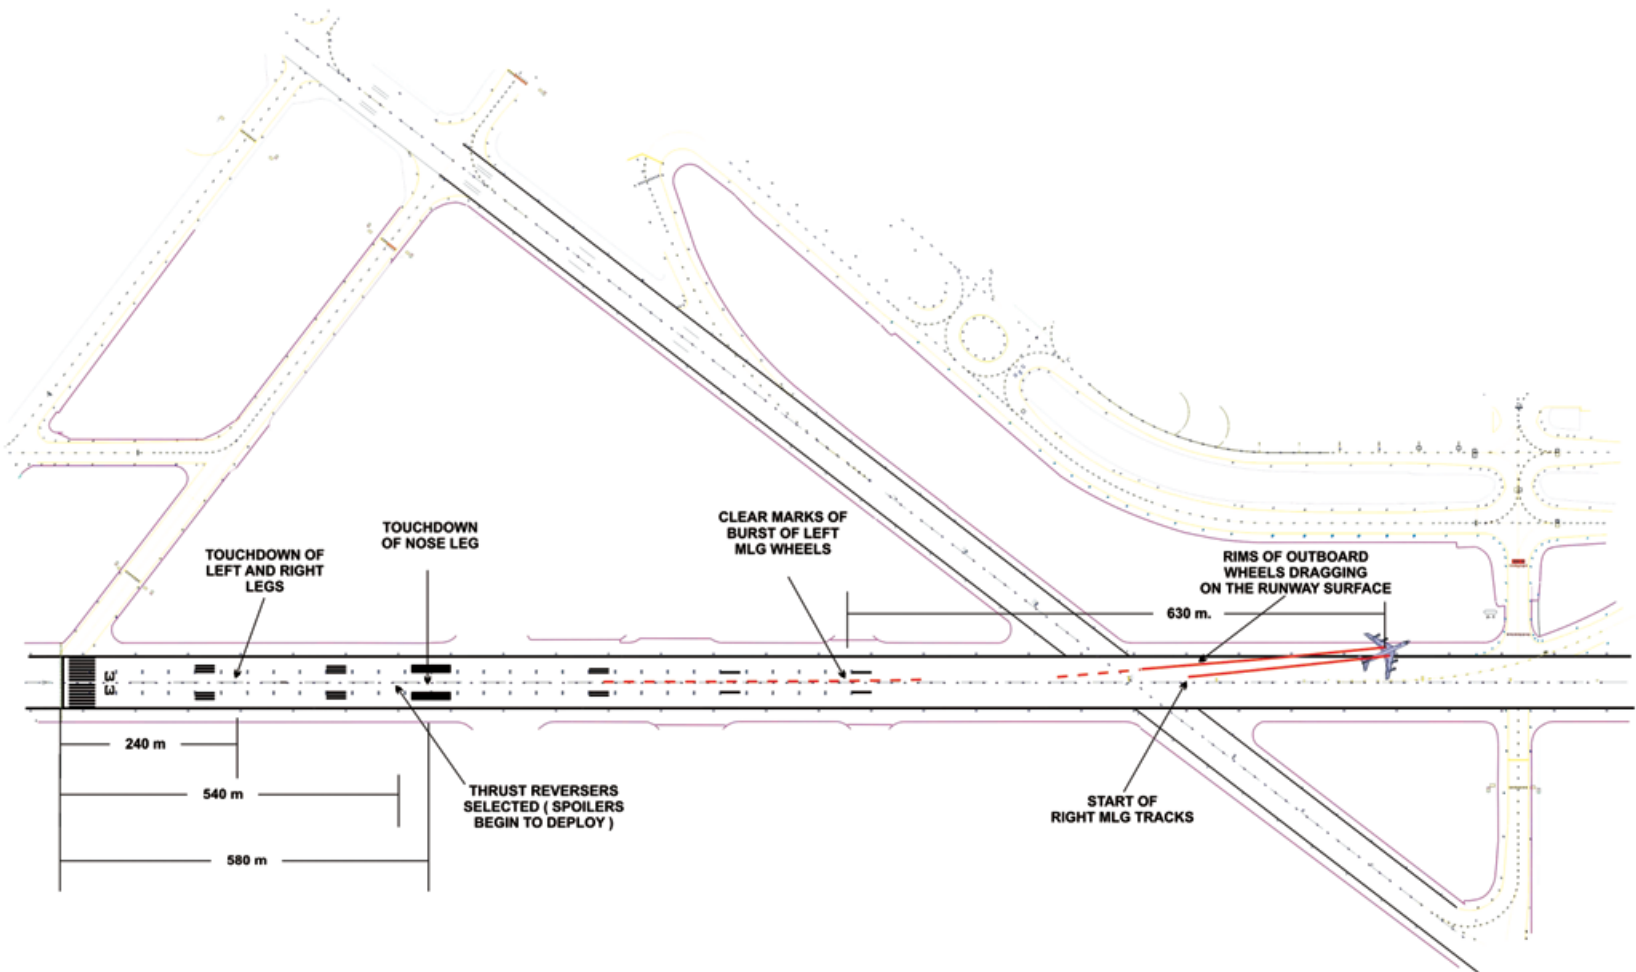
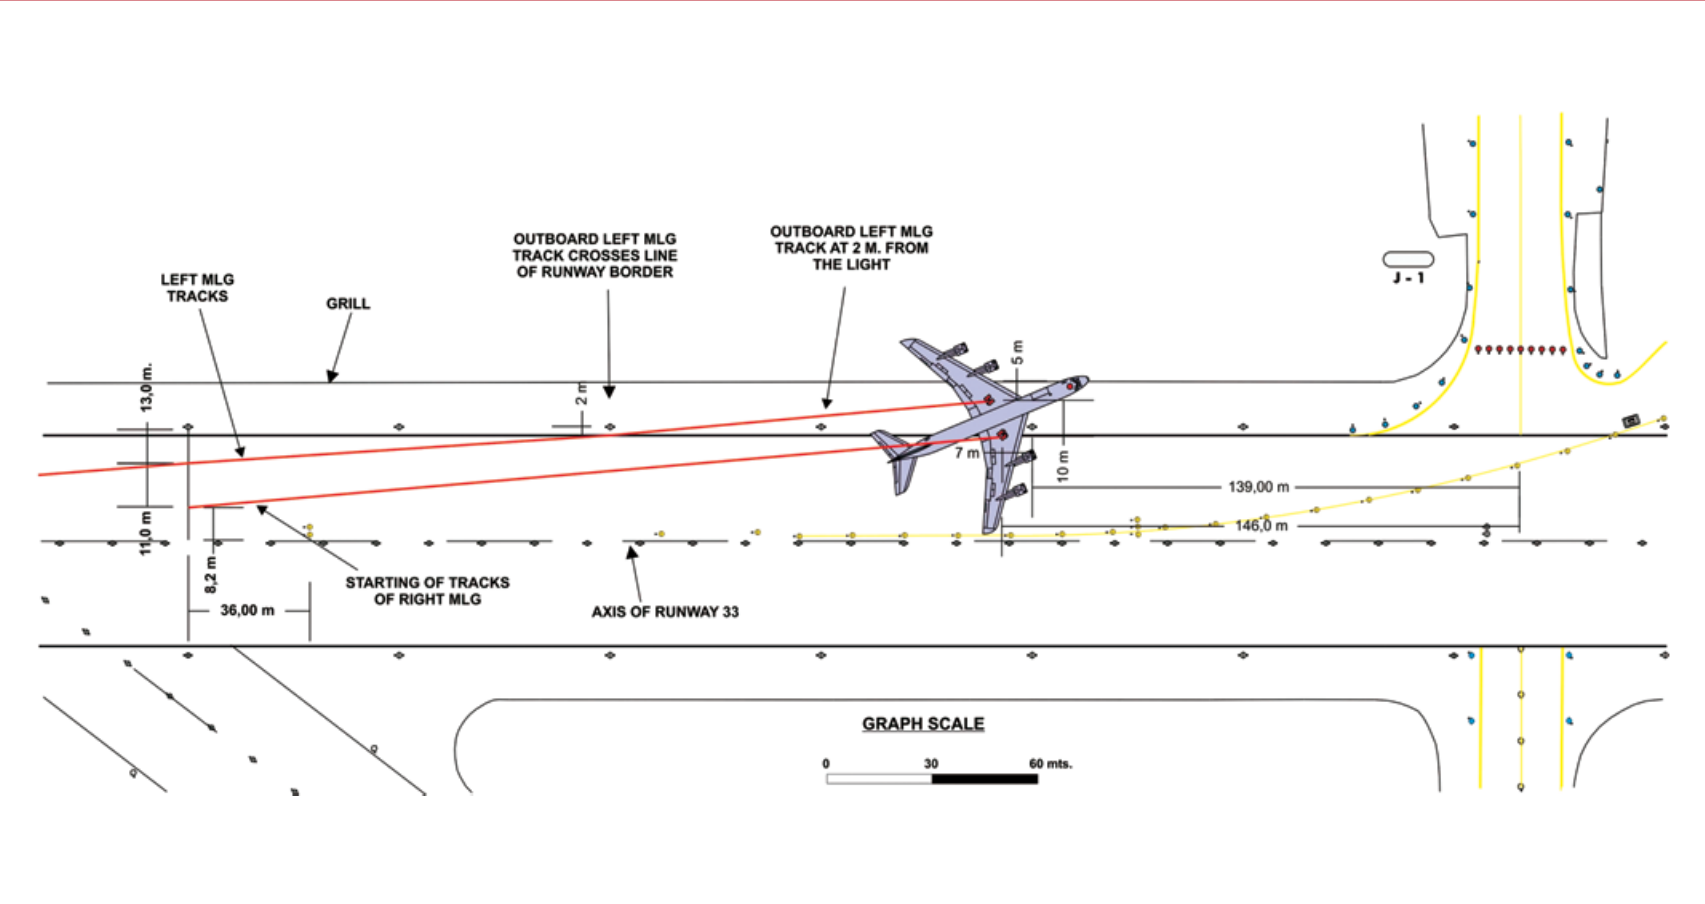
APPENDIX A
Diagram of tracks on runway 33
of Madrid-Barajas Airport

When the runway could be inspected, it was noticed that starting in the point the aircraft had stopped and coming back in the sense towards the threshold of runway 33 (i.e. going in the sense contrary to the movement of the aircraft during the landing roll), tracks of the wheels of the left and right MLG legs could be clearly noted. The tracks consisted of eight dark lines that corresponded to the sides of the tires showing that all the wheels had burst. At 60 m from the point where it was stopped, the track of the left leg crossed the runway edge lighting line (at 2 m from the next runway edge light), and 60 m backwards it crossed the white line of the runway side stripe. During the previous 60 m it could be seen that the wheel rims number 1 and 5 (both outboard wheels of the left leg) had dragged along the runway, although no appreciable grooves or other damage to the runway surface was noticed.
