Main landing gear collapse on landing, Douglas Aircraft Company MD-83, G-DEVR

Aircraft Accident Report No: 1/97 (EW/C95/4/2)

Report on the accident to Douglas Aircraft Company MD-83, G-DEVR at Manchester Airport on 27 April 1995

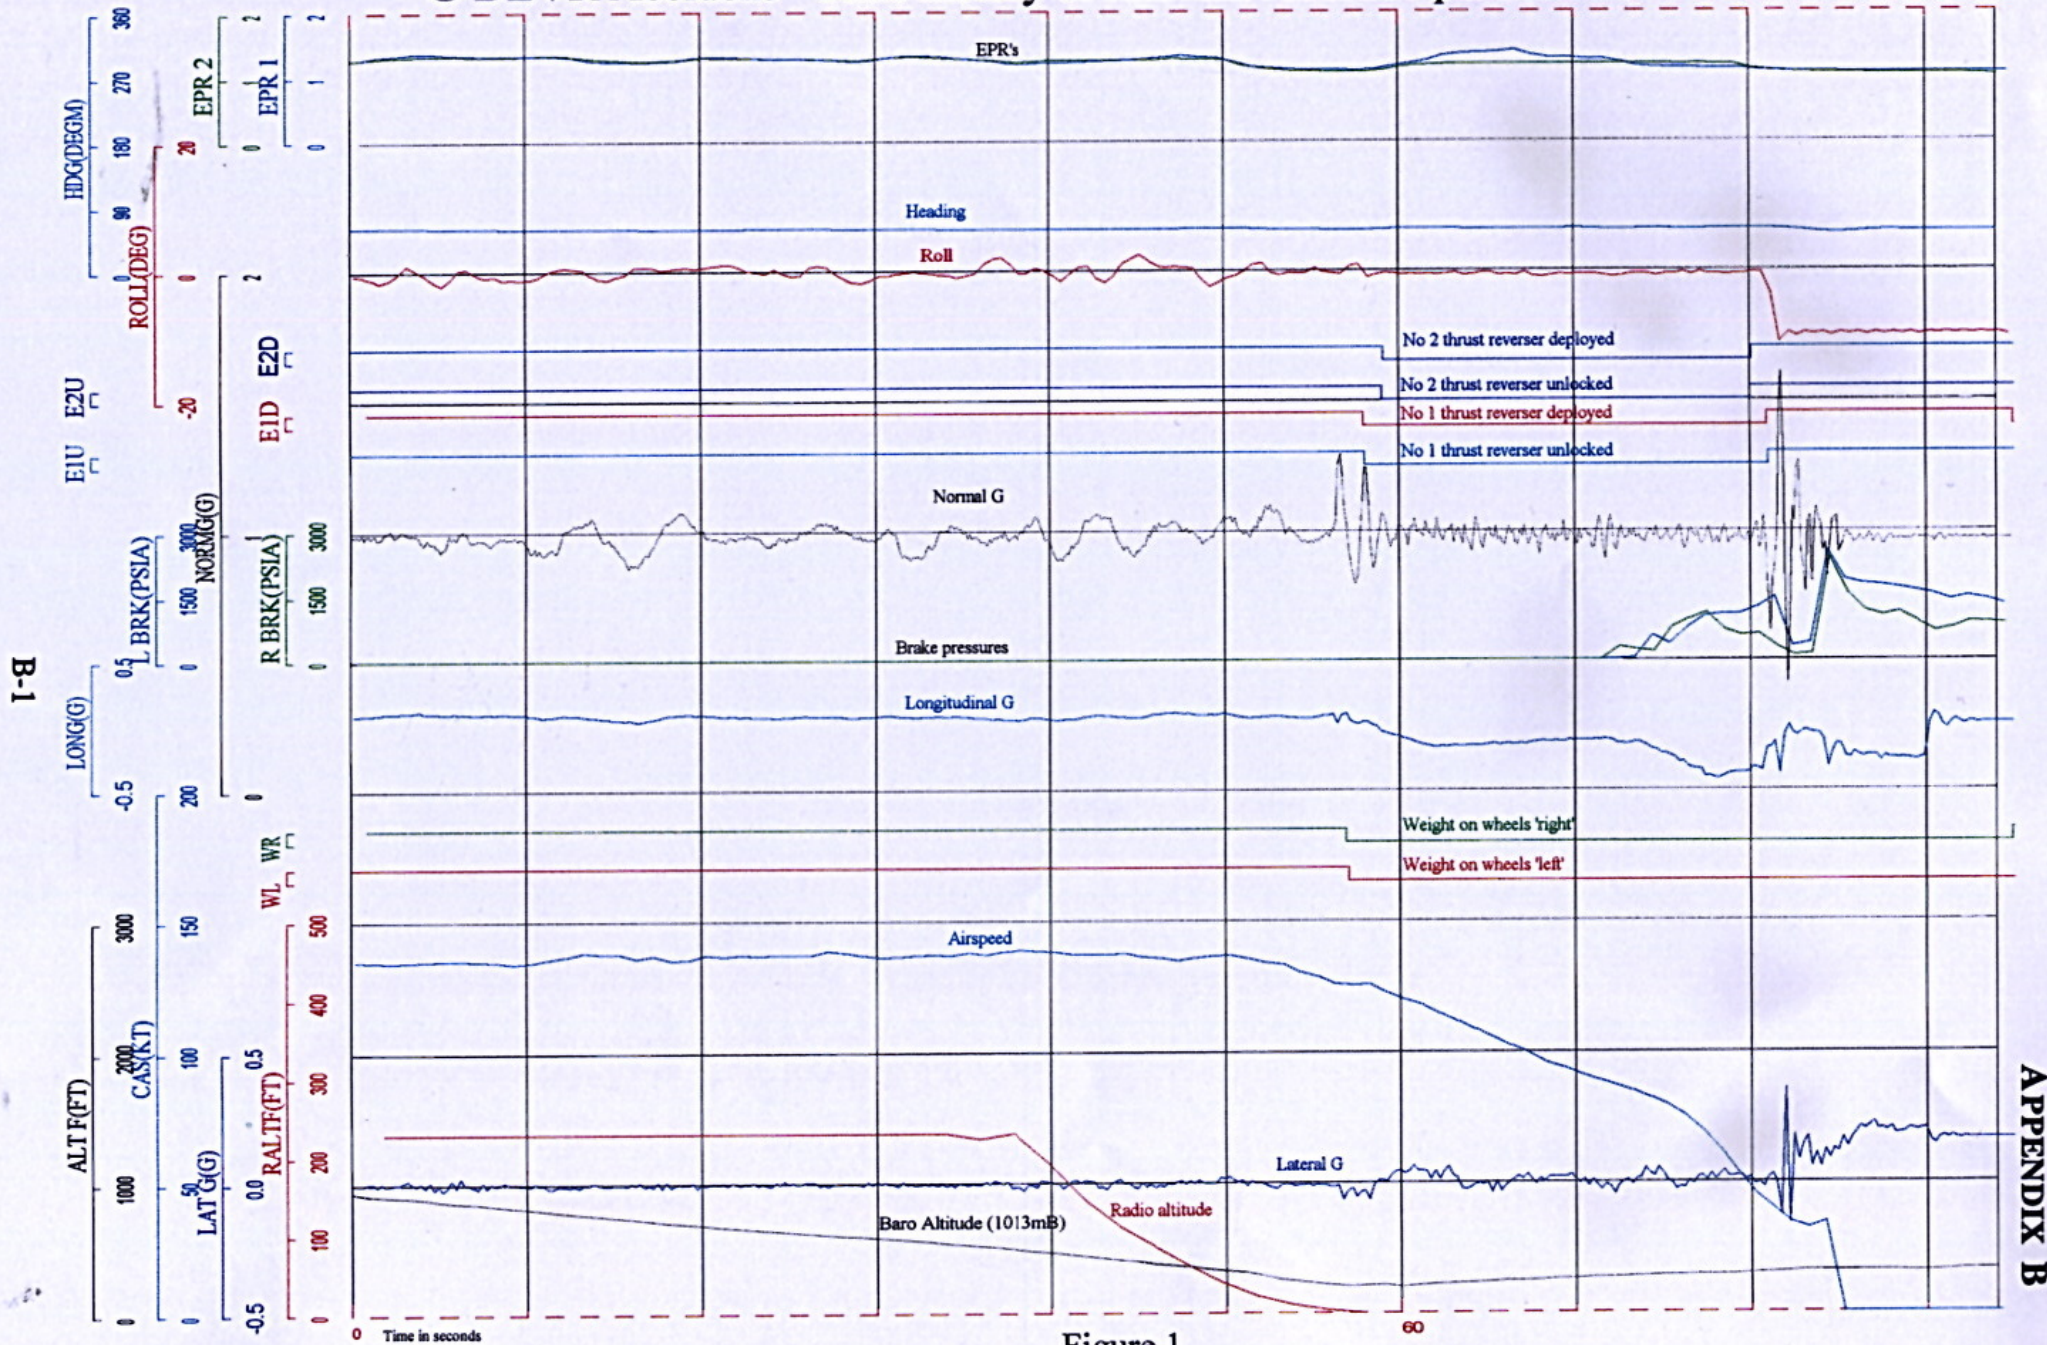
Figure 1

G-DEVR Accident - Time history of relevant recorded parameters

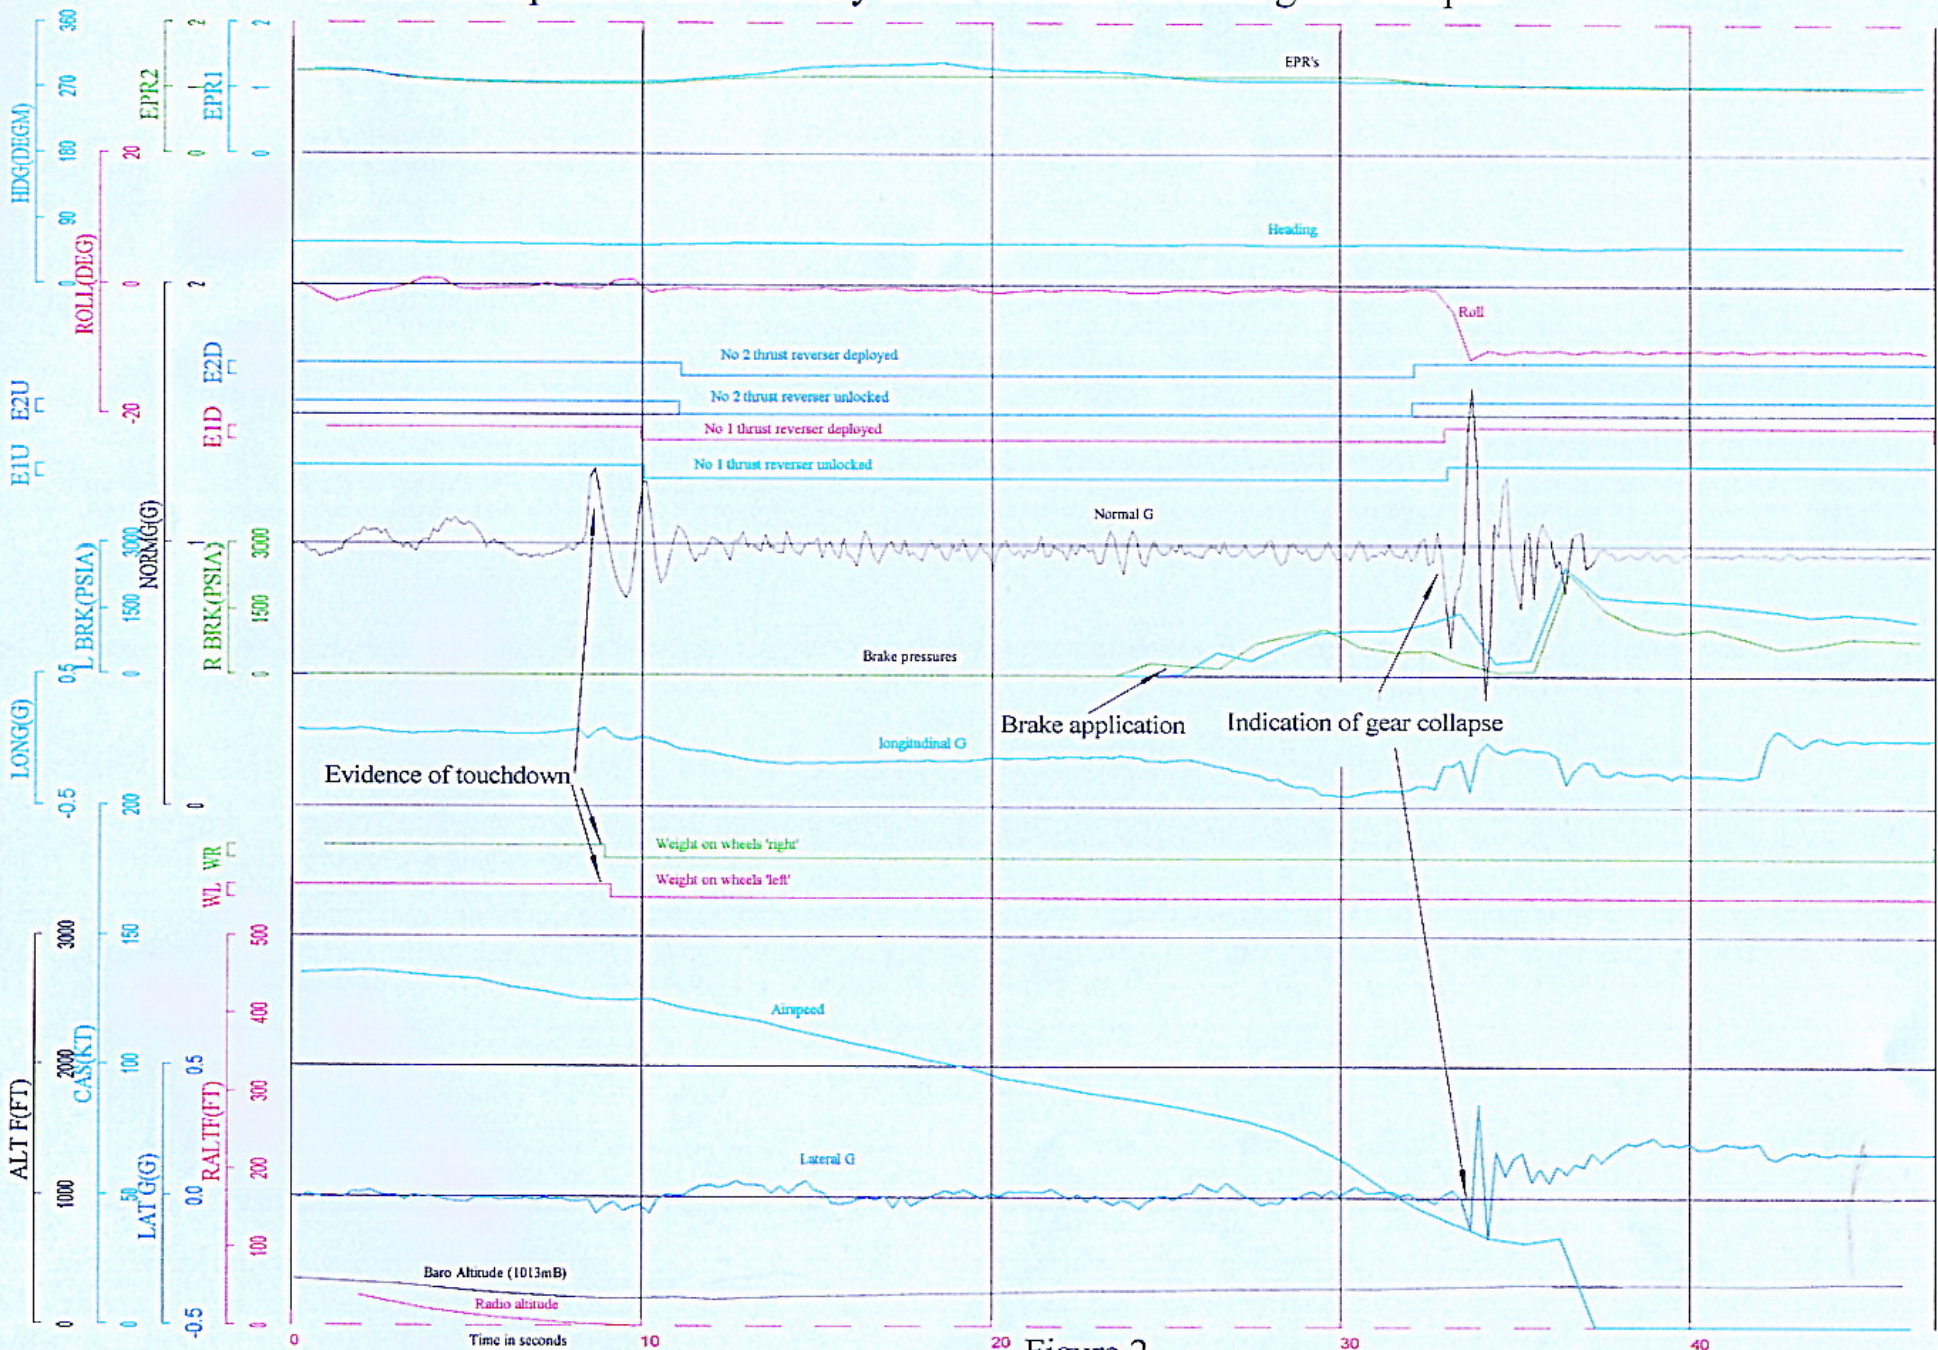
Figure 2

G-DEVR expanded time history from touchdown until gear collapse

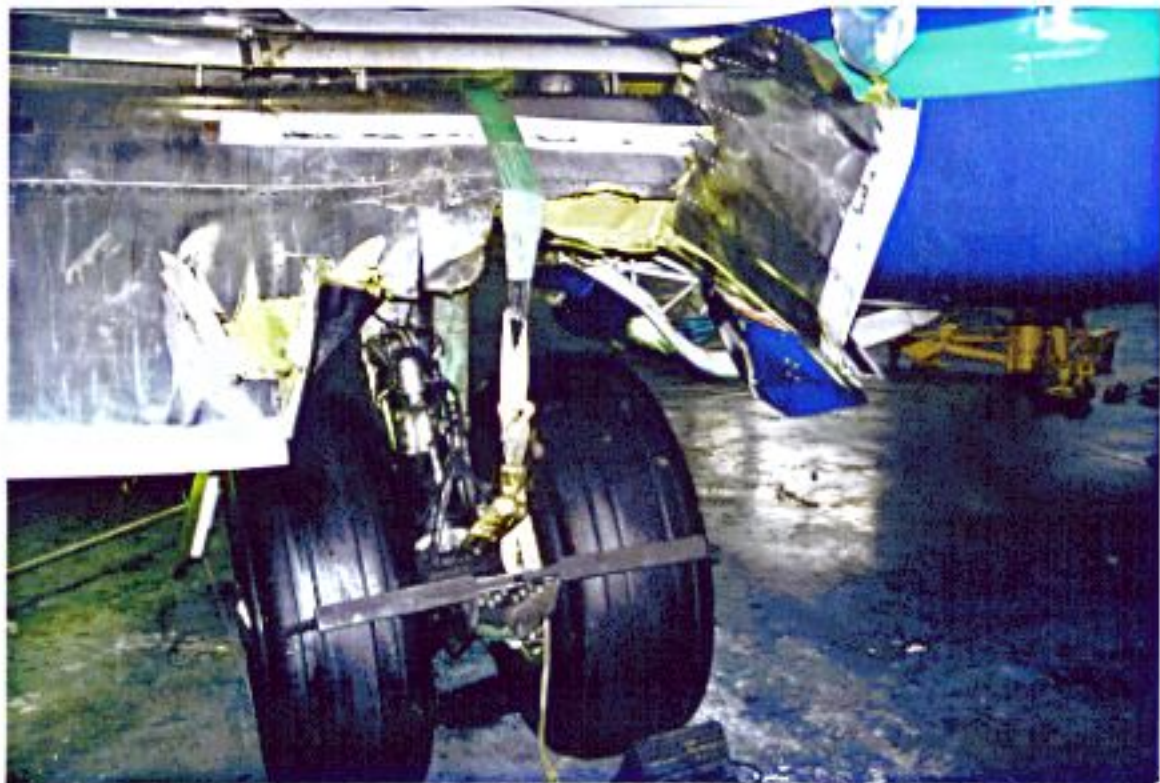
Damage to the airframe was very much as might be expected from this sort of event. The aircraft had come to rest on the left wing tip, outboard flaps and slats, all of which had severe scraping damage. Several flap hinges were scraped and distorted. The primary wing structure, including the integral fuel tank, was intact and had not been penetrated, although there was some scraping of the lower skin in the region of the front spar. On-site reports of fuel leakage are considered to have been due to drainage from the outboard surge tanks as a result of the left-wing-low attitude. All the damage was subsequently repaired by a DAC repair team but new flap and slat sections were required to be fitted.

G-DEVR on jacks post-accident. View of left MLG from aft looking forward showing damage to trailing edge flaps

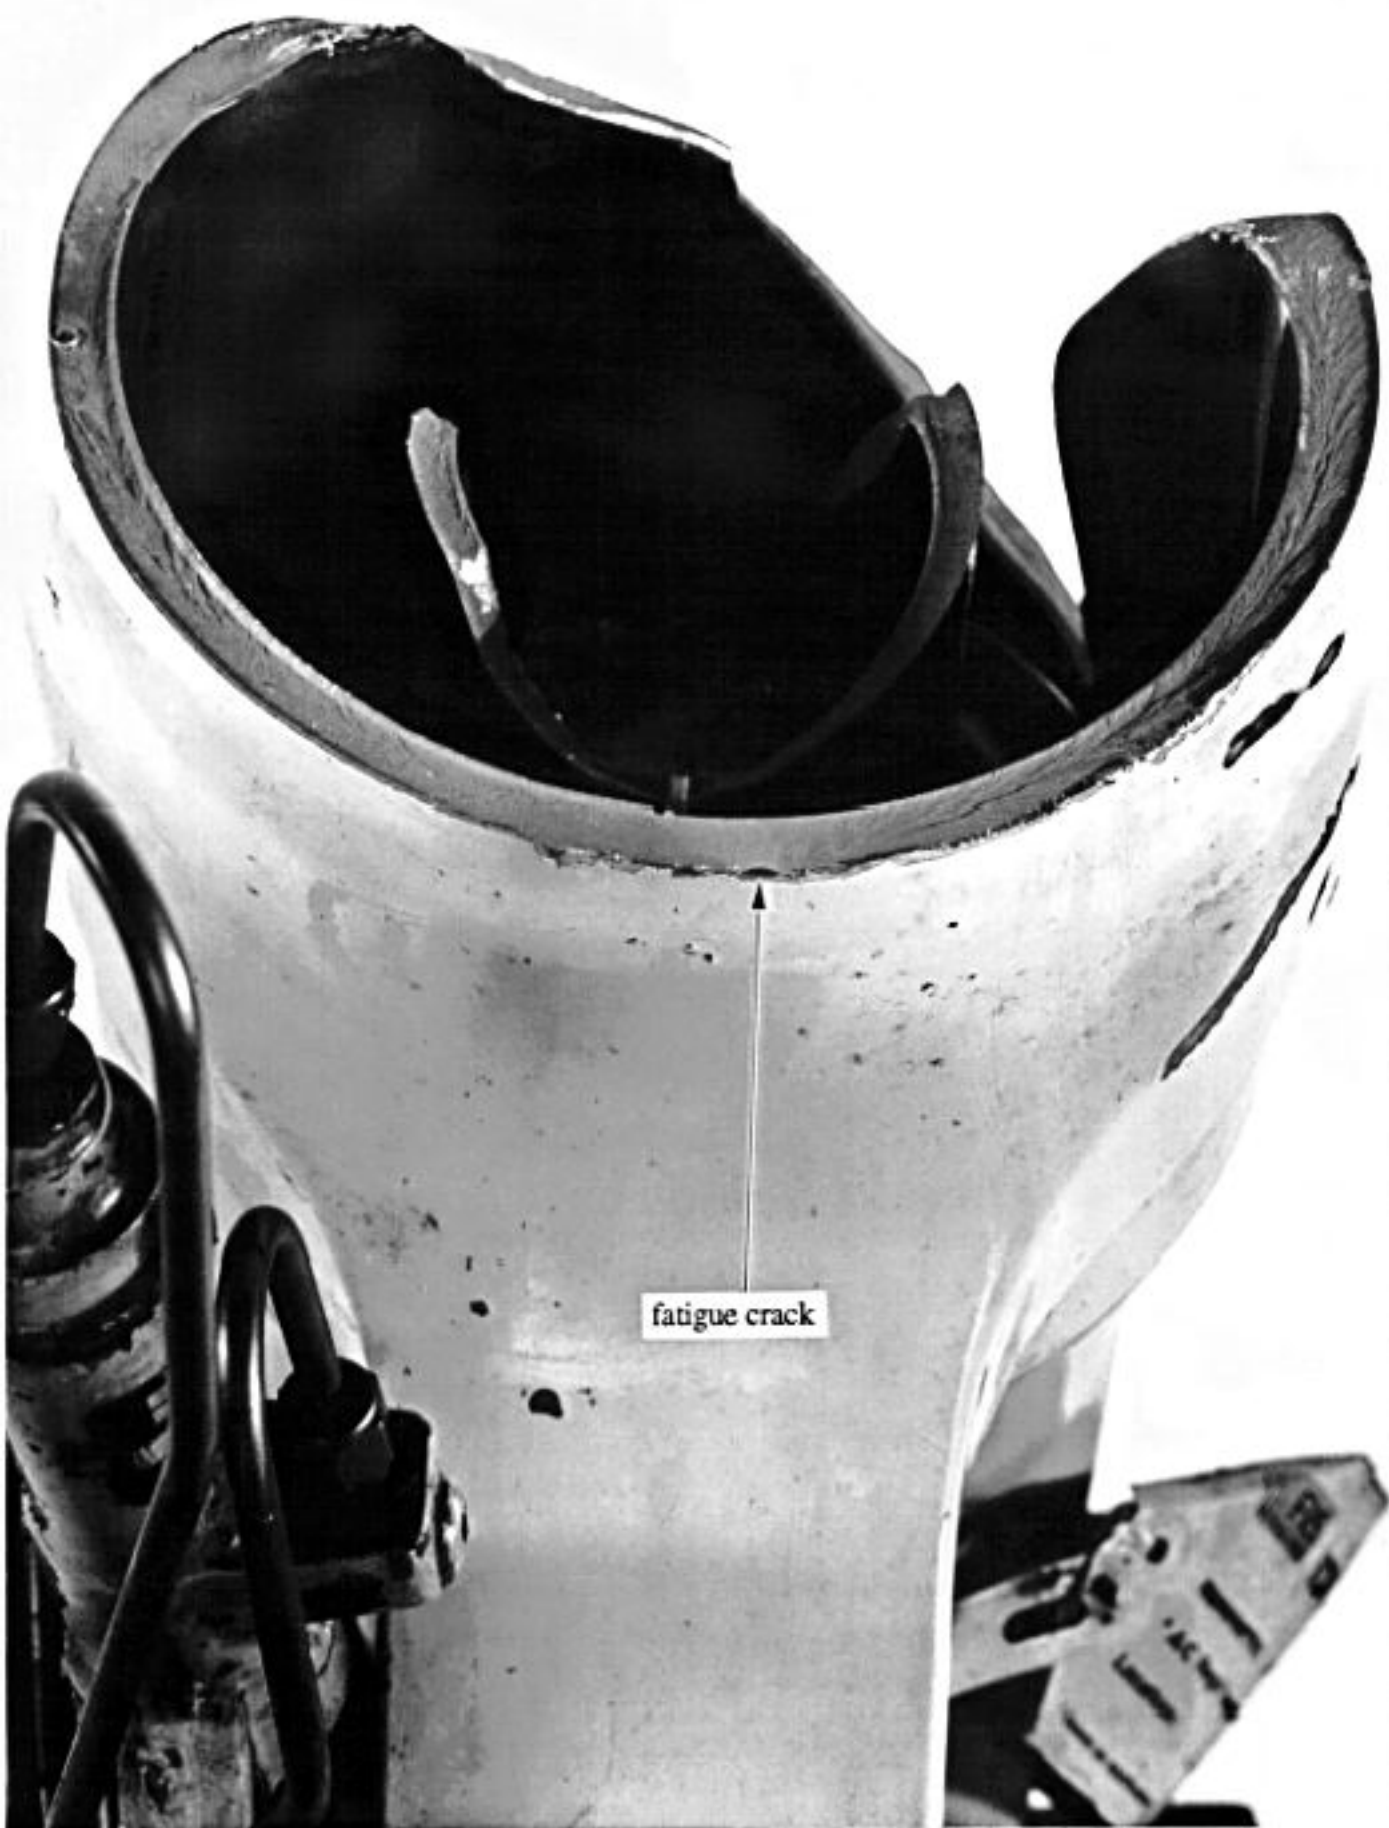
The MLG leg itself had fractured at the top of the cylinder in the manner shown in Appendix A. First examination suggested that the fracture face possessed only the characteristics of brittle overload fracture with 'chevrons' pointed towards a failure origin at the front of the cylinder. Closer examination of this origin showed the presence of a very small, brown-coloured and crescent-shaped area (Appendix D). As this bore the characteristics of a pre-existing defect, the AAIB requested the presence of a metallurgist to confirm the nature of the anomaly.

The metallurgist rapidly identified that the defect exhibited the characteristics of fatigue, and it was considered that, even though this defect was extremely small, it was probably responsible for failure of the leg, bearing in mind the characteristics of the 300M, high-strength steel used in its construction (see §1.18.3). This information was immediately transmitted to the United States National Transportation Safety Board, Douglas Aircraft Company and the UK Civil Aviation Authority. A team of three specialists from DAC were despatched to examine the component on-site and they agreed with this initial appraisal.

The failure was examined both optically and using a Scanning Electron Microscope (SEM). In addition to the obvious area of fatigue damage noted above, two further small areas adjacent to the main area could also be seen. The remainder was fast fracture (Appendix E). These pre-existing cracks had occurred in the run-out of a blend radius. The major fatigue crack was measured as 5 mm long by 1.25 mm deep.

View of lower half of failed MLG cylinder fracture face showing location of pre-existing fatigue crack (arrowed)

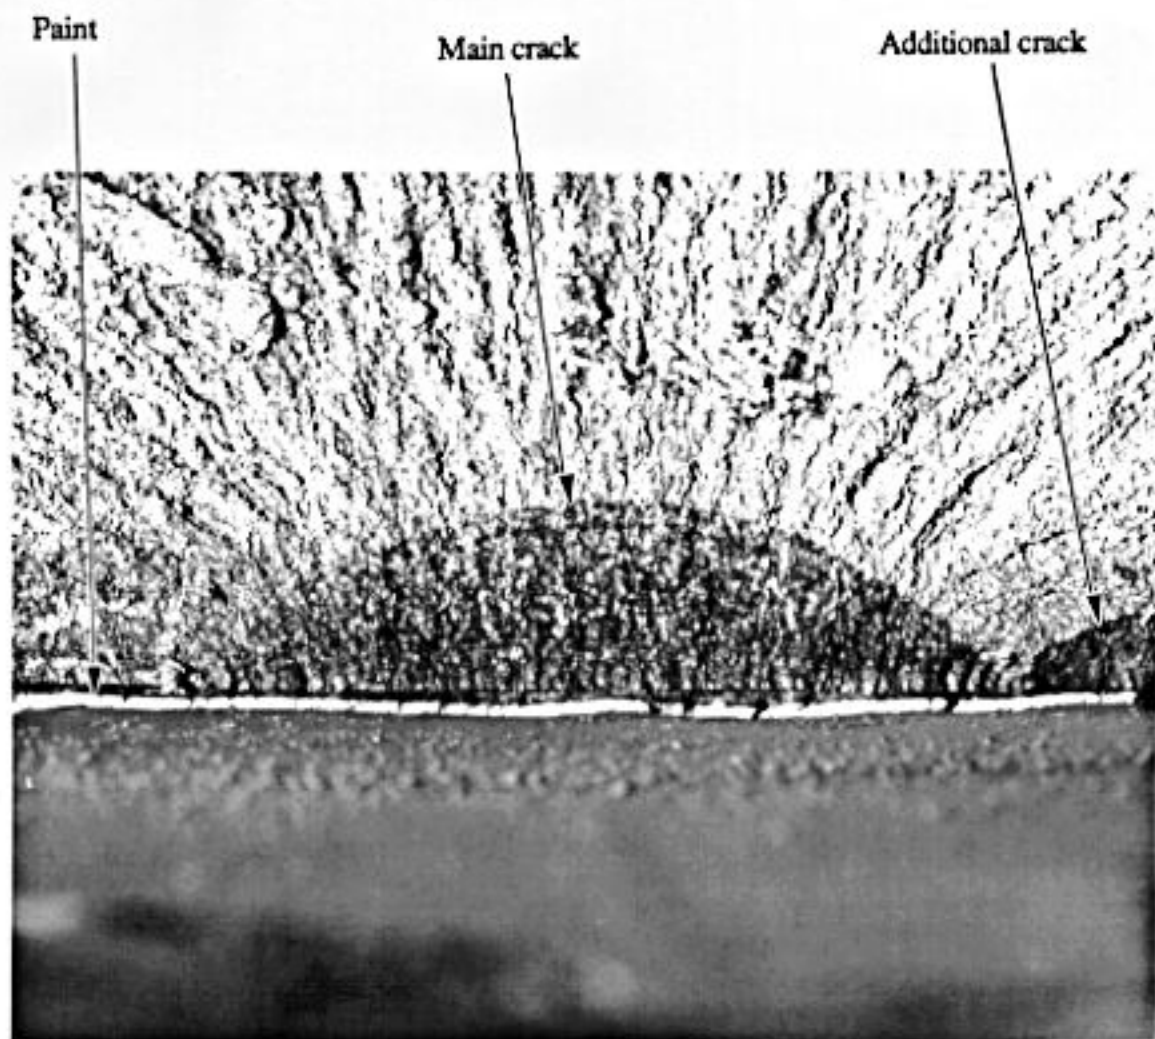
Under high magnification on the SEM it could be seen that the fatigue was multi-origined and appeared to be associated with discontinuities observed on the surface of the specimen (Appendix F). The nature of these discontinuities was initially not understood. As noted in § 1.6.3.1, the surface of the cylinder was shot-peened after machining although it was not appreciated at first

Optical microscope view of major fatigue crack (magnification approx x20)

Void induced in steel surface
by grit-blasting

Cadmium plating

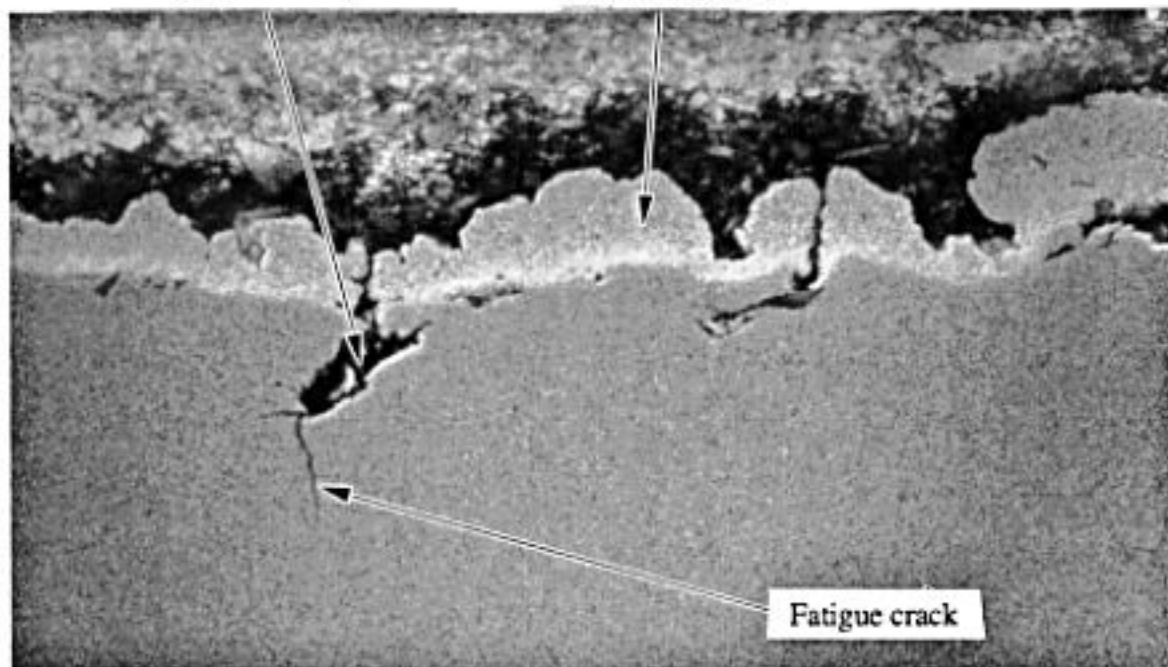
Further examination revealed the presence of some small particles of aluminium oxide grit trapped in the surface folds beneath the cadmium plating and also the presence of microscopic fatigue cracks apparently growing from some of the sharpest and deepest folds (Appendix F). A more detailed appraisal of this aspect of the surface finish appears in the § 1.16.1. There were no signs of any other material defects such as corrosion pitting or material inclusions which could have acted as an origin for the development of fatigue cracking.

Scanning Electron Microscope view of fatigued area showing irregular surface finish and 'lumpy' appearance of Cadmium plating. Note embryonic fatigue crack growing from larger fold (magnification x1000)

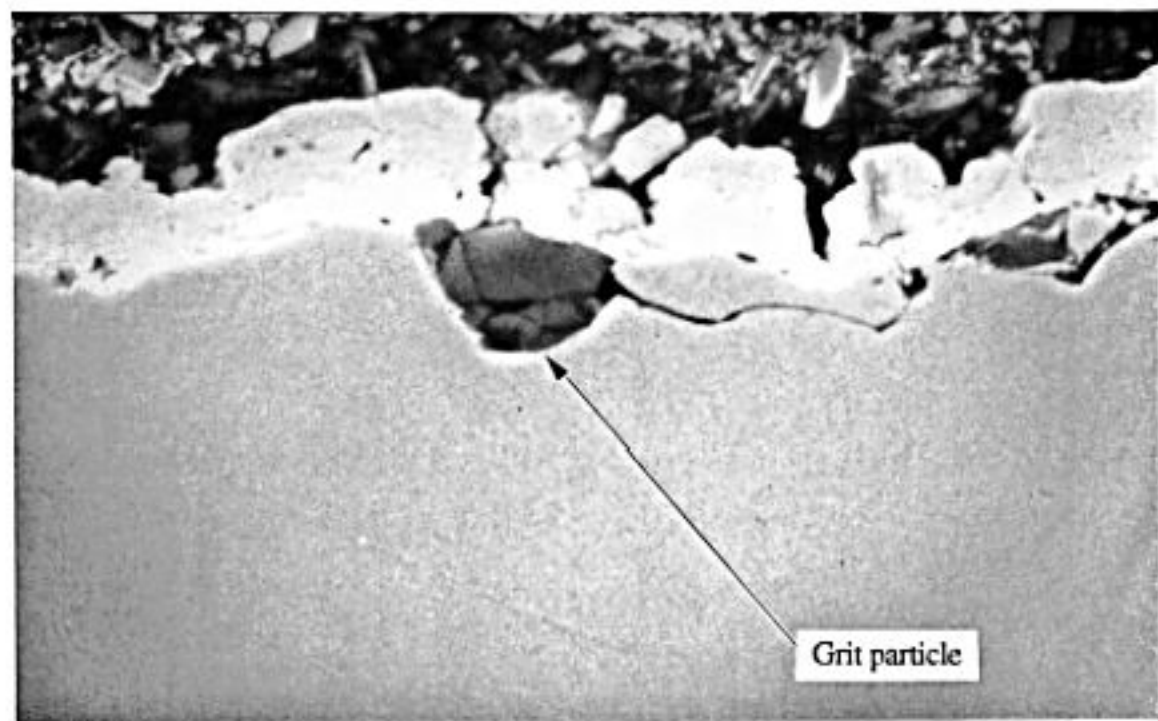
Scanning Electron Microscope view of surface showing particle of alumina grit trapped beneath Cadmium plating (magnification x1900)

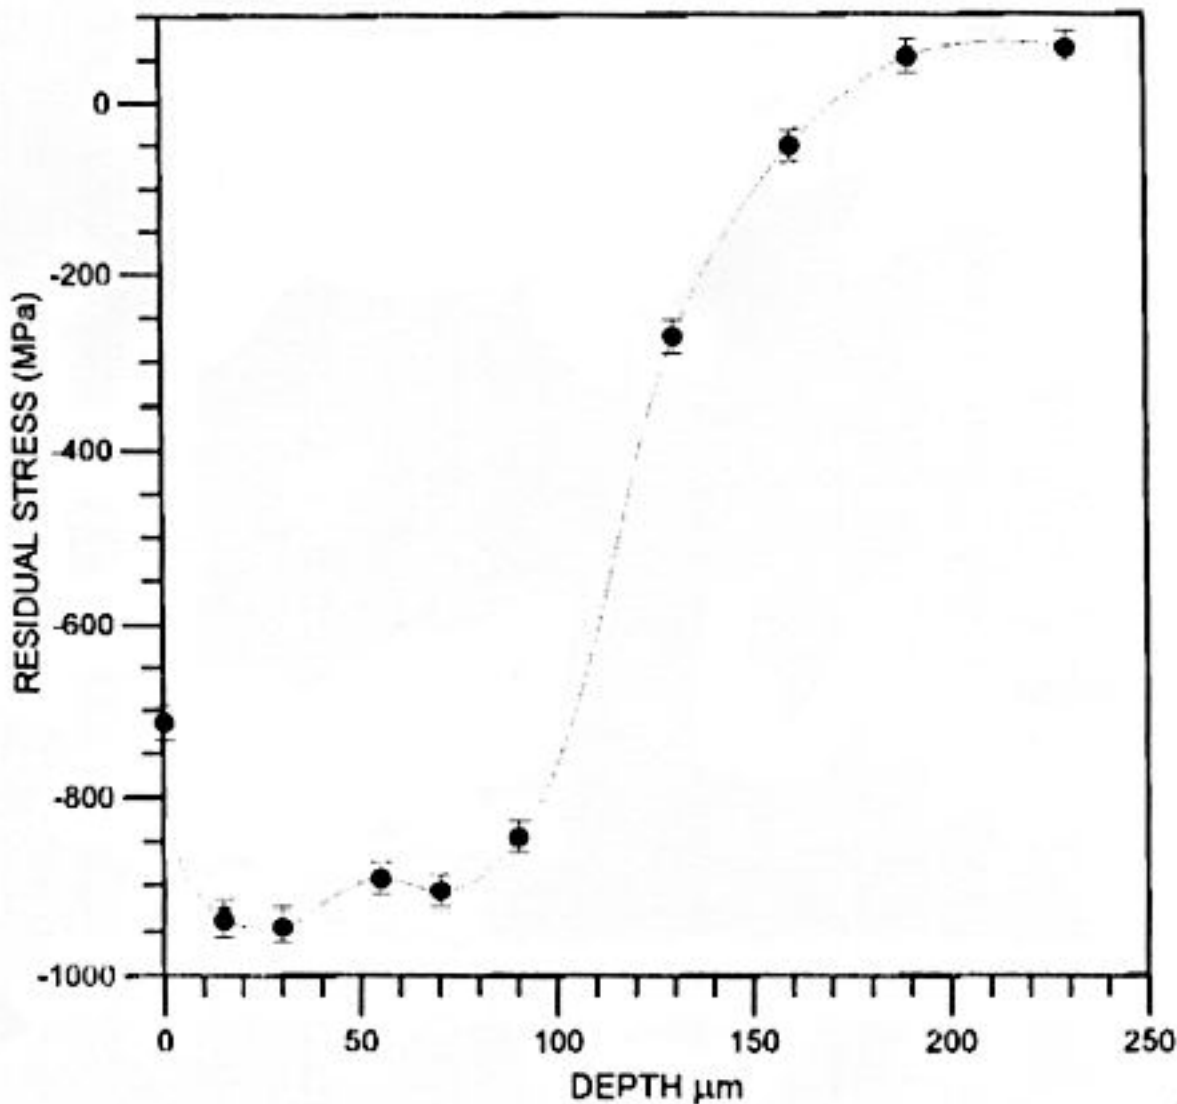
Perhaps the most meaningful test for effectiveness of shot-peening is to measure the consequential residual stresses in the surface and sub-surface material. This is not an easy check since, although non-destructive electronic instruments are known to be available which claim to be able to test for residual stresses, other, more accurate methods are strictly destructive on the specimen. Samples from G-DEVR, close to the fracture, were subjected to such a process which involved progressively electro-polishing the surface away whilst subjecting it to XRay diffraction examination at each stage. These tests were done both at DRA and independently in the United States.

Chart showing results of X-ray diffraction test to measure residual stress in the surface of the cylinder induced by shot peening.

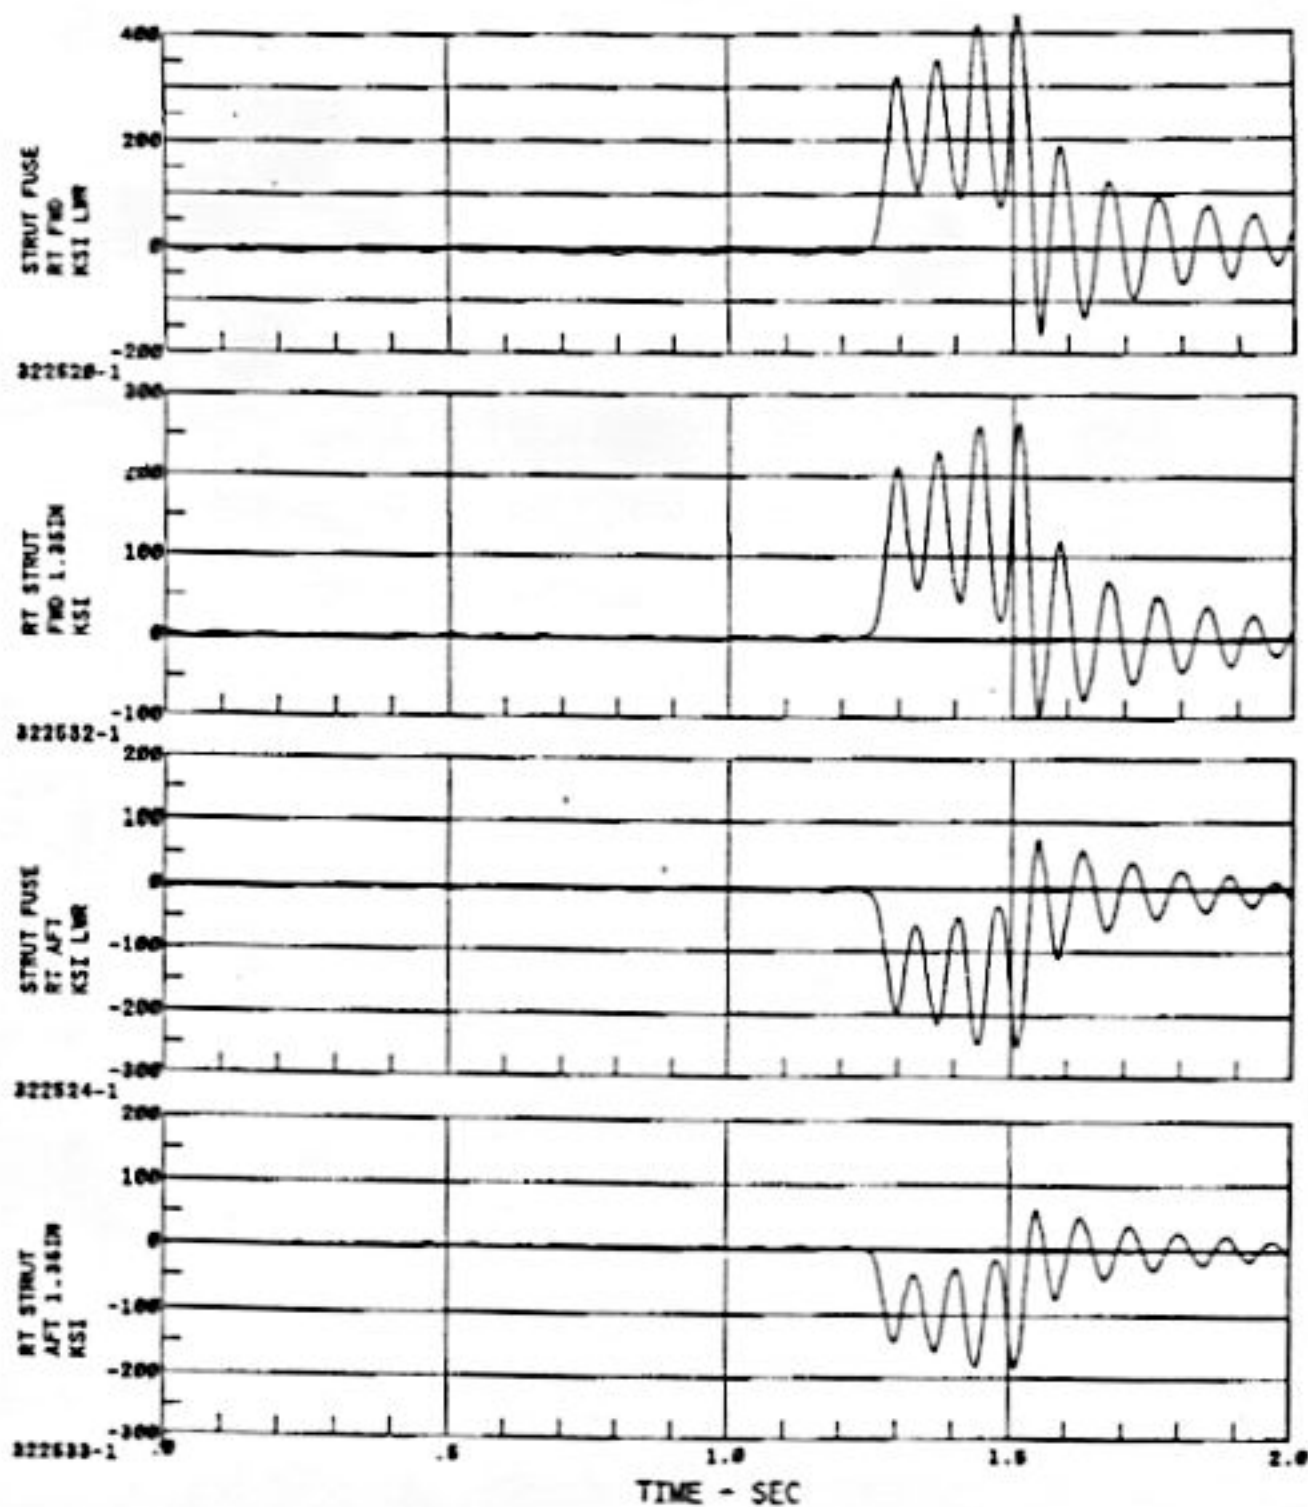
It was found that, under rapid and heavy brake application at 40 kt (the known 'critical' condition at which walking can occur), if walking was not induced then the principal stresses were within the expected range. Oscillating maximum stresses in the order of 220 and 180 ksi were recorded with minimum stresses of 100 and 150 ksi respectively when 'gear walk' modes 1.1 and 1.2 were induced (§ 1.18.5). However, when 'gear walk' mode 2 was generated, the stresses became much higher, reaching levels of 272 ksi coupled with an additional fatigue-damaging minimum stress of 75 ksi. A chart of the measured stresses during 'gear walk mode 2' is given at Appendix H. From this it can be seen that the phenomenon appears to last for roughly seven or eight high-stress cycles, although the test aircraft was fitted with a 'fuse' which activated at a pre-set longitudinal acceleration value to prevent the oscillation becoming divergent and breaking the MLG leg. In-service aircraft are not fitted with such a device but the manufacturer considered that any occurrence of 'gear walk mode 2' would be so violent that the handling pilot would instinctively release the brakes.

Strain gauge charts showing stresses measured during DAC tests which deliberately induced 'gear walking' on the right main landing gear of a Company MD-87 aircraft.

The second two charts record the same information measured on the rear of the leg

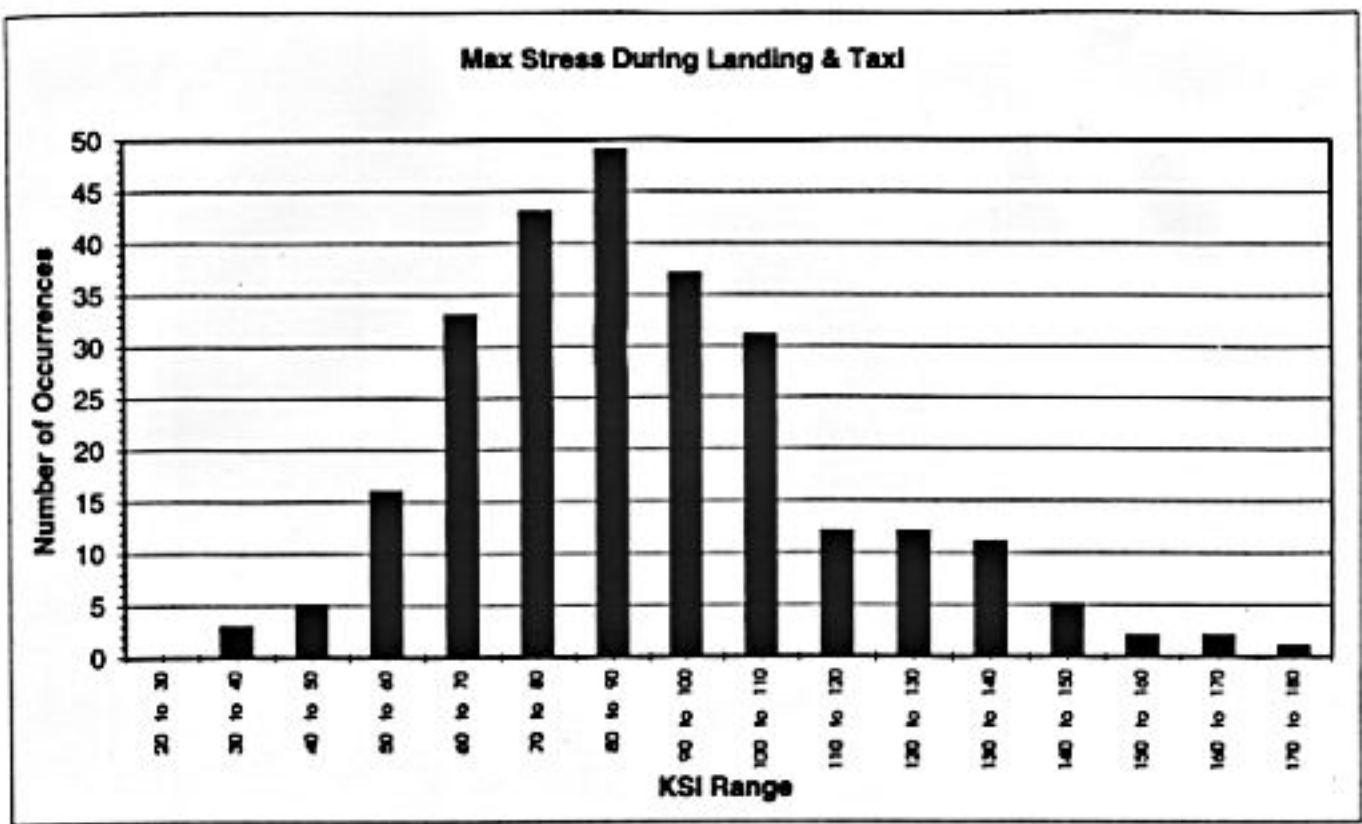
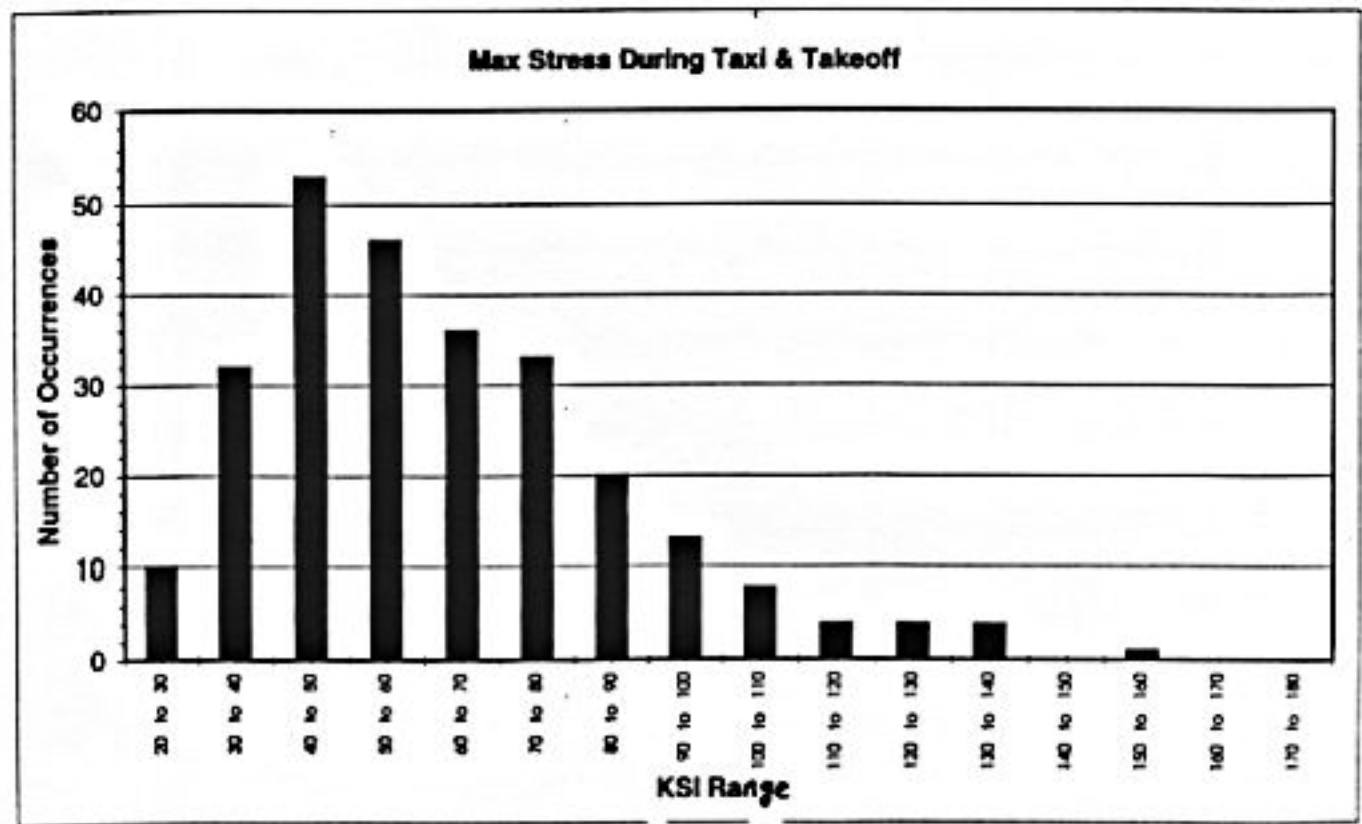
In order to verify that the operator's environment for the MD83 was not generating in-service MLG stresses outside those assumed during the fatigue life calculations, DAC took the decision to instrument the replacement left MLG leg fitted to G-DEVR when it returned to service. By this time, G-DEVR and all other aircraft in the Airtours fleet had been fitted with restrictors to SB 32246 (§ 1.18.5) and 'gear walking' was not expected to occur. Indeed, on its first post-repair flight, G-DEVR was handled by a DAC test pilot who was unable to generate 'gear walking', despite several attempts using the known conditions under which it can occur.

Results of in-service landing gear stress measured by strain gauges fitted to left MLG of G-DEVr after repair
