Windshield failure in flight, Airbus A320-212, G-DACR, 28 April 1996

Airbus A320-212, G-DACR, 28 April 1996

AAIB Bulletin No: 8/96 Ref: EW/C96/4/12 Category: 1.1

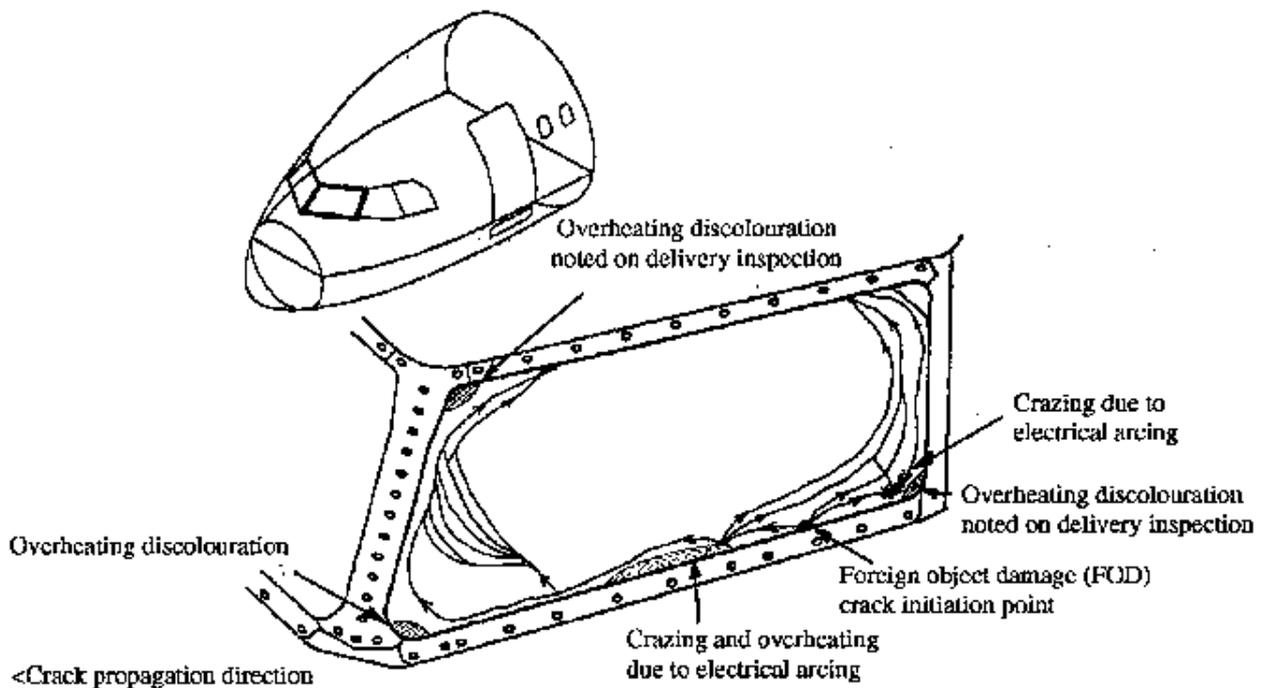
Figure 1 Damage to the windscreen

Examination of the windscreen revealed that foreign object damage (FOD) was present on the rear lower edge on the outer surface of the outer glass pane (figure 1) and had occurred prior to the incident flight. There was no evidence that the FOD had caused overheating or arcing in the underlying electrical junction between the windscreen heating conductor film and the bus bar. Cracks in the outer glass pane had progressed from the FOD both forward and rearward along the bottom edge of the windscreen. The crack that ran forward from the FOD exhibited extensive crazing, overheating and arc damage. This damage was most severe in the area that was adjacent to the FOD and was a result of the crack causing delamination and local disturbance in the electrical continuity between the busbar and the conducting film. Where the rearward running crack ran close to the overheating discolouration in the bottom right-hand corner of the windscreen, crazing due to electrical arcing had also occurred. From the ends of both the forward and rearward running cracks numerous cracks fanned out and ran almost right around the outer pane of the windscreen.

Two areas of discolouration damage to the windscreen were noted when the aircraft was received by the operator in February 1996 (figure 1) but the examination concluded that these damaged areas did not contribute to the damage investigated.
