## **Smoke emergency, Boeing 737-436, G-DOCH**

# **Boeing 737-436, G-DOCH**

<b>AAIB Bulletin No:</b> 6/2004	<b>Ref:</b> EW/C2002/11/02	<b>Category:</b> 1.1
<b>INCIDENT</b>		
<b>Aircraft Type and Registration:</b>	Boeing 737-436, G-DOCH	
<b>No &amp; Type of Engines:</b>	2 CFM56-3C1 turbofan engines	
<b>Year of Manufacture:</b>	1991	
<b>Date &amp; Time (UTC):</b>	8 November 2002 at 1458 hrs	
<b>Location:</b>	Near Clacton, Essex	
<b>Persons on Board:</b>	Crew - 6	Passengers - 68
<b>Injuries:</b>	Crew - None	Passengers - None
<b>Nature of Damage:</b>	Damage and shorting within electrical wiring loom in cabin ceiling and associated failure of water supply hose	
<b>Commander's Licence:</b>	Airline Transport Pilot's Licence	
<b>Commander's Age:</b>	35 years	
<b>Commander's Flying Experience:</b>	4,400 hours (of which 4,150 were on type)	
	Last 90 days - 144 hours	
	Last 28 days - 52 hours	
<b>Information Source:</b>	AAIB Field Investigation

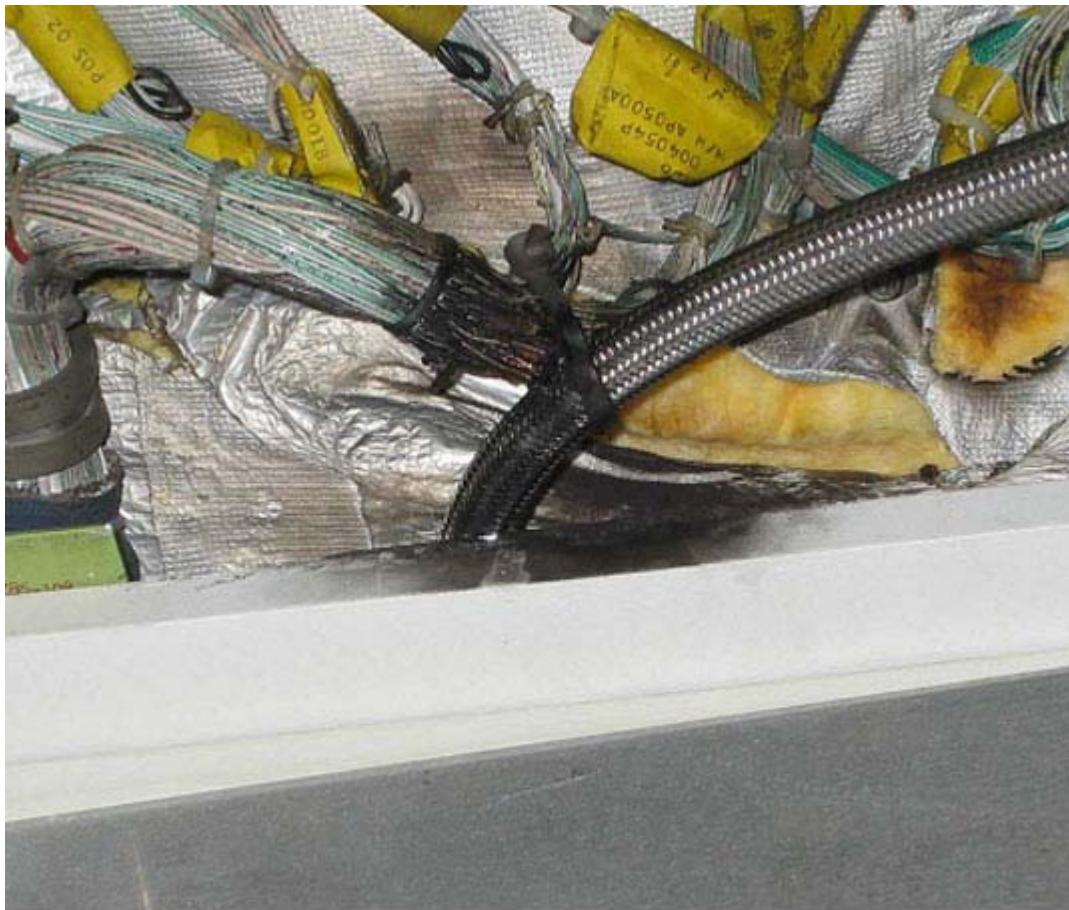
The visible damage to the aircraft was found principally in the area above the 'drop-down' ceiling panel immediately aft of the flight deck door, Figure 1, in the forward vestibule of the cabin: this panel is hinged on the left side and secured by two latches on the right side. There was also some scorching and sooting of this panel and around the top of the cockpit door frame.

**Figure 1: Damaged loom and hose, G-DOCH**

**Figure 1 Damaged loom and hose, G-DOCH**

Within this area, damage had occurred to a wiring loom where a braided steel hose had been secured by means of a single electrical 'tie-wrap' strap (the generic cable tie system formed of nylon-type UV-resistant material). It appeared that there had been abrasion and arcing between the wires and the hose, resulting in the severing and shorting of a number of the wires. The braided steel hose was lying against the frame of the ceiling panel and it appeared that there had also been electrical shorting to this portion of the airframe.

The analysis indicated that the probable sequence of failure was that one or more wires chafed against the steel braid of the water hose. The wire's insulation was worn through to the point of establishing an arcing fault with the steel braid portion of the hose, which is effectively earthed at both ends, and this initial arcing would have damaged the insulation on surrounding conductors. The process of arcing would then spread through the bundle. The arcing on some conductors would then stop, either due to the circuit breaker tripping or melting of the conductors. It is also possible that arcing may have stopped at some stage and then restarted as some movement occurred between wires with damaged insulation. Polyimide (Kapton) was used for the insulation on some of the wires and this, when subjected to arcing, will degrade to produce conductive carbon, allowing additional tracking paths to be formed ('carbon-arc tracking'). This could have contributed to the spread of the fault within the wiring bundle.

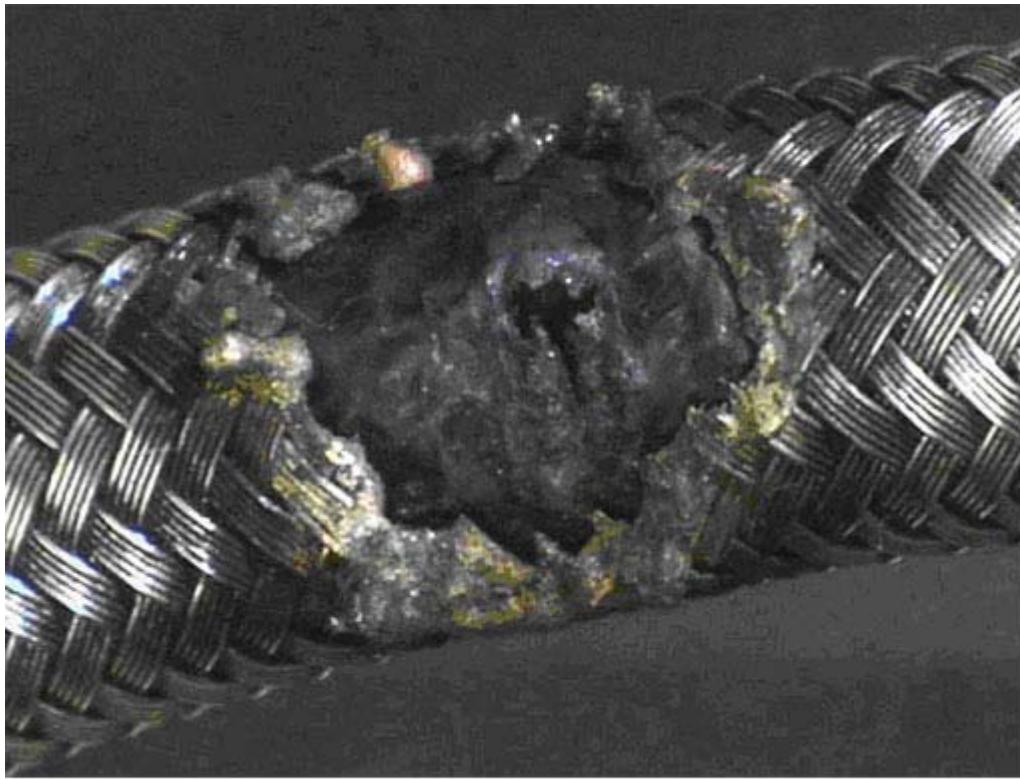
The hose involved was a water hose which supplied potable water from an aircraft connection in the crown of the fuselage, to the back of the No 1 galley; this was located at the right-hand side of the forward cabin. An area of this hose in which the steel braid appeared to have melted, was apparent, and at least two holes had been created in the PTFE inner hose, Figure 2, which resulted in the substantial water leak.

**Figure 2: Damaged hose, G-DOCH**

**Figure 2 Damaged hose, G-DOCH**

Comparison with a sister aircraft, G-DOCW, indicated that the hose was too long for this application and that the extra length in G-DOCH had been looped through this overhead area and then only secured by a tie-wrap to adjacent wire bundles. Part of the hose was protected by plastic spiral wrap but this did not extend to the portion of the hose in contact with the wire bundles.

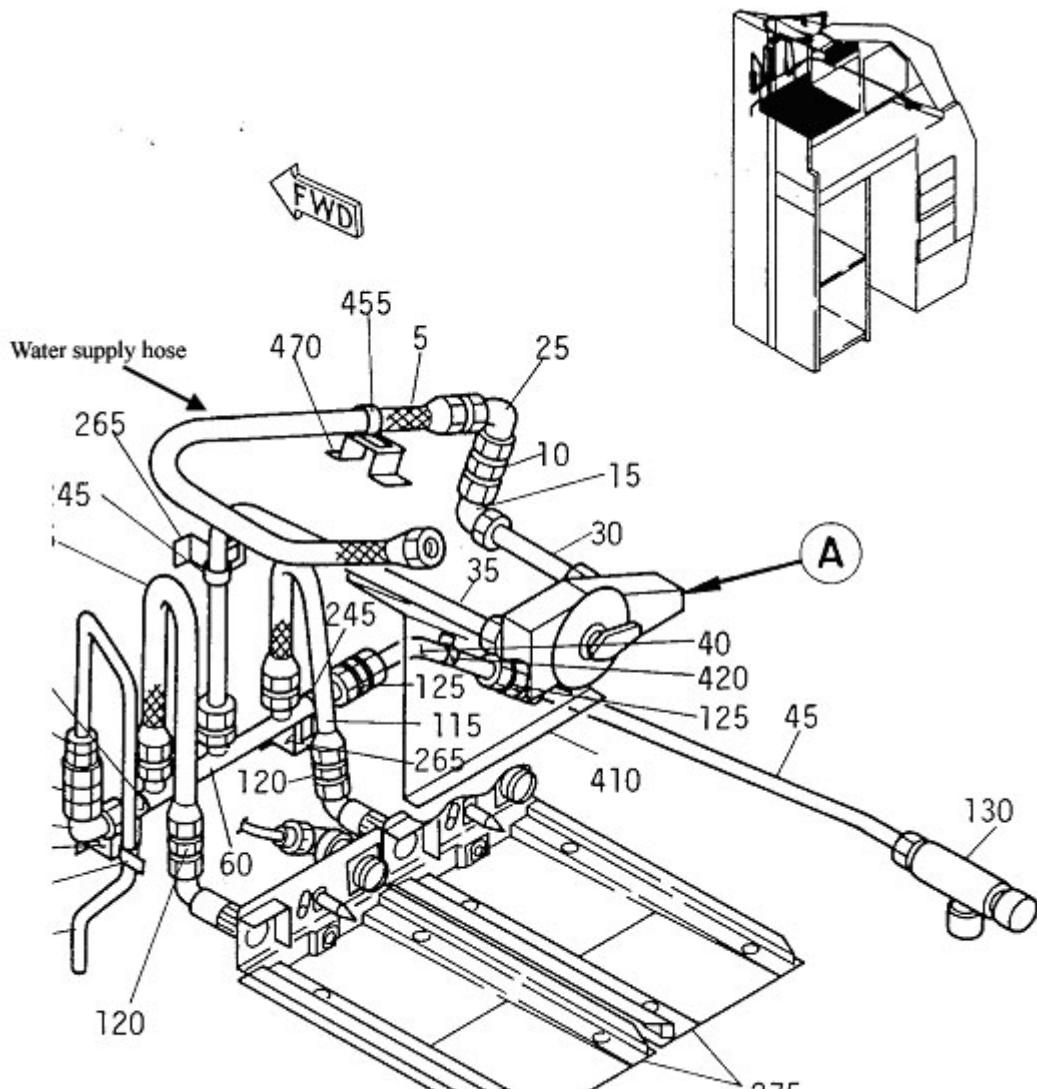
The water supply hose was removed from the aircraft for examination. The galley, Figure 3, was designed and manufactured by the JAMCO manufacturing company in Japan as buyer-furnished equipment (BFE), specified by the customer but fitted, in this case, at the time of the aircraft's manufacture.

**Figure 3: Illustration from galley Component Maintenance Manual**

**Figure 3 Illustration from galley Component Maintenance Manual**

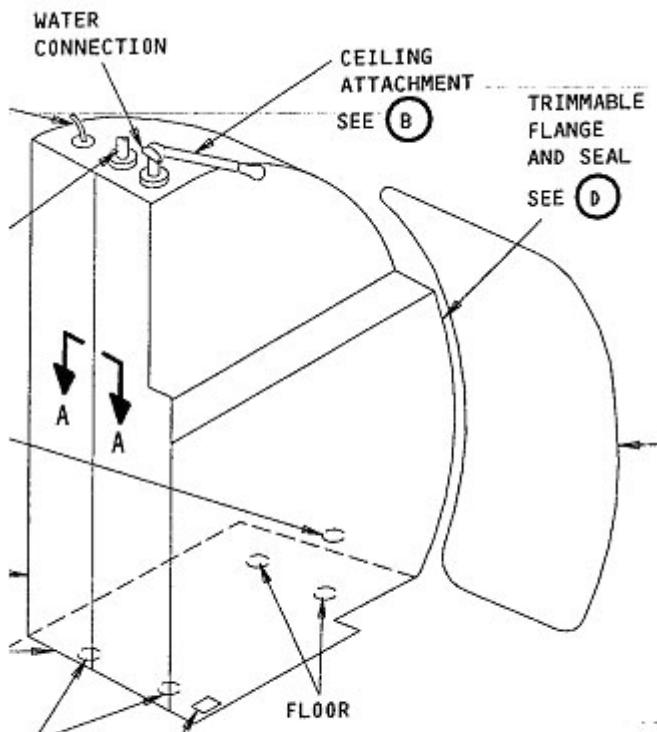
but the associated diagram, Figure 4, showing a generic galley unit, labelled the water connection as being on top of the galley and did not indicate any hose between this connection and the point in the aircraft ceiling at which it should be disconnected.

**Figure 4: Illustration from aircraft Maintenance Manual**

**Figure 4 - Illustration from aircraft Maintenance Manual**

Generic diagram identifying water connection. No information concerning supply hose or its method of installation

There is no positive evidence as to whether the galley illustration in the airframe Maintenance Manual, Figure 4, was used as reference in the disconnection of the water hose in G-DOCH. The illustration does, however, have the potential to mislead in suggesting that the connection is made adjacent to the galley unit rather than at the interface with the aircraft water system in the crown of the fuselage. The following recommendation is therefore made:

It is recommended that the Boeing Commercial Airplane Company review the illustration and text material of the Maintenance Manual relating to the installation of the forward galley installation in the B737-400, and any other affected model, to give clear instruction as to where the galley water supply hose disconnection should be made when removing the galley.
