Access door loss and fuselage damage, Boeing 777-236B, G-VIIA

Micro-summary: The crew opted to divert back to base after an access door disengaged and damaged the airframe.

Investigative Body: Aircraft Accident Investigation Board (AAIB), United Kingdom

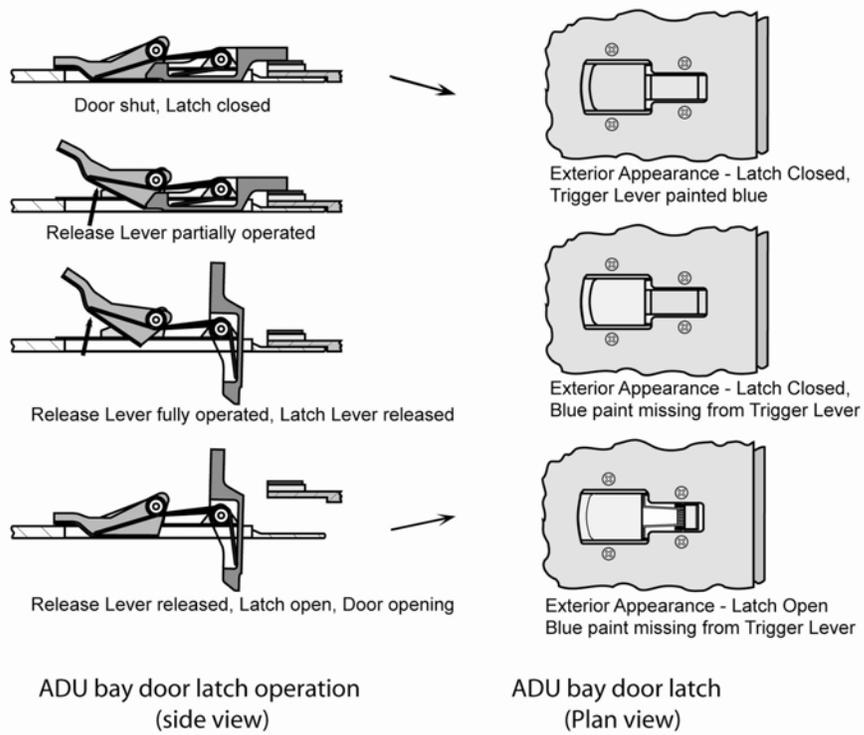
Figure 5

The latch lever is spring-loaded to open and is retained closed by contact with a trigger lever, which itself is spring-loaded to close against a stop on the catch frame. The latch lever/trigger lever contact point is positioned so as to over-centre the mechanism; ie an increased latch lever opening force provides an increased trigger lever closing force.

The catch is released by manually pushing the trigger lever inwards until it disengages from the latch lever, allowing the latch lever to rotate under spring loading and disengage from the pad (Figure 5). The latch lever rotates 90°, its inner end passing through the door cut-out and protruding 0.85 inch beyond the outer surface of the door. The protruding portion has a generally rectangular cross section of approximately 0.7 x 0.4 inch; on G-VIAA the exterior face (when closed) was painted the same dark blue as the door and the side and inner faces were generally unpainted silver-coloured aluminium. It was noted that the side faces of the latch levers on the replacement door were painted orange. The trigger lever returns to its flush position when released. The outer face of the trigger lever was generally painted dark blue; in G-VIIA's case this paint had disappeared from some of the catches, leaving the silver-coloured metal surface of the trigger levers visible (Figure 6).

The square, perpendicular appearance of the released latch levers and their regular spacing might appear less abnormal than a more irregular, angulated mechanism. The trigger levers would have been in their normal closed position and the metallic finish of some of them might have made protruding latch levers somewhat less conspicuous. The orange paint found on the latch levers of some other ADU bay door catches did not appreciably add to their conspicuity and could be considered likely to have been of only marginal benefit.

ADU bay door latch operation
(side view)
