Ground collision between Airbus A340-313, 6Y-JMP and Boeing 777-222, N781UA

ACCIDENT

Synopsis

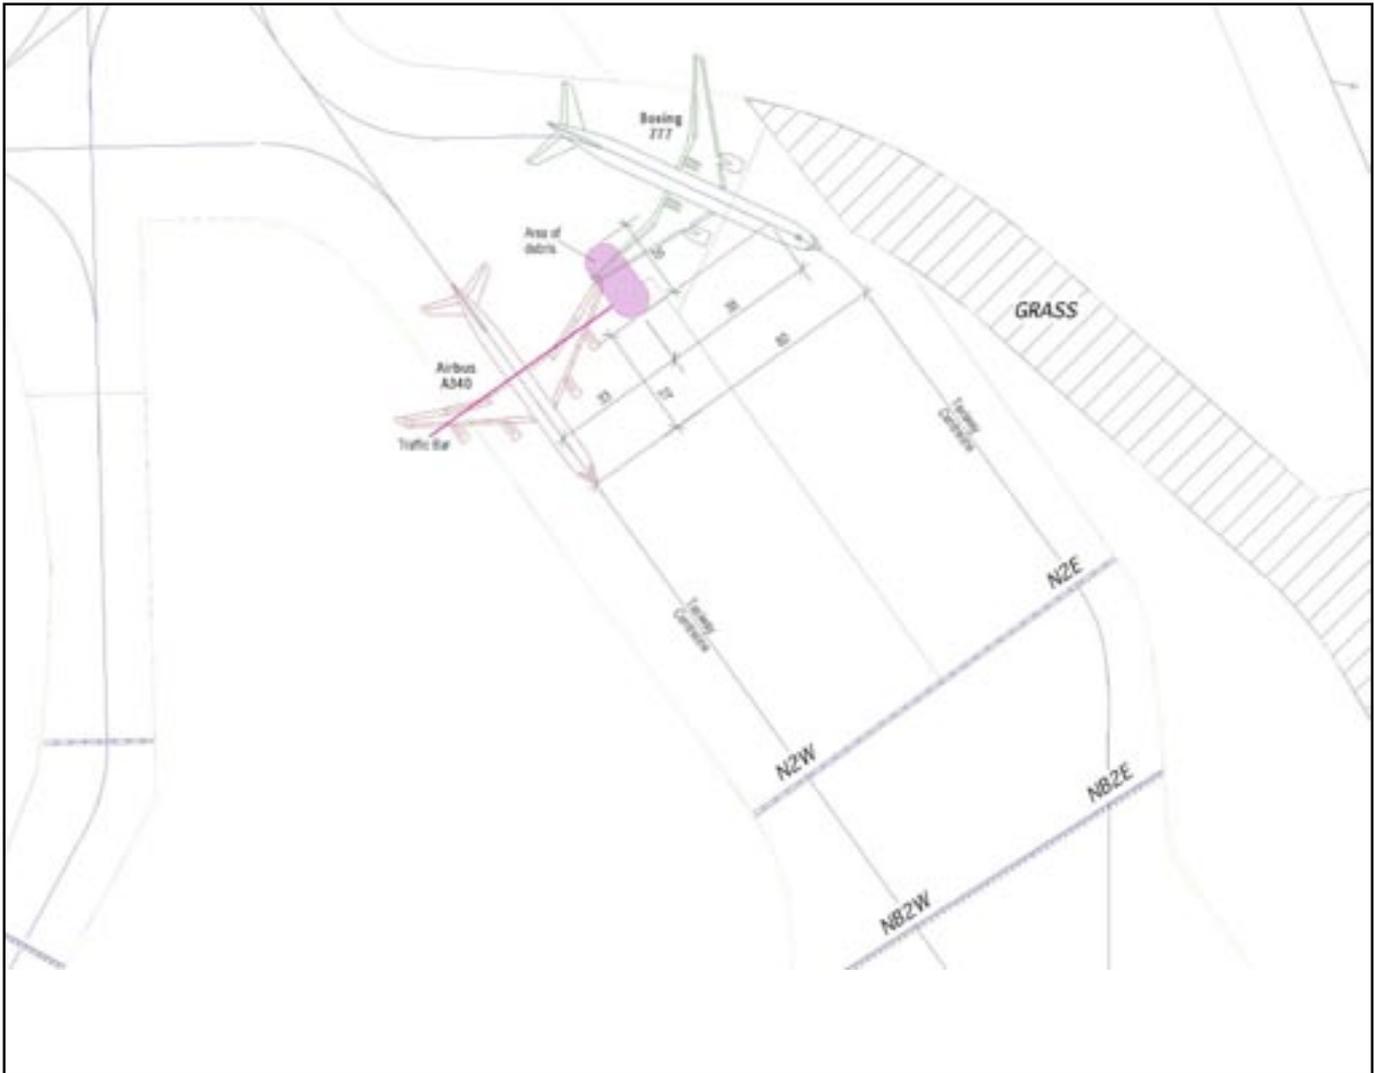
Figure 2
Aircraft positions at Runway 27L Holding Area
(measurements in metres)

Although the taxiway was cleared of debris by a mechanical sweeper before any record of its position could be made, a careful examination of the taxiway surface revealed some coloured glass shards consistent with the fractured lens on the B777's right wing tip. Although the precise position of the collision could not be determined from this debris, due to potential disturbance by the sweeping machine, it was considered unlikely that these items would have been displaced significantly from their original post-collision positions. Accordingly, the boundary of the region containing these items was noted for inclusion in a later analysis of aircraft and taxiway geometry, Figure 2.

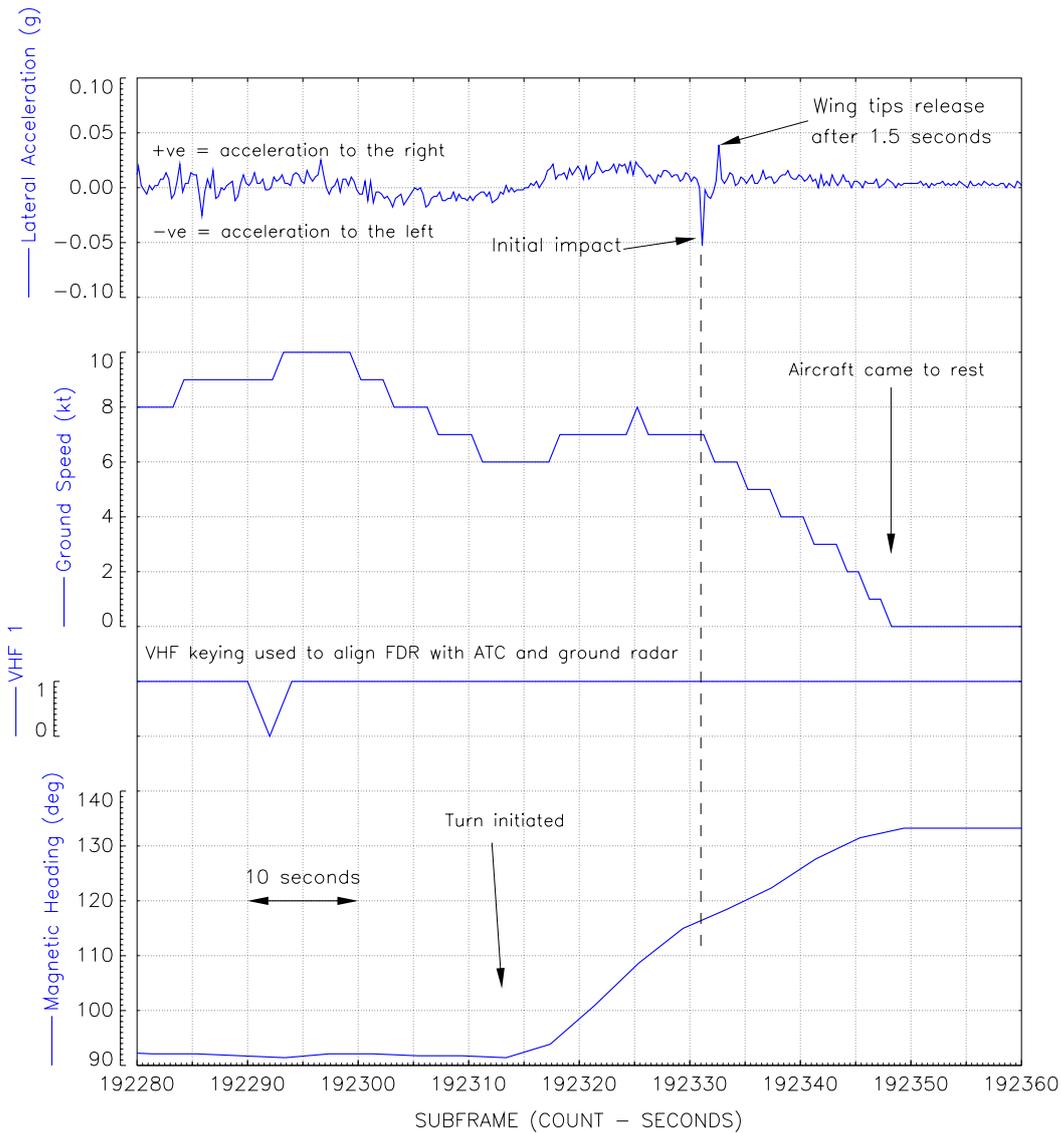
Figure 3
 Key FDR parameters from the B777.
 Accident to N781UA / 6Y-JMP on 14 July 2004 at Heathrow

The data confirmed that the B777, which was crossing behind the stationary A340, was turning to take up a heading parallel to the A340 on its right. At the time the B777's right wingtip struck the rear of the A340's left wingtip, it was travelling at approximately 7 kt, and turning right, resulting in a wingtip speed of approximately 2.7 kt. The wingtip impact generated a lateral acceleration (g) of 0.05g to the left and, after the B777's wingtip rubbed along the A340 wingtip for approximately 1.5 seconds, a spike

of 0.04g to the right. At this point the aircraft's speed was recorded as 6 kt and its magnetic heading samples either side of the initial impact g spike were recorded as 115°M and 118.5°M.

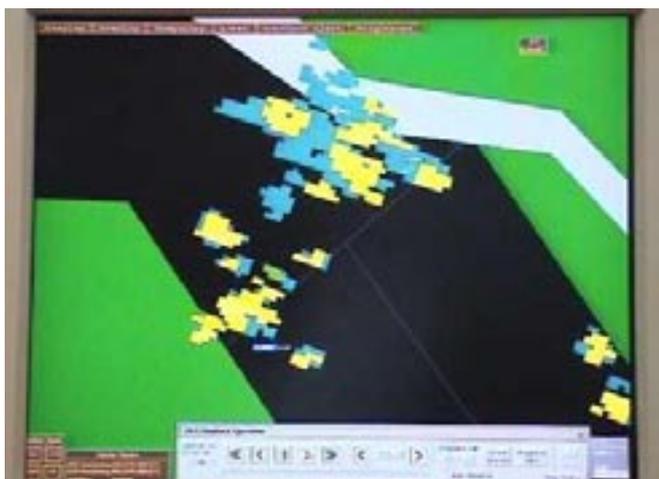
**Figure 4**

The different sources of recorded data all used separate timebases. However, matching the FDR recorded VHF keying with the ATC radio transmissions, along with NATS records of the differences between the ATC audio and ground radar time bases, allowed the different sources to be correlated. Figure 3 shows the main parameters from the FDR. The collision occurred at 12:53:51 hrs and three ground radar plots covering this time, each separated by 1 second, are presented in Figures 4 to 6.

Ground radar - 12:53:50 UTC - video time reference

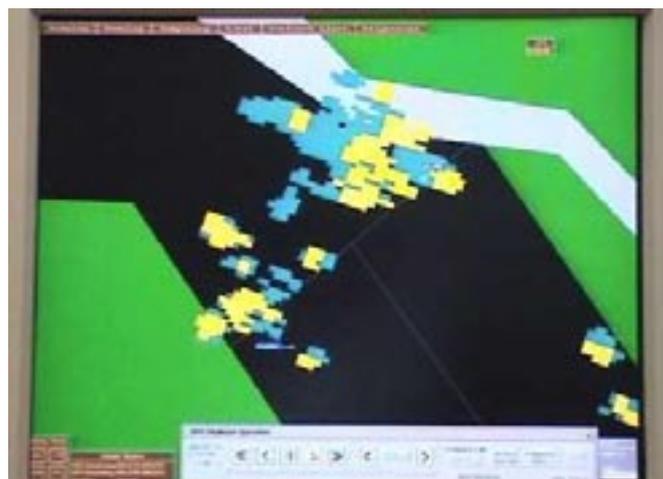
**Figure 5**

Ground radar - 12:53:51 UTC - video time reference

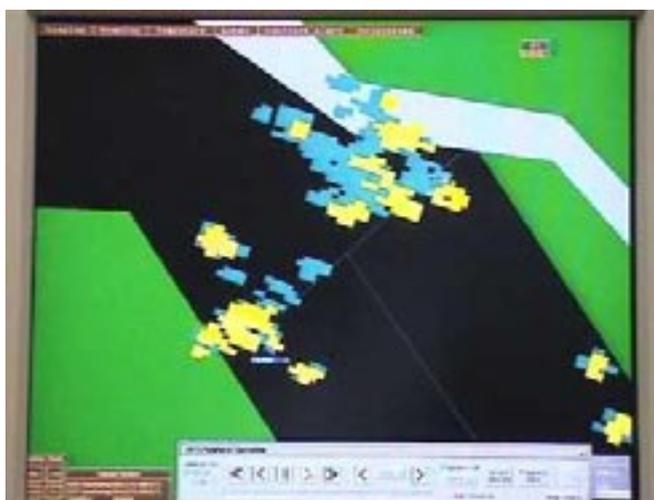
**Figure 6**

Ground radar - 12:53:52 UTC - video time reference
