Loss of de-icing boot and fuselage damage, Aurigny Air Services, Fairey Britten Norman BN2A Mk III-2 'Trislander', G-BEVT

Micro-summary: A de-icing boot separated from this Fairey Britten Norman BN2A Mk III-2 'Trislander, damaging a window and injuring passengers.

Investigative Body: Aircraft Accident Investigation Board (AAIB), United Kingdom

**‘Examination of G-BEVT
Trislander De-icing Boot Failure’**

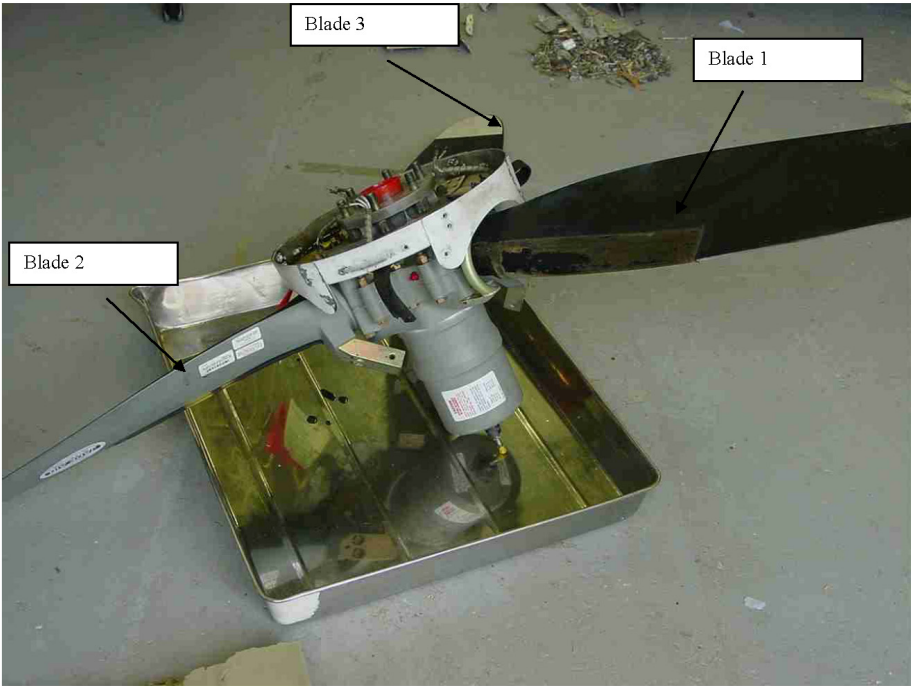
- 2.1 Figure 2 shows a photograph of the propeller identifying the three blades. Blade 1 had shed the de-icing boot and Blades 2 and 3 appeared well bonded. On arrival at QinetiQ each part of the propeller and the damaged de-icing boot was photographed and visually examined.

Figure 2: Photograph showing propeller from Trislander G-BEVT

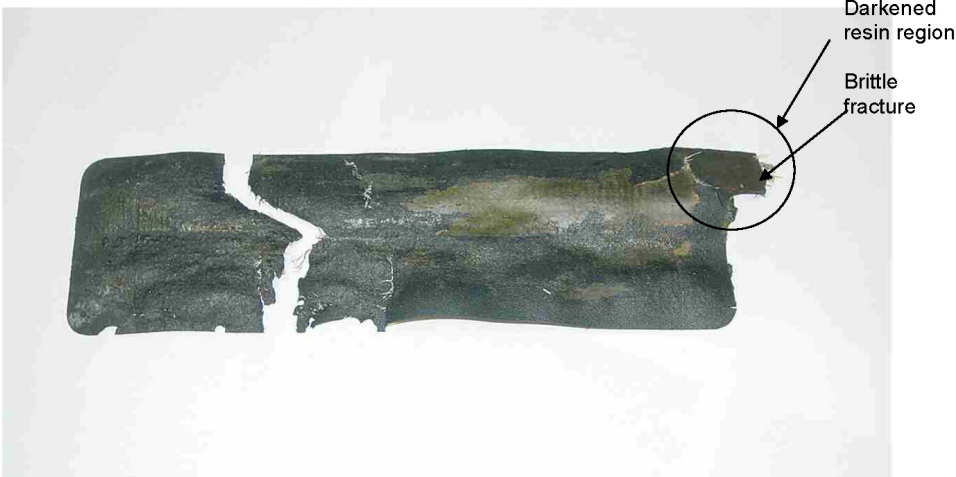
- 2.2 The failed de-icing boot was supplied in two parts, the separation into the two halves was believed to be a result of the impact with the window, see Figure 3. On the bonded surface of the boot there was a small patch of adhesive near the centre. The remainder of the surface showed no residual adhesive. At the root end of the boot the resin appeared much darker (marked in Figure 3). The boot strap had fractured at the root of the de-icing boot, this failure of the rubber appeared brittle, see Figure 4. Examination of the surface of Blade 1 showed the adhesive to be well bonded in most regions with the exception of the root end as shown in Figure 5.

Figure 3: Photograph showing failed de-icing boot from Blade 1

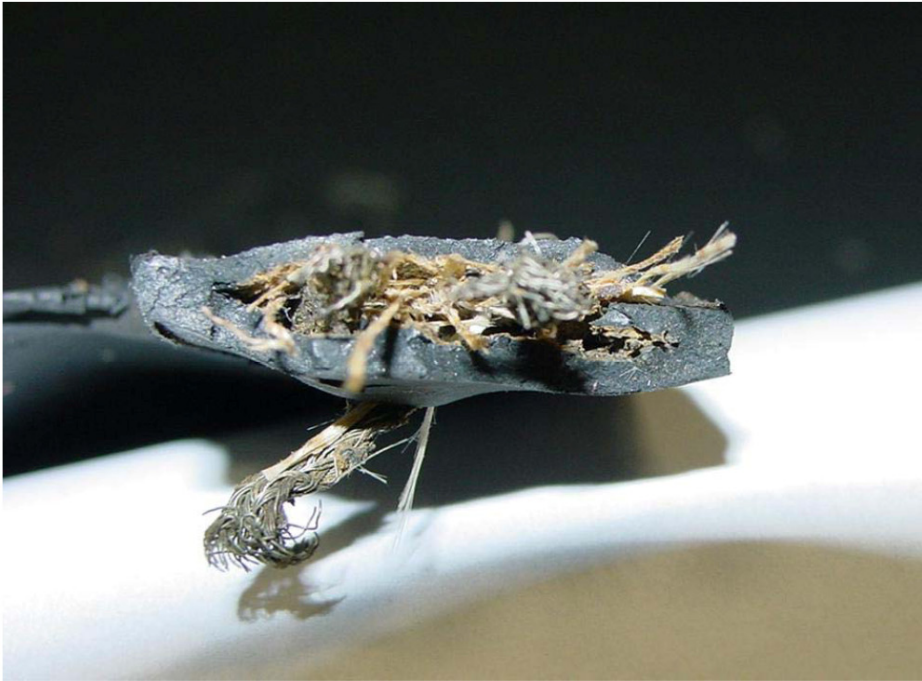
The report shows that a brittle fracture of the de-icer lead strap occurred at the root near the restrainer strap. Moreover, the fracture in the middle of the boot was also brittle. Both of these fractures indicated a high strain rate, typical of impact. A third fracture near the electrical termination was ductile indicating a lower rate of strain onset. Also, a substantial section of the lead strap was missing. These findings are consistent with the sudden release of the boot and its impact with the window. They imply that the lead strap failed first and the boot was then pulled through the restrainer strap and released. Evidence of rubber on the restrainer strap itself supported this explanation.

Figure 4: Rubber failure at the root end of boot from Blade 1

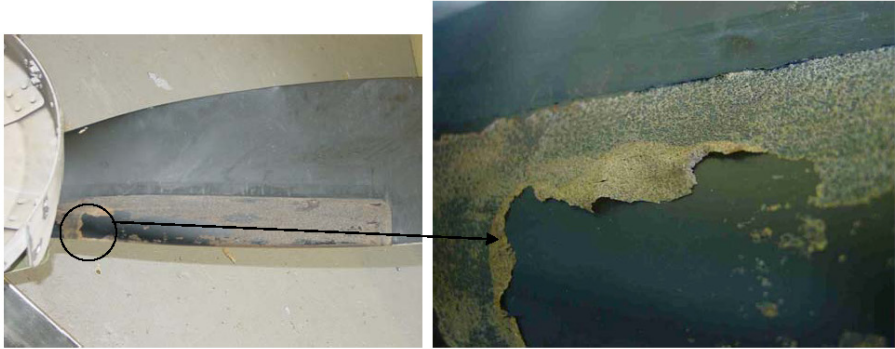
Figure 5: Bonding area of Blade 1, showing disbonded adhesive

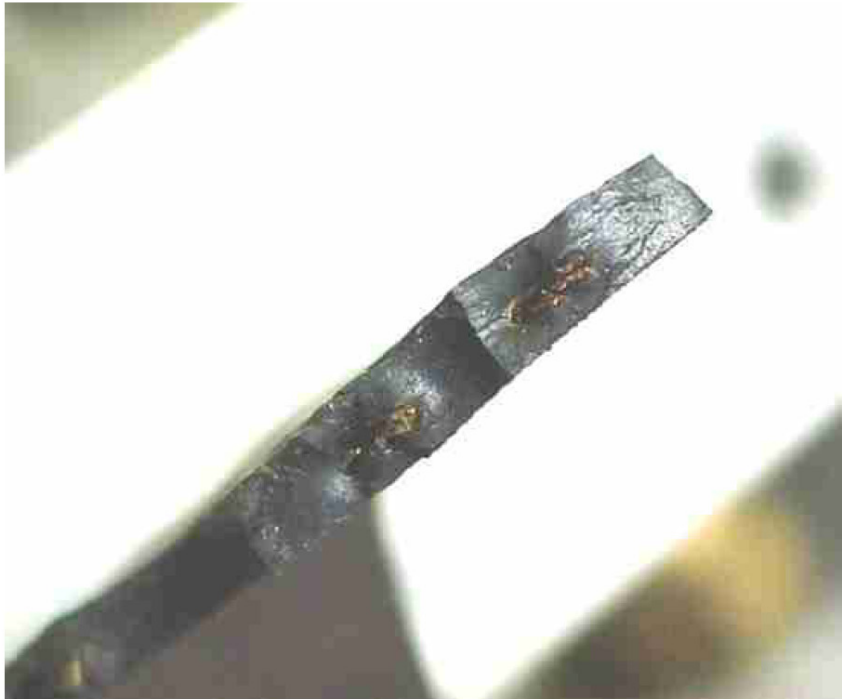
- 2.3 Near the electrical termination, a second fracture in the strap was found (Figure 6). In this case the fracture appeared to be ductile. It was apparent, however, that a large section of the strap was missing between the two fractures when compared to the strap on the de-icing boot of blade 2 (Figure 7).

Figure 6: Second fracture in strap, near electrical termination

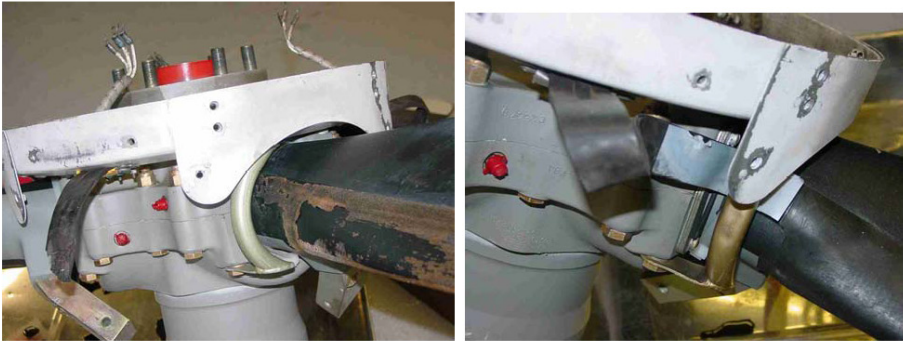
Figure 7: Remains of strap attached to hub from Blade 1 de-icer boot (left-hand image) and equivalent strap on Blade 2 (right hand image)

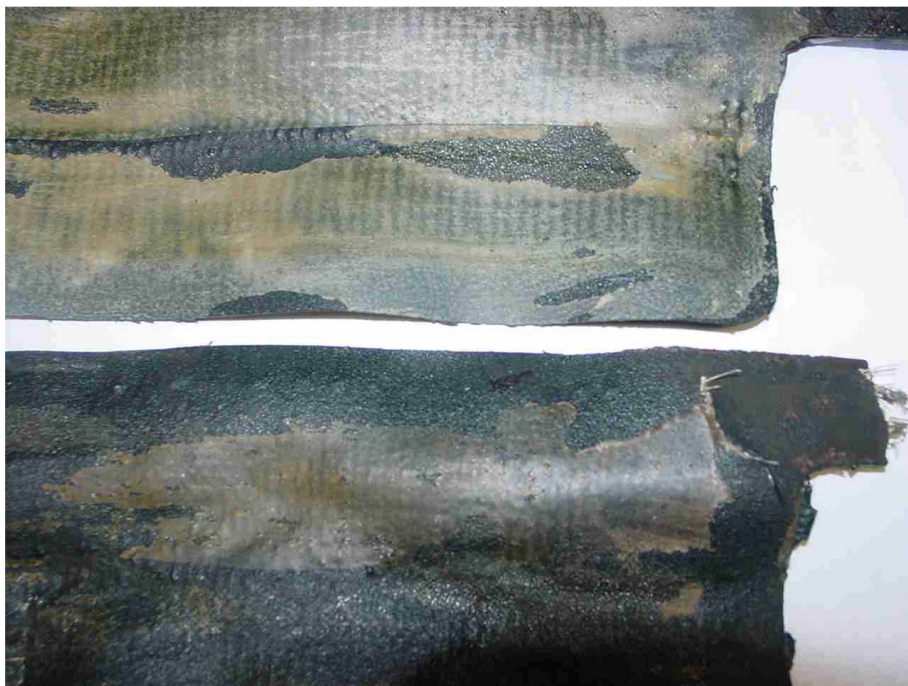
- 2.5 There was also a notable colour difference between the adhesive on the surfaces of the de-icing boots from Blade 1 and Blade 2. The adhesive on Blade 2 was a light yellow colour whereas the adhesive on Blade 1 was light brown, see Figure 11. Two weeks after the removal of the de-icing boot from Blade 2, the de-icing boot from Blade 3 was removed and it was observed that the adhesive from Blade 2 had significantly darkened during this period (Figure 12). This darkening has been noted by other users of the adhesive at

Figure 11: Comparison of adhesive colouration on de-icer boots from Blades 1 (bottom) and 2 (top)

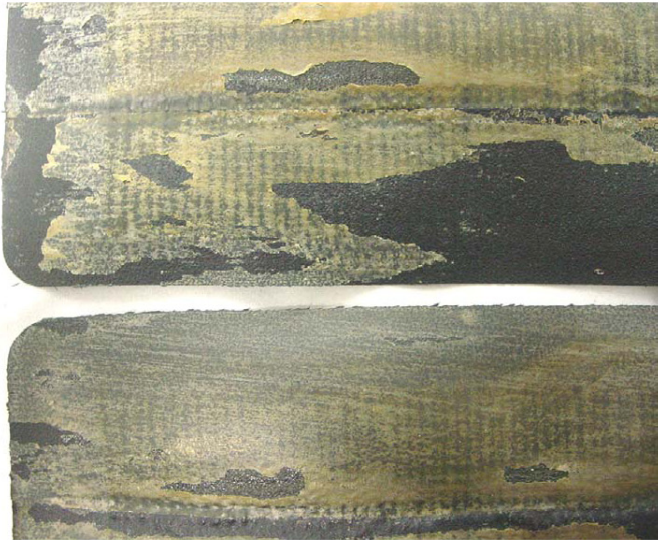
Figure 12: Comparison of colouration of de-icer boots removed from Blades 3 (top) and 2 (bottom), showing discolouration of the former with time

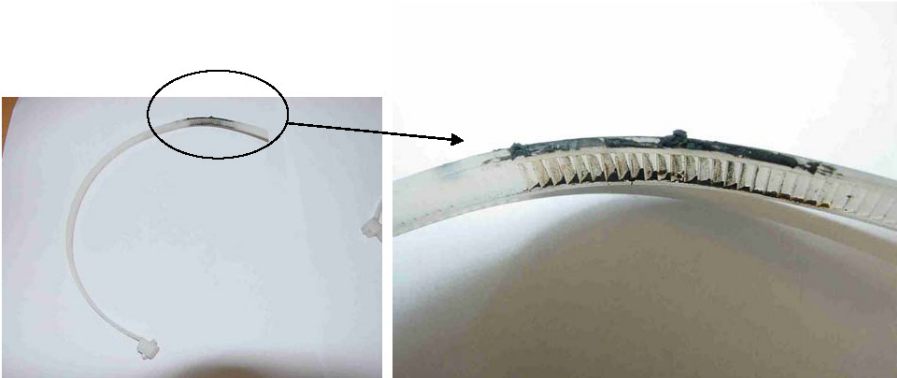
- 2.6 Figures 13 and 14 show the tie wraps from the failed and good de-icing boots. It was observed that the tie wraps from the undamaged boots showed no evidence of marking. On the tie wrap from the failed de-icing boot there was a build up of residue on the root edge (near electrical termination) suggesting that the boot strap had been pulled through.

Figure 13: Tie wrap from failed de-icer strap showing residue on root edge.

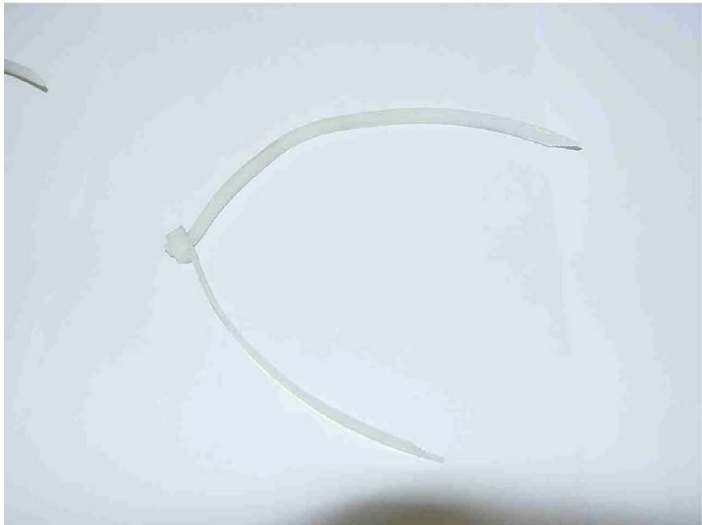
Figure 14: Tie wrap from good de-icer boot (Blade 2)

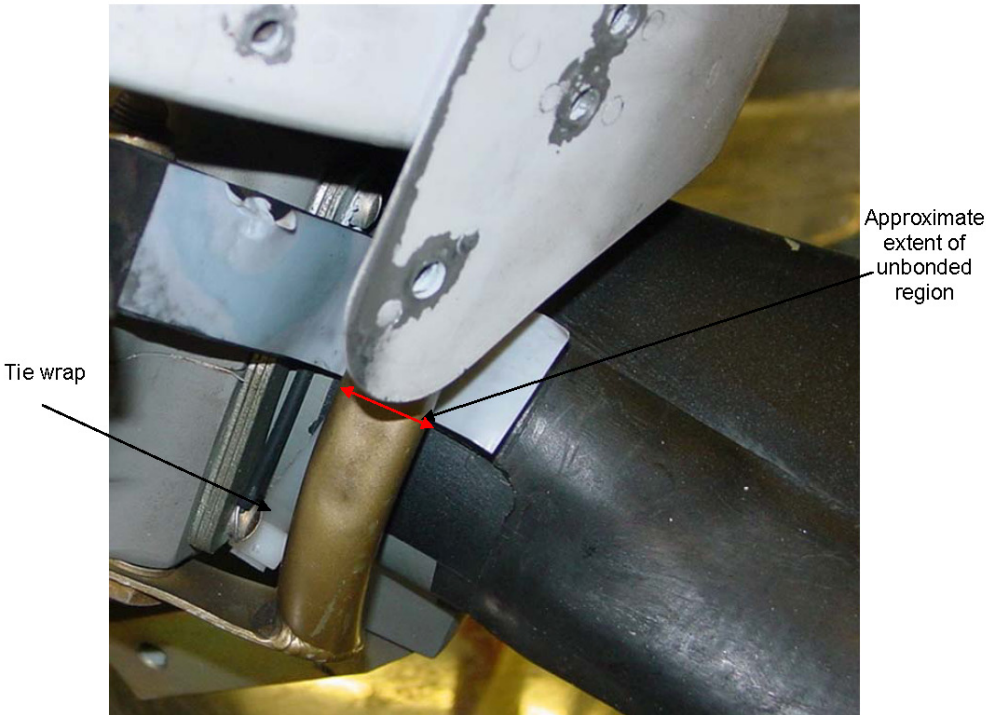
- 2.7 The position of the tie wraps on Blades 2 and 3 was significantly further from the root end of the boot than shown in the manufacturer's example images (Figure 1). The tie wrap is applied over the bonded region in the manufacturer's example but on Blades 2 and 3 the tie wrap was applied over the strap beyond the bonded region. This resulted in a region of unbonded strap, approximately 5-8 mm long between the bonded root of the boot and the tie wrap, see Figure 15. The position of the tie wrap with respect to the bonded region on the failed de-icing boot is unknown as the piece of strap that would have been beneath the tie wrap is missing.

Figure 15: Photograph showing the location of the tie wrap with respect to end of bonded region on blade 3

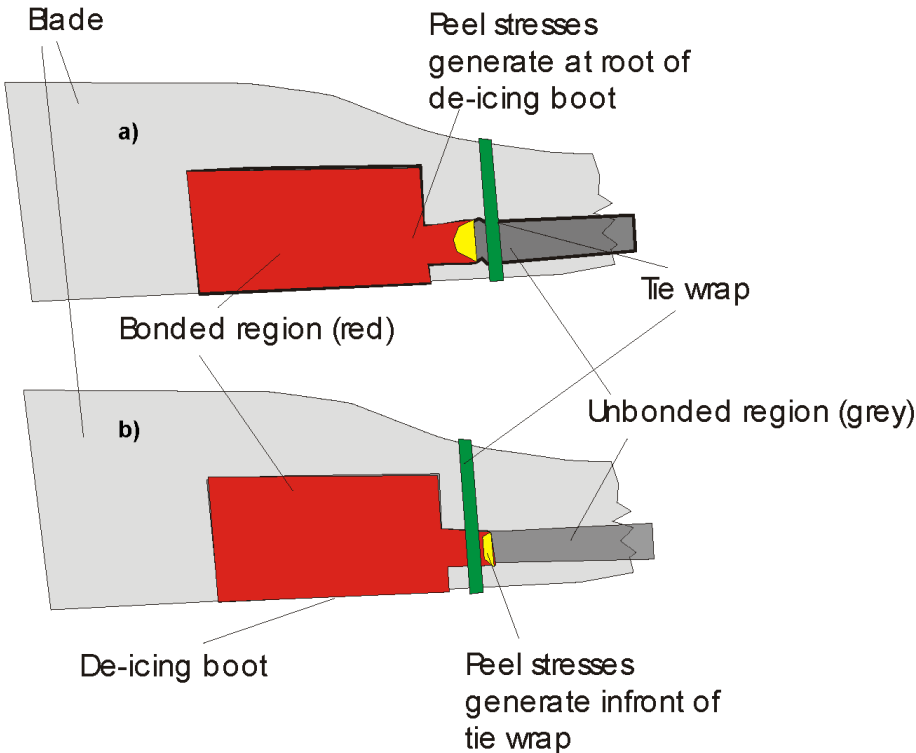
Figure 16: Schematic showing location of tie wraps and bonding on a) blade 2 and 3 from Trislander propeller examined and b) manufacturer's example

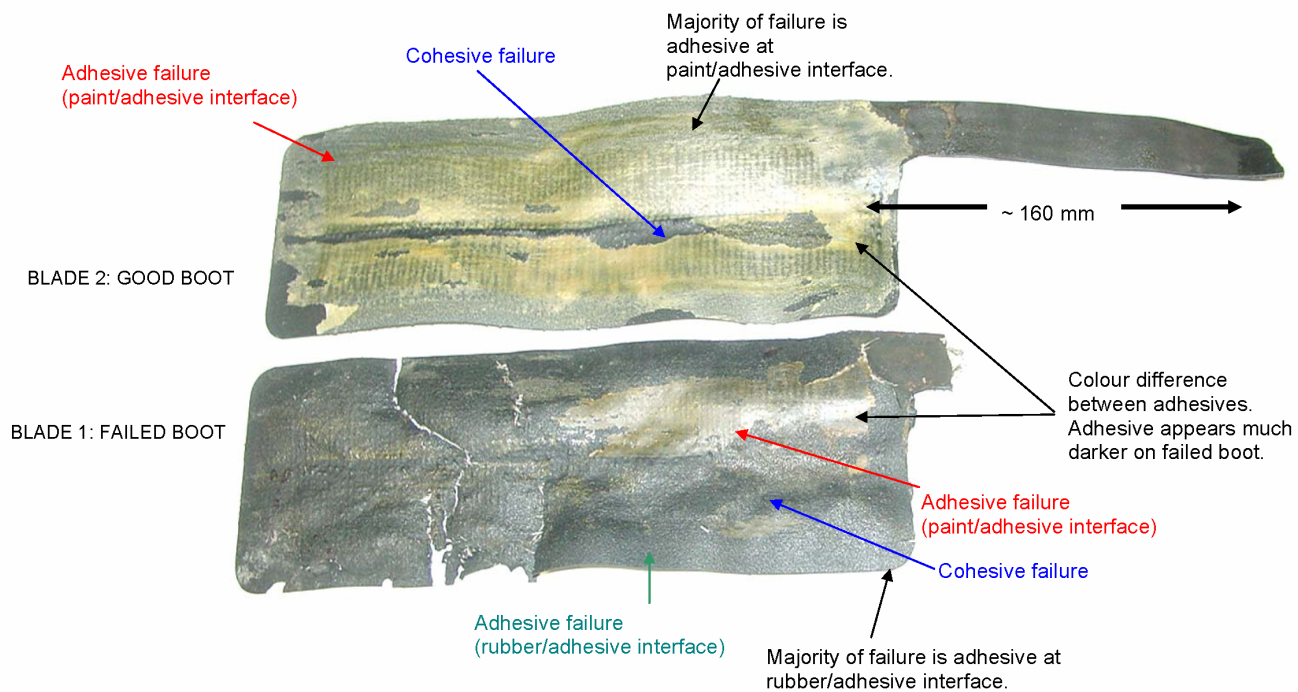
- 2.9 Figure 17 shows a summary of the bonded fracture surfaces from boots 1 and 2.
- 3 NDE**
- 3.1 Before the de-icing boots were detached from Blades 2 and 3, they were examined using the ANDSCAN non-destructive evaluation (NDE) technique. This technique utilises high frequency ultrasonic scanning with water as the contact medium. Changes in material properties, such as the presence of voids in the adhesive bond, result in a change in the bulk attenuation from which a map of damaged areas can be obtained. A number of different ultrasonic probes were tried with the ANDSCAN. However, the material was found to be highly attenuative and a scan of the whole bonded area was not possible. A 5MHz single crystal probe worked relatively well on the thin section of the boot. In these areas of the de-icing boot the bond appeared to be good, however NDE was not able to detect changes in the adhesive where the rubber thickness increased near the root region or at the leading edge where a tight radius of curvature existed.

Figure 17: Failure across bonded surfaces of good (top) and failed (bottom) de-icer boots
