## Hard landing, Report on the accident to Boeing MD11 B-150 at Hong Kong International Airport on 22 August 1999

**AIRCRAFT ACCIDENT REPORT 1/2004**

**ACCIDENT INVESTIGATION DIVISION**

**Report on the accident to  
Boeing MD11 B-150  
at Hong Kong International Airport  
on 22 August 1999**

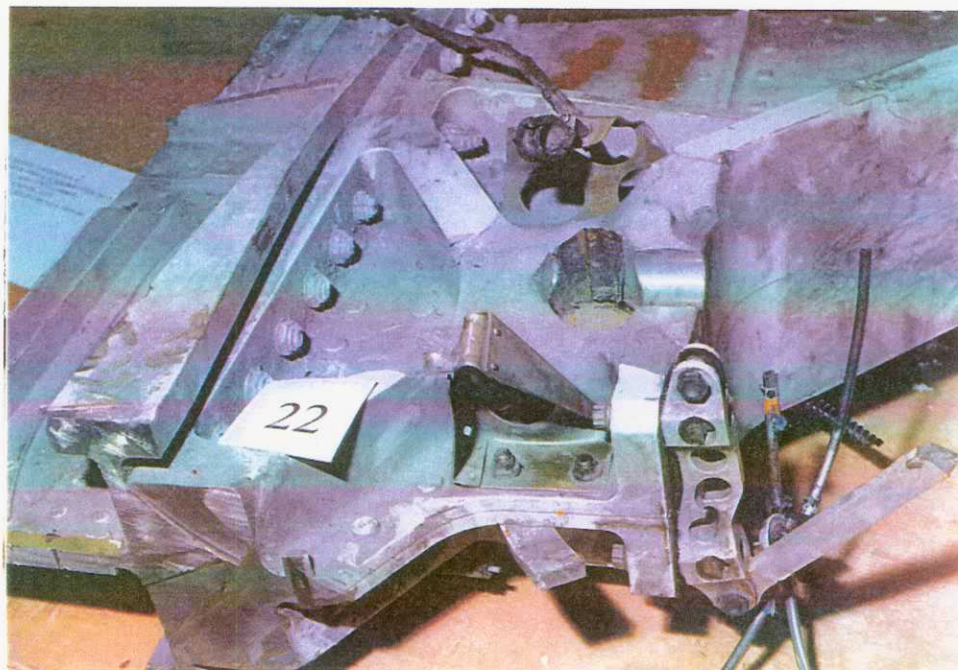
**Fractured Trapezoidal Panel (Figure 12)**

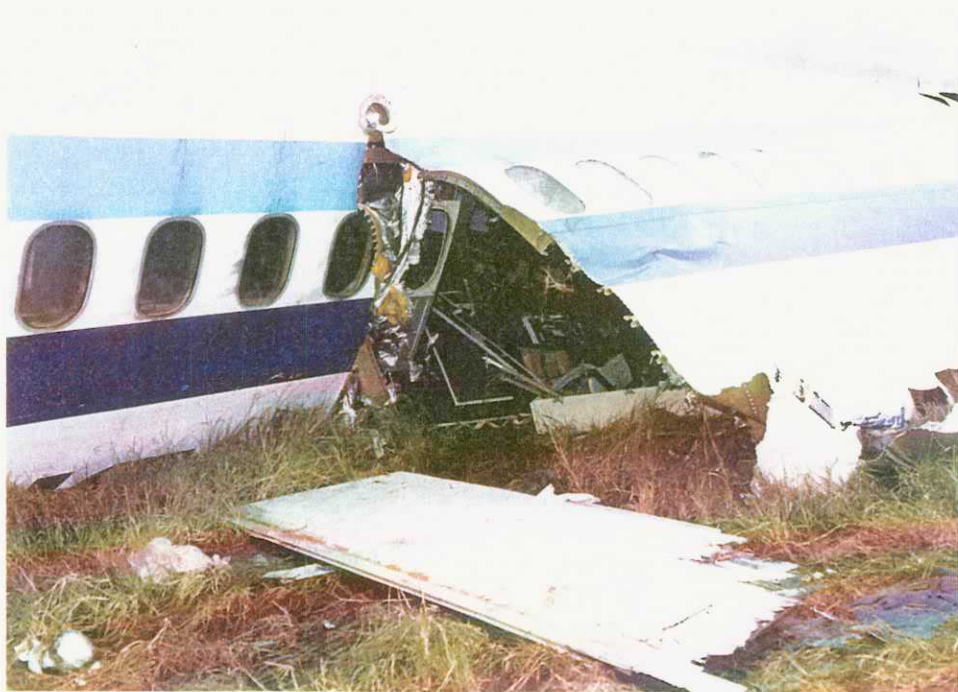
9. View of crack in right fuselage (aft).

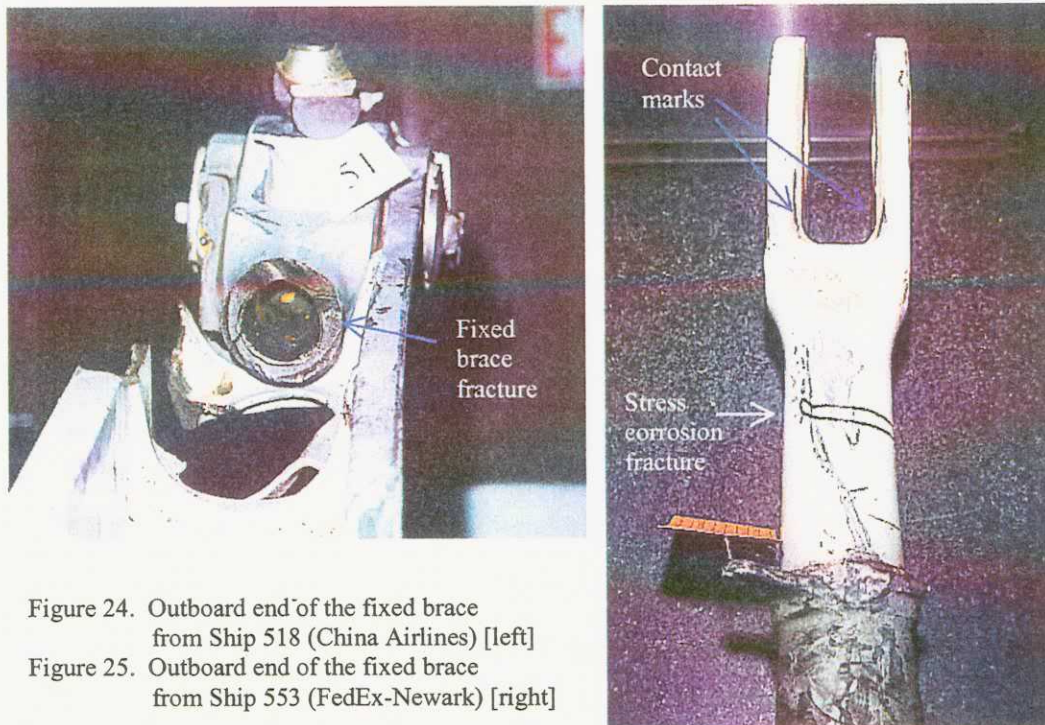
Figure 24. Outboard end of the fixed brace from Ship 518 (China Airlines) [left]
