Landing gear failure, Boeing 737-204ADV (EI-CJC), Dublin, Ireland, June 8, 2004.

FINAL REPORT

AAIU Synoptic Report No: 2006-007

Aircraft Type and Registration:	B737-204ADV, EI-CJC
No. and Type of Engines:	2 x P & W JT8D
Aircraft Serial Number:	22640
Year of Manufacture:	1982
Date and Time (UTC):	8 June 2004 @ 09.45 hrs
Location:	Dublin Airport
Type of Flight:	Commercial
Persons on Board:	Crew - 2 Passengers - 112
Injuries:	Crew - Nil Passengers - Nil
Nature of Damage:	Left Hand main landing gear trunnion pin sheared
Commander's Licence:	Irish Air Transport Pilot Licence
Commander's Details:	Male, aged 46 years
Commander's Flying Experience:	12,000 hours total
Information Source:	Aer Rianta Duty Officer

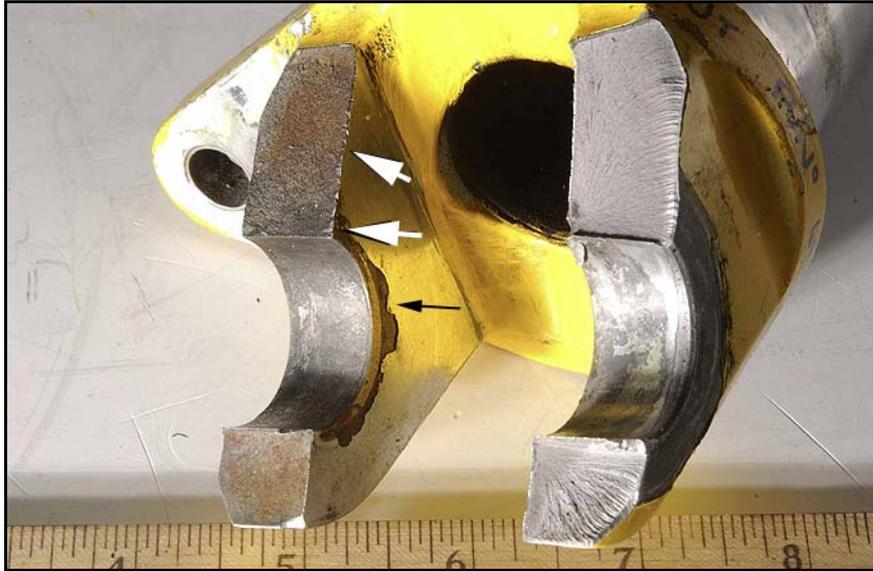
APPENDIX A

The LH main landing gear trunnion pin Part No. 65-46113-16, Serial No. LMC0422 failed at the outboard end at the MLG actuator attachment point (**Appendix A**). This trunnion pin assembly had been fitted, “in overhauled condition”, on another aircraft of the fleet, EI-CKQ (B737-2K2) on 25 June 1999. It was removed from that aircraft as unserviceable on 22 February 2000 during a P12 check in the UK and had 52,887 cycles since new (CSN) and 1511 cycles since last overhaul (CSO) at that stage. The overhaul period for this component is 16,000 cycles and the pin should be scrapped at 75,000 cycles.

1. Fracture of the lugs was due to poor chrome plating and chrome plate grinding damage on the inner face of the lug adjacent to the anti-rotation bolthole flange.

The white arrows denote the fracture origin region of the lug adjacent to the flange, which fractured first. The black arrow shows where chrome plating has flaked off the inner lug face.

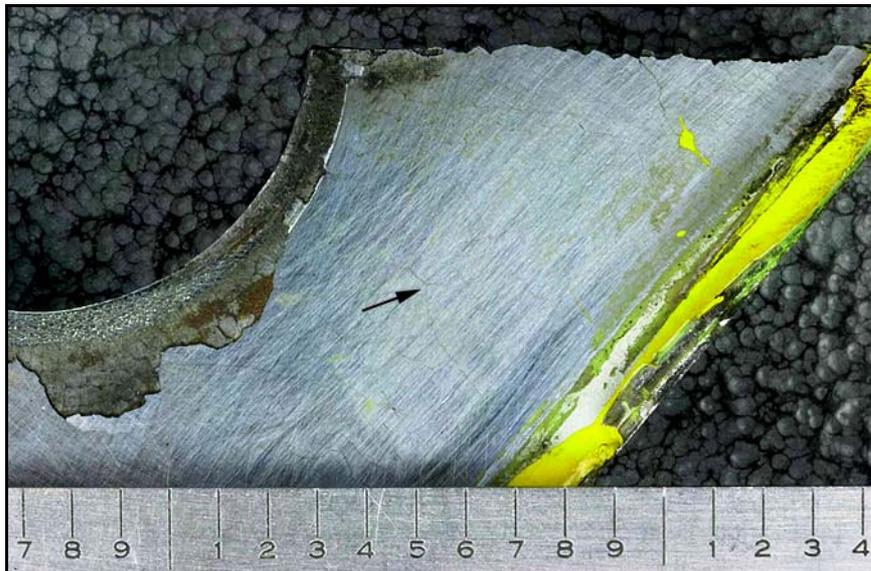
2. The chrome plating exhibited poor adhesion characteristics and numerous through-thickness chicken wire cracks. The severe cracks in the plating are indications of poor plating techniques.
3. The crack propagation mode, which led to the fracture, was due to Stress Corrosion Cracking (SCC). Final fracture occurred in the primary fracture lug as well as in the adjacent lug by ultimate tensile separation.
4. The grinding damage most likely resulted in a thin overtempered martensite layer found beneath the chrome plating on the inner face of the lug. However, the bulk of the trunnion pin material confirmed that the part was fabricated from the drawing specified 4340M alloy steel in the 275-300 ksi heat treat condition.

The chrome plating on the inner surface of the fracture lug exhibits severe through-thickness cracking. The black arrow shows an area of "chicken wire cracking."
