## Runway overrun Onur Air, Runway overrun after rejected take-off of the Onur Air MD-88, registration TC-ONP, at Groningen Airport Eelde on 17 June 2003

Runway overrun after rejected take-off of the Onur Air MD-88, registration TC-ONP, at Groningen Airport Eelde on 17 June 2003

The Hague, 6 April 2006 (investigation number 2003071)

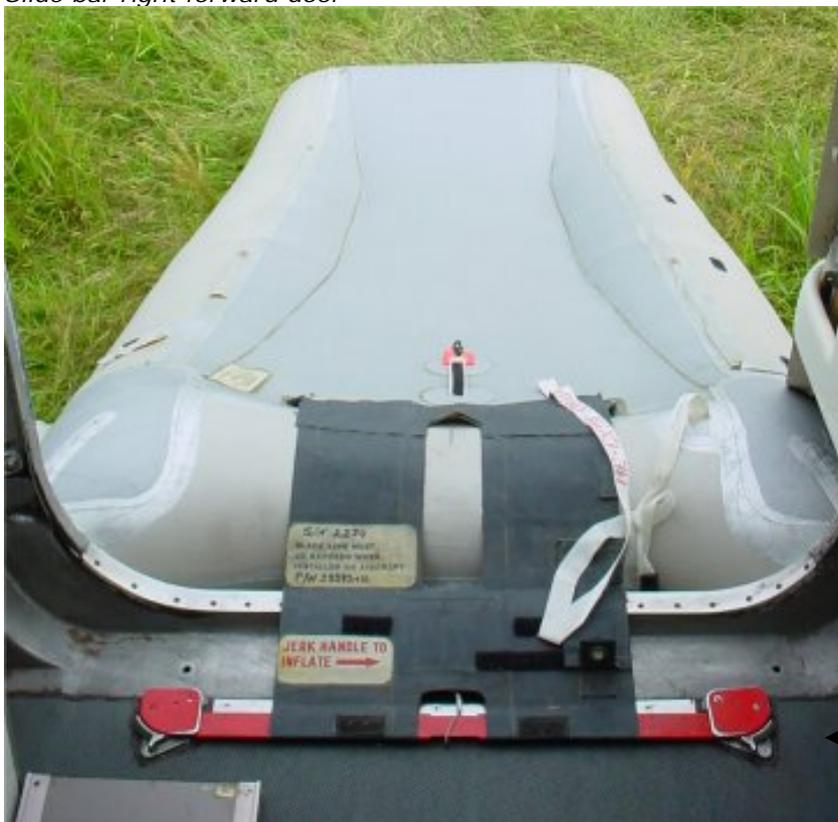
During the investigation it was noted that two different systems that hold the slide bar were used for the left and right forward aircraft doors. (See pictures below)

Slide bar left forward door

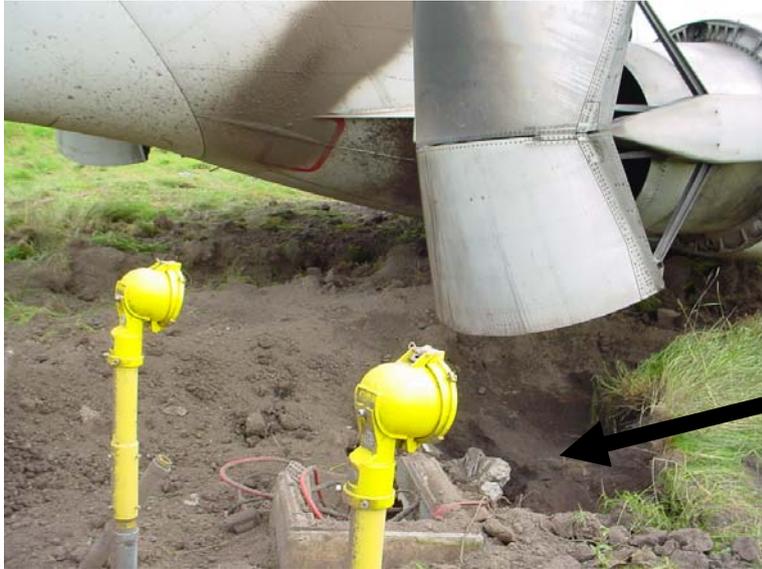
Investigation revealed that at the Groningen airport, in the area after the end of the runway, the so-called 'overrun area', there are underground concrete structures (transformation wells) in soft soil. The Dutch Safety Board holds the view that such a combination (underground structures and soft soil) entails a great fire hazard for the occupants in the event of a collision (the aircraft fuel, the risk of ignition of sparks and the engines which are hot). As Onur Air's MD-88 is a type of aircraft of which the engines are not located under the wing, but are mounted on the rear side of the fuselage, reducing the risk of contact with the ground.

At the day of the accident the soil in the overrun area was not strong enough to support the aircraft. During the overrun the main landing gear sank in the soft soil and damaged several of the approach light system embedded concrete structures and their contents. The centre and wing fuel tanks and engines did not encounter the concrete construction.

- It is recommended to the Minister of Transport, Public Works and Water Management to investigate to which extent the requirements concerning the underground infrastructure in the direct vicinity of start and landing runways has to be stepped up to prevent serious damage to aircraft that overrun the runway.

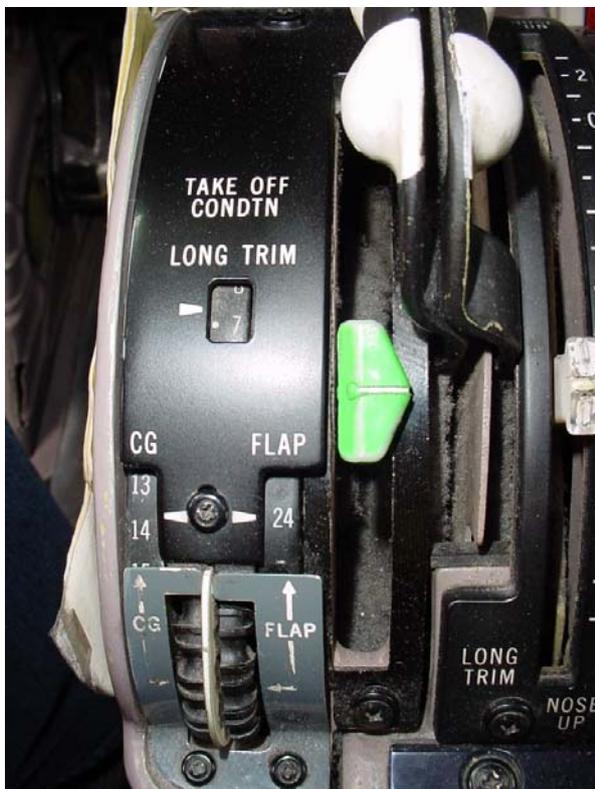
*Figure 2: pedestal take-off condition computer.*

The captain stated and the CVR recording confirmed that during the take-off a stabilizer warning sounded. After the accident DTSB investigators found the TO-CG input on the take-off condition computer set at approximately 13.5 % MAC (and flap input 24 degrees), which positioned the green band opposite to the stabilizer trim position indicator.

Functional checks were carried out in order to verify proper functioning of the stabilizer warning system. Stabilizer configuration warning tests in accordance with the Aircraft Maintenance Manual (AMM) showed no anomalies in the system. Additional tests were performed to verify what TO-CG (thumbwheel) inputs on the take-off condition computer would generate a stabilizer warning. It was found that 13.5 % MAC input could not produce a warning. When 11.1 % MAC was inserted the stabilizer warning sounded.

The stabilizer take-off setting is determined by entering the calculated CG value from the load and trim sheet and the required flap setting in the pedestal mounted take-off condition (mechanical) computer. The stabilizer calculated numeric outcome will appear in the take-off condition long trim window. The crew have to set the horizontal stabilizer by running the stabilizer till the take-off position indicator matches the long trim window numeric outcome, see also the picture left.

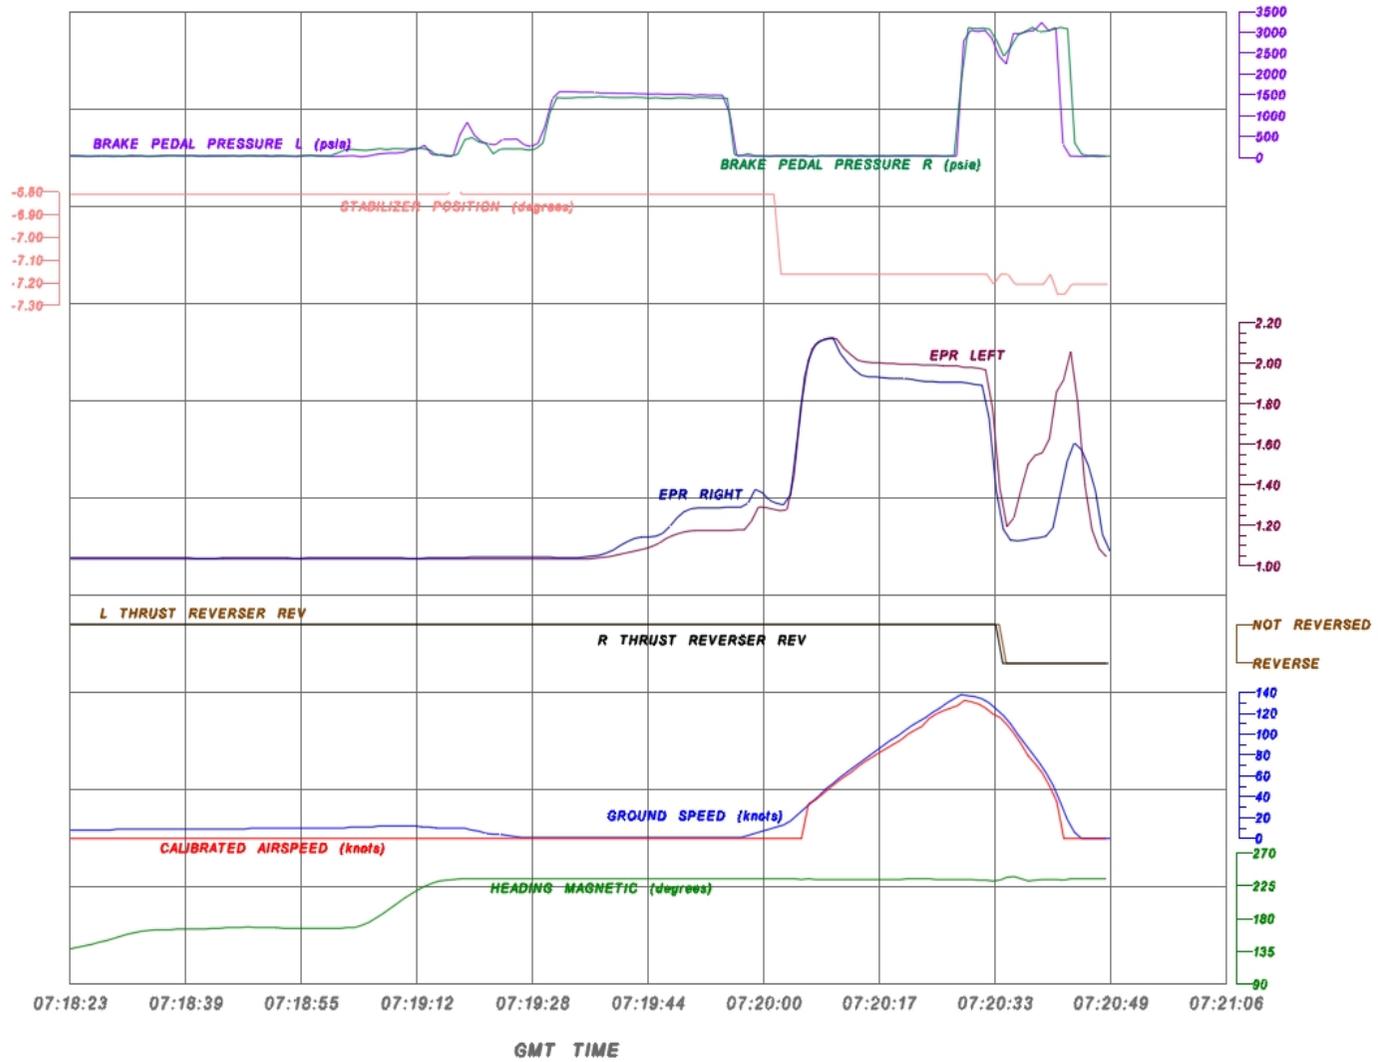
APPENDIX H  
FDR data plot

On the runway checks were performed. FDR data indicated a stabilizer position change from 6.8 to 7.2 degrees aircraft nose up (ANU). Thereafter the crew initiated a static engine spin-up. Again the stabilizer warning sounded. The crew released the brakes and started the take-off roll. From the CVR it is derived that during the entire take-off roll the warning sounded continuously.

When attempting to rotate the captain experienced a heavy elevator control force. The captain stated that he needed much more than normal back pressure on his control column to lift the nose. He felt "it was impossible to make the take-off", and as the nose did not rise he decided to reject the take-off. Post accident analysis revealed that the rejection was initiated at 128 knots.
