## Yaw problems on approach, Report on the Serious Incident at Bergen Airport Flesland (ENBR) ON 24 March 2003, involving SAS329, MD-81, LN-RMO, Operated By Scandinavian Airlines

**Investigative Body:** Accident Investigation Board Norway (AIB), Norway

SL Report: 48/2005

**REPORT ON THE SERIOUS INCIDENT  
AT BERGEN AIRPORT FLESLAND (ENBR)  
ON 24 MARCH 2003,  
INVOLVING SAS329, MD-81, LN-RMO,  
OPERATED BY SCANDINAVIAN AIRLINES**

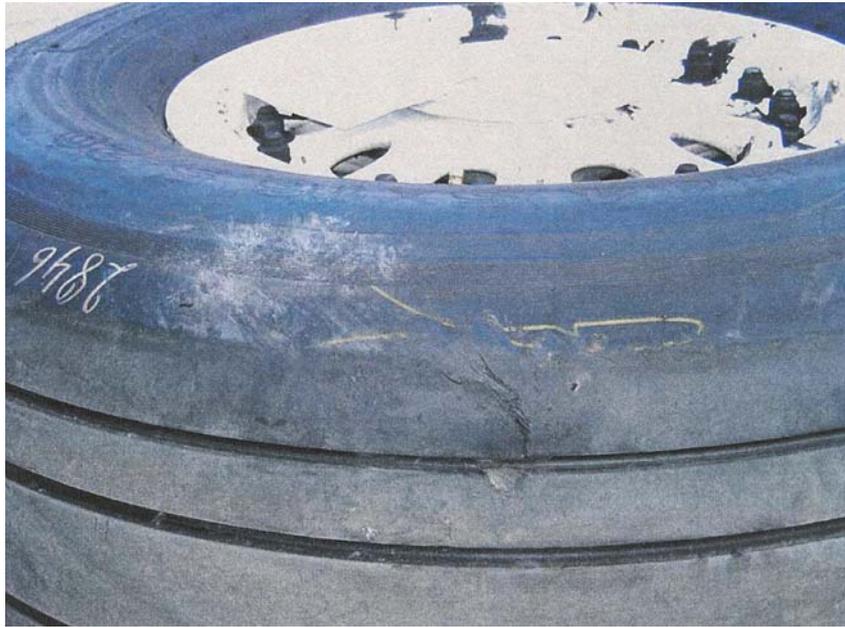
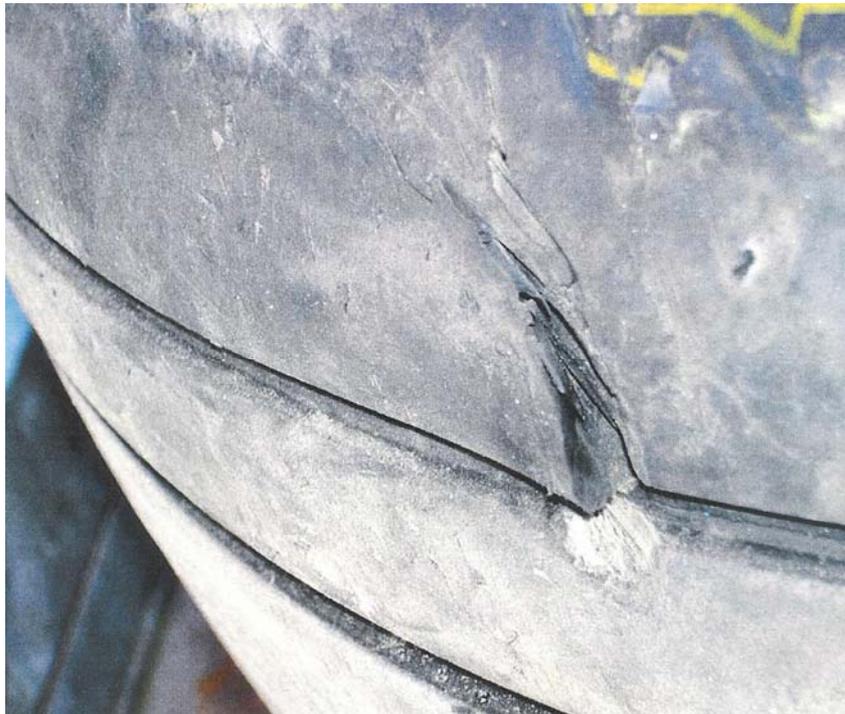
APPENDIX 1 LN-RMO

The damage to the aircraft was limited to a deep slash in the left outboard main wheel tyre (wheel no. 1). No further damage was found on the aircraft or its systems. The wheel was replaced at ENBR. Cf. Appendix 1.

*Damaged aircraft tires*

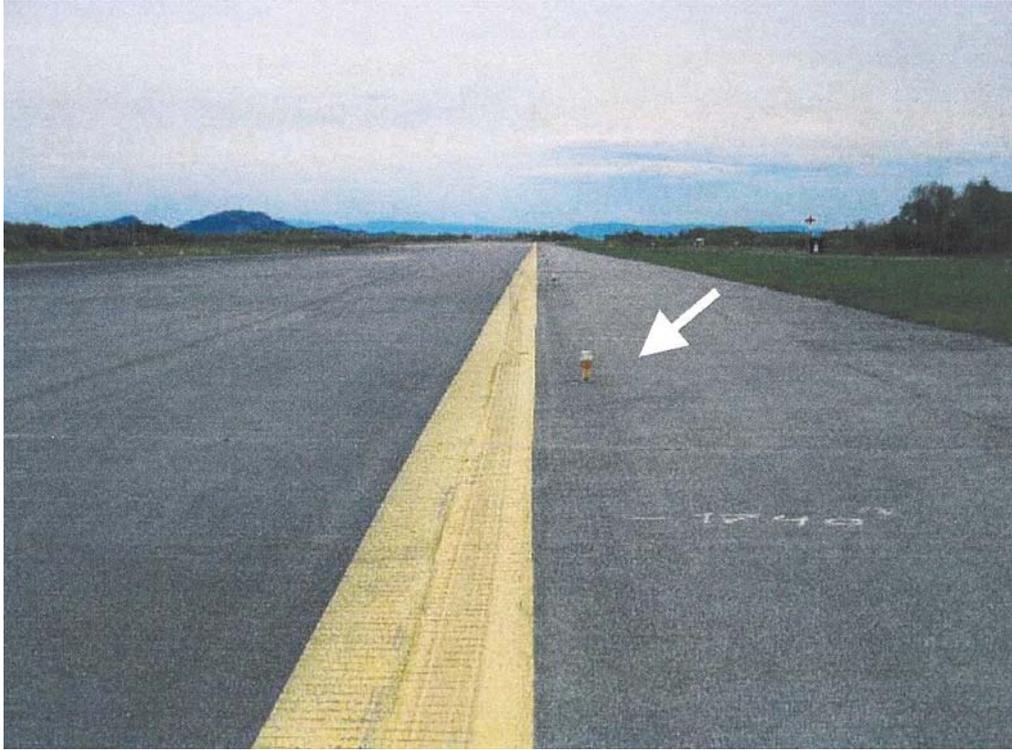
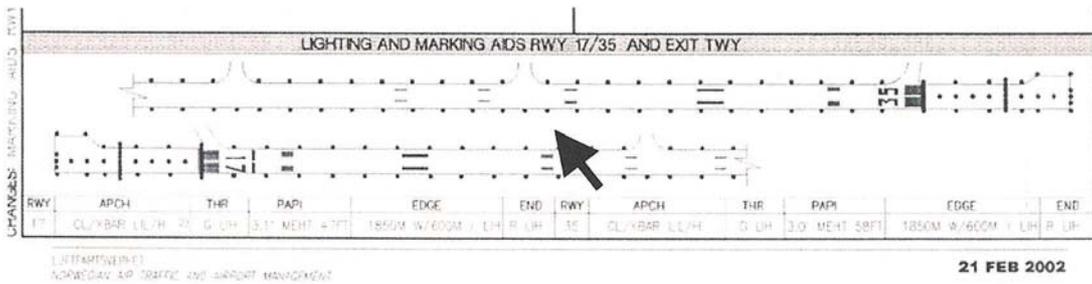
APPENDIX 2 LN-RMO

One (1) runway edge light, located 700 m from the threshold on the left hand side of runway 35, was broken. Cf. Appendix 2.

*Damaged runway edge light*

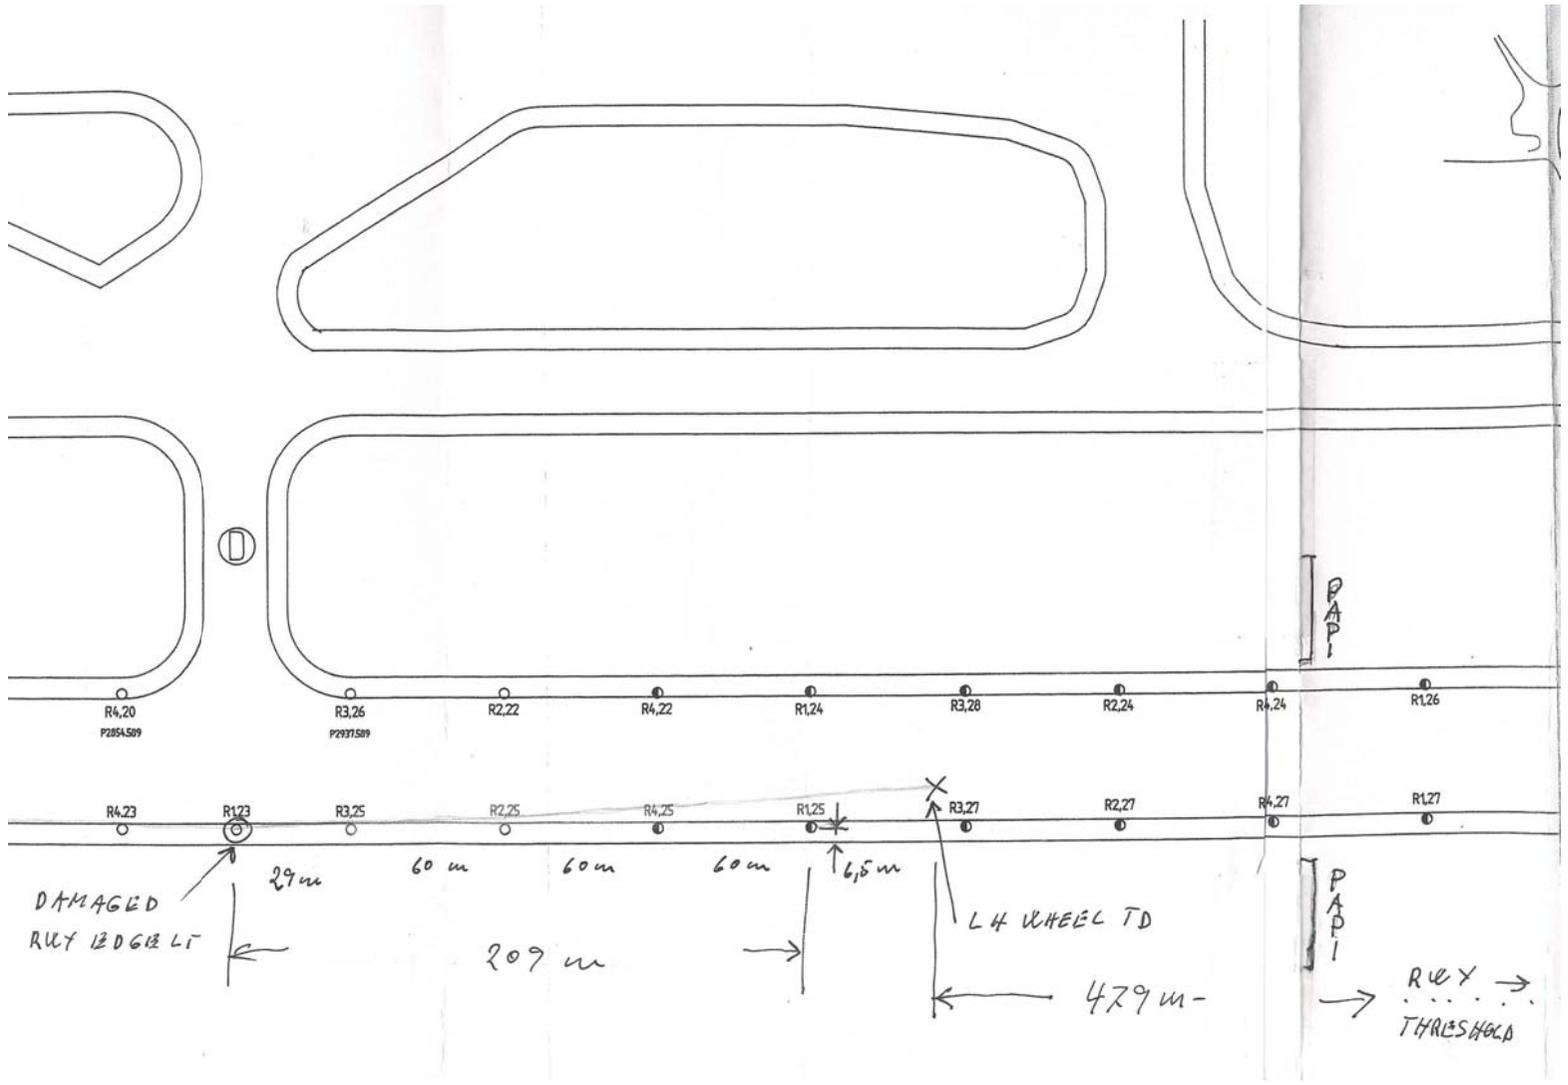
- 1.1.14 During this turn, the outer left main (no. 1) wheel tyre collided with a RWY edge light, which was broken.
- 1.1.15 The rest of the rollout and taxiing to parking was uneventful.

Touch down and aircraft ground track

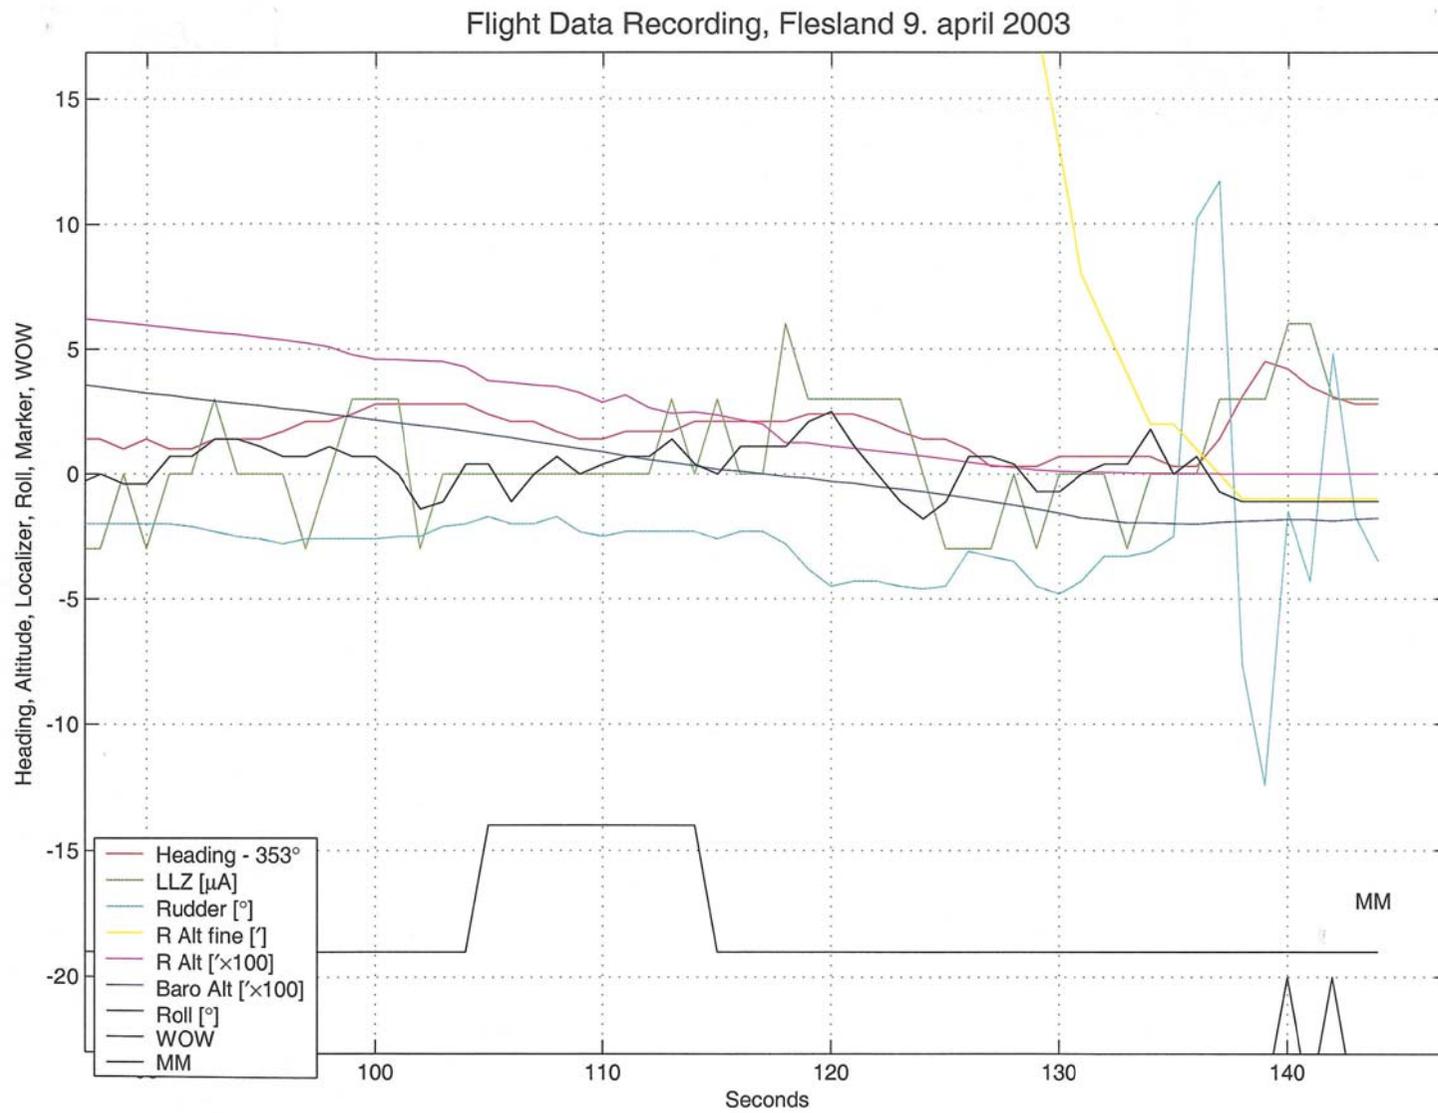
- 1.18.2.2 A closer look at the LLZ recordings show that there is a small deviation of the LLZ shortly before TD. There is a slight right deviation followed by a slight left deviation. This compares well with the incidents and may be the cause for the AP drift to the right at about 100 ft radio altitude. During autolandings the AP will correct back as the LLZ beam straightens out. Cf. Appendix 4.
