Near-miss between a DHC-8-311, LN-WFR, and Boeing 737-800.

REPORT

Date: 12.12.2005
SL Report: 45/2005

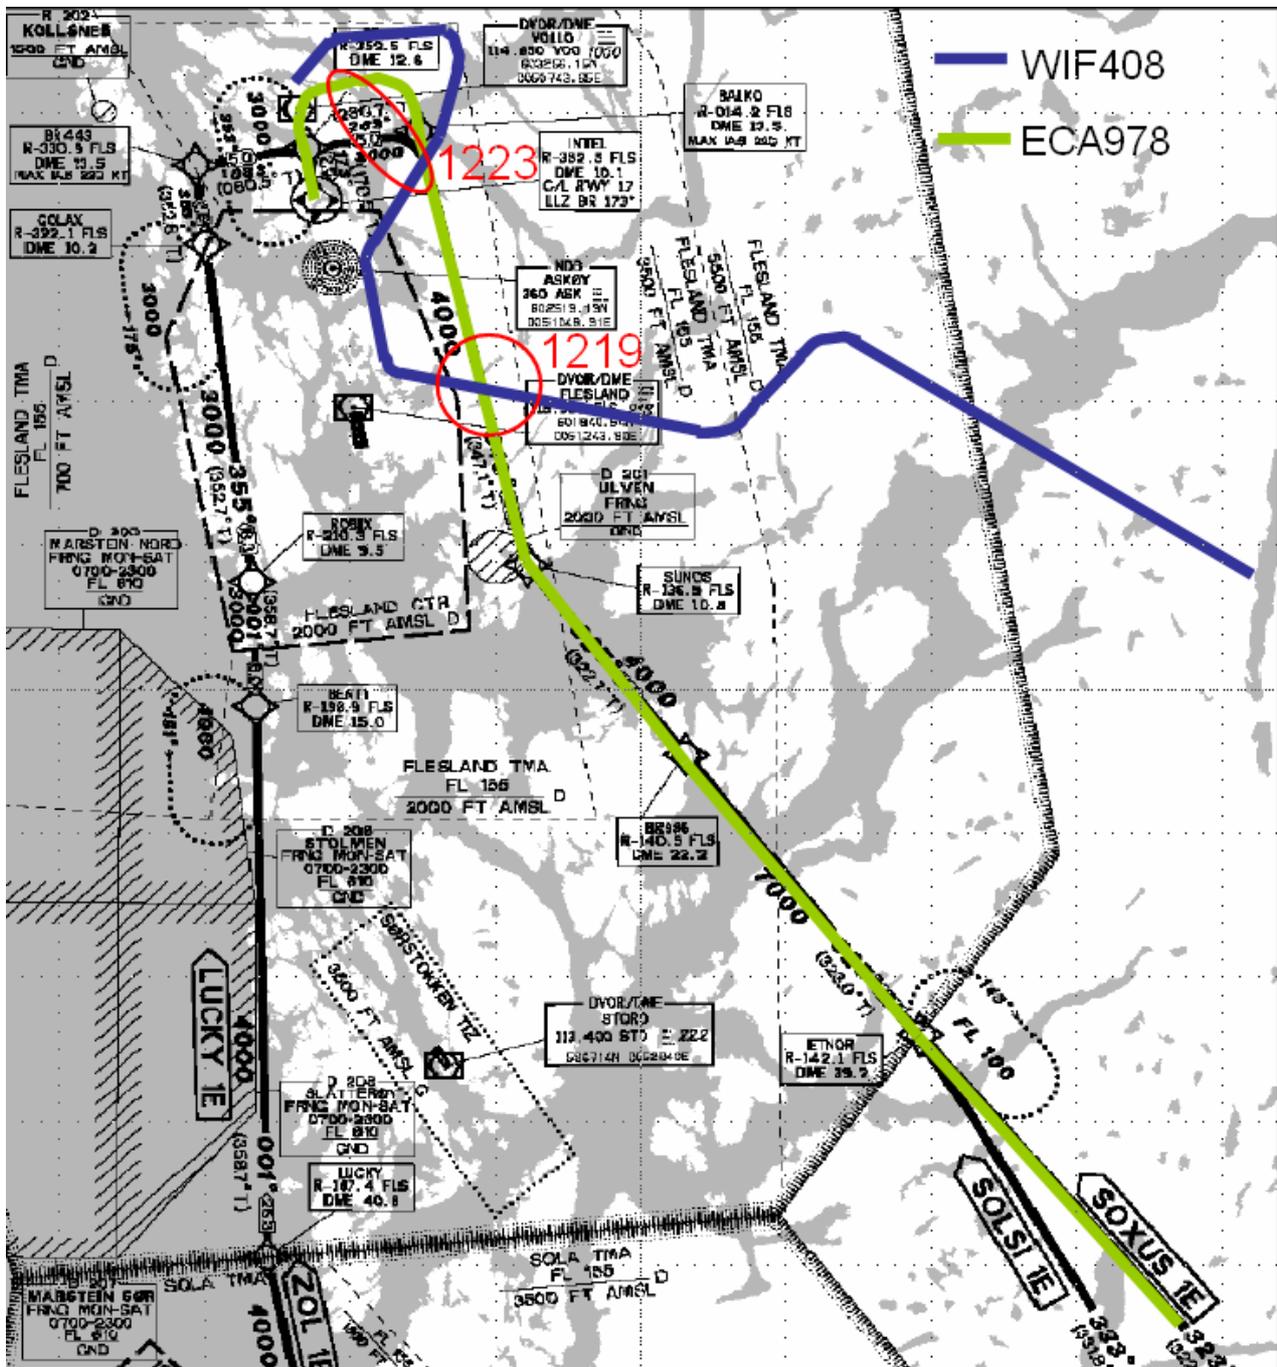
By mistake the air traffic controller cleared WIF408 direct to OKITO, a reporting point on extended centreline of RWY 35. This made WIF408 turn onto a southwesterly heading. When the air traffic controller observed the turn on the radar screen he corrected this by reclearing WIF408 direct INTEL, a point on the extended centreline of RWY 17. Sequencing was no longer favouring WIF408 due to the unintended delaying “dog leg” turn. The air traffic controller decided to keep the sequence with WIF408 as number 1 by giving WIF408 the opportunity to track direct to the field for a later visual approach. At 12:17:00 WIF408 was cleared by Flesland APP to fly heading 270° and to descend to altitude 5 000 ft, anticipating to get visual with the field in sight. Heading was adjusted to 280° one minute afterwards. Tracks of the aircraft are shown on a cut from the AIP Norway STAR Chart AD2 ENBR 4-18 in the Appendix (based on radar recording).

AIBN considers that a loss of separation occurred in Flesland TMA at 1219 hrs which lasted 30 seconds. Separation was lost due to descent clearances without rate restrictions. The descent profile of WIF408 was not like the air traffic controller assumed from previous experience and a change in descent rate led to less than minimum prescribed vertical distance to ECA798 during 30 seconds. The air traffic controller was not able to correct the reduction of vertical distance by alternate clearances.

A cut from AIP Norway AD 2 ENBR 4-18 “Standard Arrival Chart Instrument (P-RNAV STAR based on VOR/DME FLS or GNSS except Class A GPS) Arrival from S” with tracks of WIF408 and ECA978 marked, based on ATC radar recorded by Avinor.

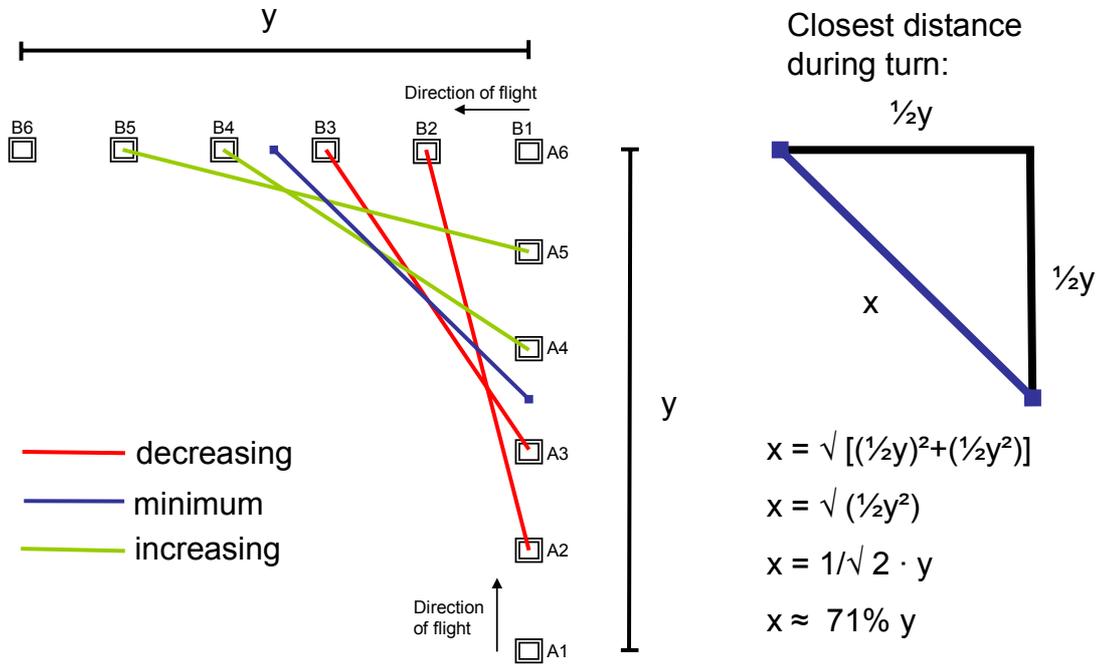
Reduction of distance during turn to base leg:

AIBN considers that a loss of separation occurred at 1223 hrs. which lasted 30 seconds. Separation was lost during the subsequent vectoring of the two aircraft to ILS-17 due to the 90° turn of the first of two trailing aircraft that were close to radar separation minimum (5 NM). After ECA798 made the turn to base leg, distance to WIF408 was reduced to a minimum of 4.6 NM before vertical separation was re-established.

The use of radar separation minima for aircraft with crossing tracks require attention to the fact that distance between them will decrease after the first has crossed ahead of the other. The same applies in this case where aircraft number 1 was given a 90° turn ahead of the other. The trailing distance immediately started to decrease until aircraft number 2 had number 1 in a position 45° away from its own track. From there on, distance started to increase.

A geometrical analysis of this situation is shown in the Appendix, depicting two aircraft. To simplify the example, both aircraft are considered to have same ground speed and follow a right angled (square pattern) radar circuit. Two aircraft with 5 NM trailing distance will have a minimum of 3.54 NM between them after a 90° turn of the first aircraft. To ensure 5 NM distance at their nearest point, trailing distance must be at least 7.1 NM at the beginning of the turn.

Aircraft A is trailing aircraft B with distance y when B is turned 90° left.
