## Attempted takeoff from taxiway, Boeing 737-800, TC-APH, October 23, 2005 at Oslo Airport Gardermoen, Norway

## FINAL REPORT

Date: 26.07.2006  
SL Report: 20/2006

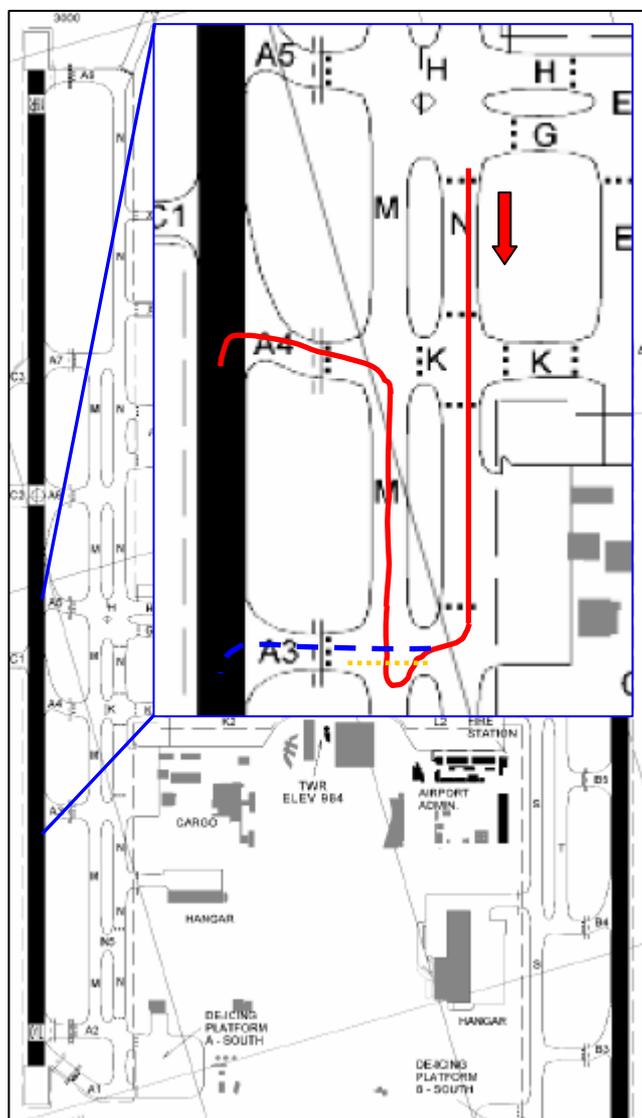
The crew taxied, in accordance with their clearance, in a southerly direction on taxiway (TWY) N (see map). The commander was pilot flying (PF) and the first officer was responsible for radio communication with Air Traffic Services. There was also a third pilot in the cockpit who had newly joined the airline and was being trained. He had no other tasks than to observe. While taxiing in a southerly direction on TWY N the crew was given clearance for take-off on RWY 01L via intersection A3. The first officer acknowledged this with the flight's radio call sign, and the air traffic controller followed up with clearance to taxi in a southerly direction on RWY 01L, if necessary. The crew had calculated that the runway available from A3 was sufficient for take-off. The stated TORA in AIP for RWY 01L from A3 is 2,696 metres. The red line on the map shows the aircraft's movement. The data source is the airport ground radar.

In her report, the commander says that when they were given clearance for take-off and turned to the right towards A3 she increased the engine rpm slightly and lit the landing lights. She then saw the yellow dashed line across TWY M, south of A3 which marks the intermediate holding point. The commander writes:

*"When I saw the yellow dash lines on the left on taxiway, because of the notam, I misinterpreted the lines as if I am aligning on the runway centreline".*

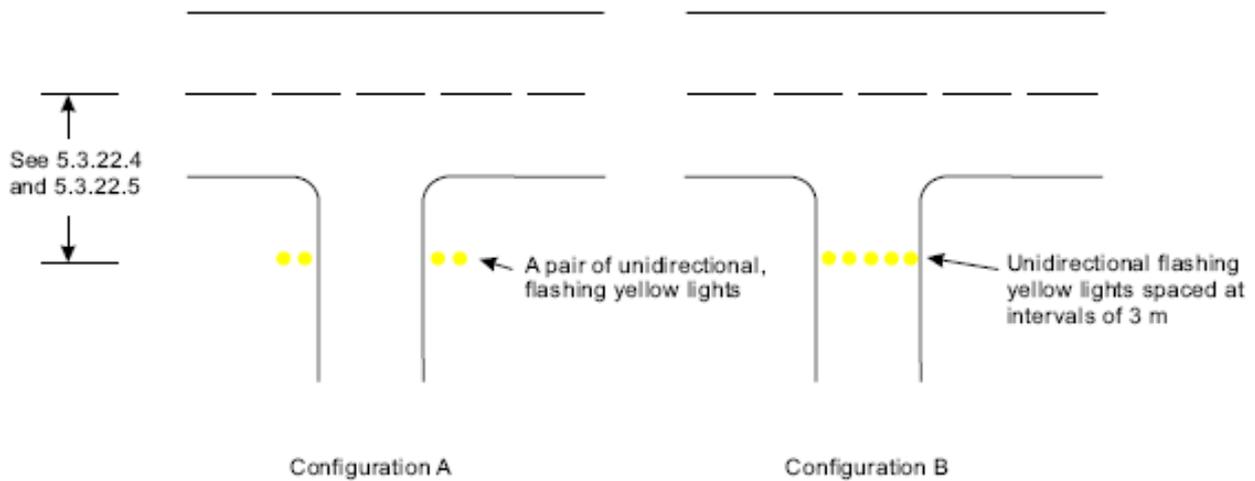
Figure 5-27. Runway guard lights

- 5.3.22 *Runway guard lights*
- Note – The purpose of runway guard lights is to warn pilots, and drivers of vehicles when they are operating on taxiways, that they are about to enter an active runway. There are two standard configurations of runway guard lights as illustrated in Figure 5-27*

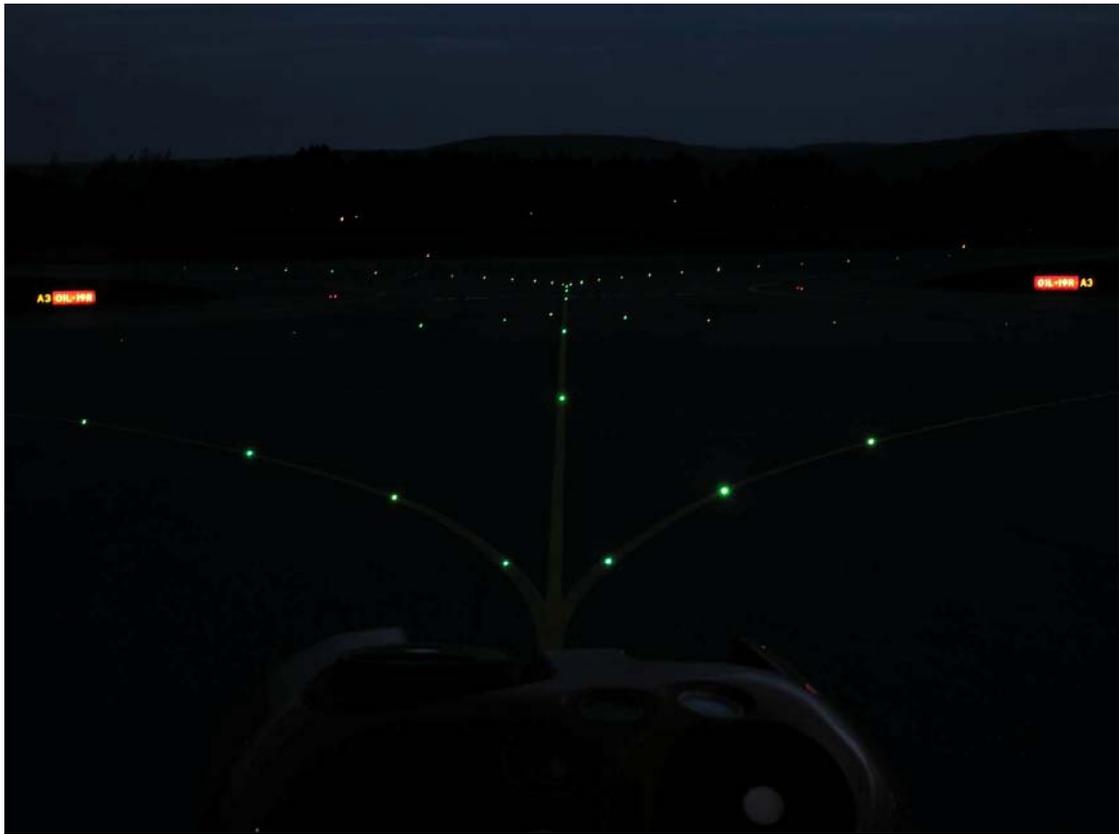
**On TWY A3 at intersection TWY N.**

To illustrate lighting of taxiways and the runway in use at the time of the incident, the AIBN has made photos and enclosed them with this report. The pictures are taken from 4 m above surface. They do not represent a reconstruction, as there is not enough information available from the incident. Further the pictures were taken during a Nordic summer night and ambient light is therefore artificially made darker using underexposure. Lights were set at 10%, as is common during darkness in good weather. On the picture taken from TWY A3, intersection TWY N, runway guard lights are barely visible, halfway between the instruction signs and taxiway centre lights.
