Boeing 767-200, Air New Zealand ZK-NBF, Los Angeles International Airport, September 6, 1993

NO. 93-011

BOEING 767-200

6 SEPTEMBER 1993

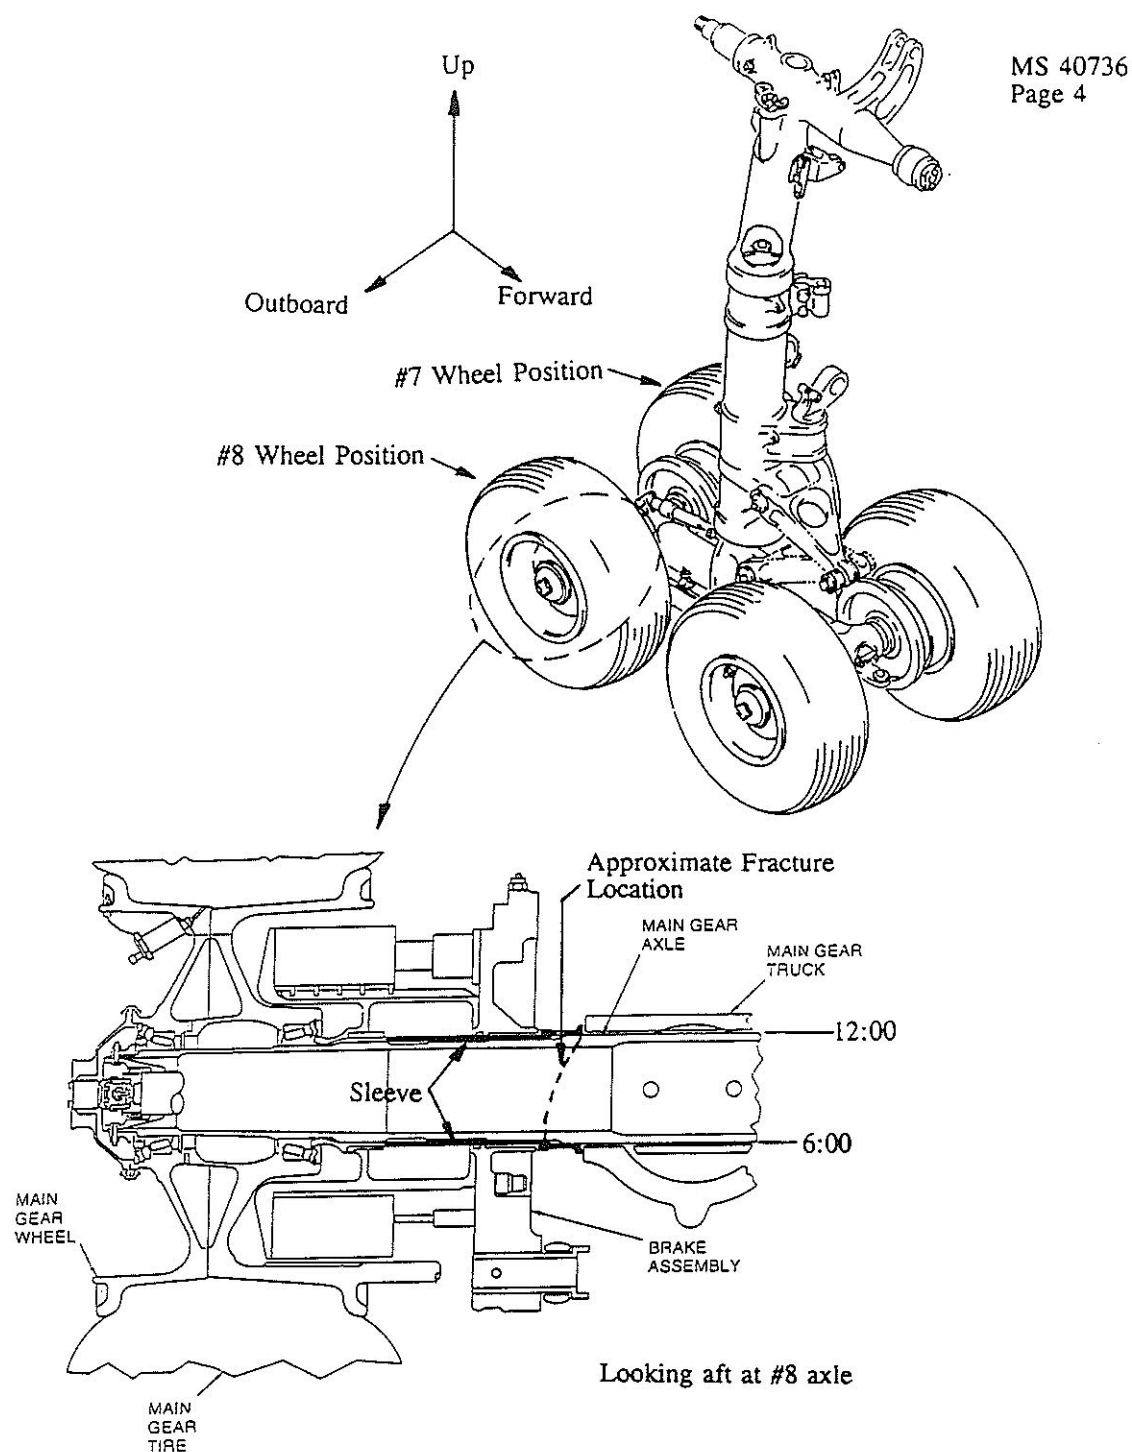
1.3 An investigation revealed that the rear axle (part number 161T1138-4, serial number CPTO166AT) of the right main undercarriage assembly (part number 161T0000-14, serial number 8154) had fractured adjacent to the rear outboard (number eight) wheel. The axle was encased in a sleeve in that area. (See Figure 1).

Figure 1: Illustrations depicting the location of the fracture through the #8 axle on the right hand main landing gear assembly of the model 767 airplane.

1.8 The failure initiated from a pit in an area of corrosion on the outer face of the axle on its lower surface beneath the sleeve which surrounded it at this point.

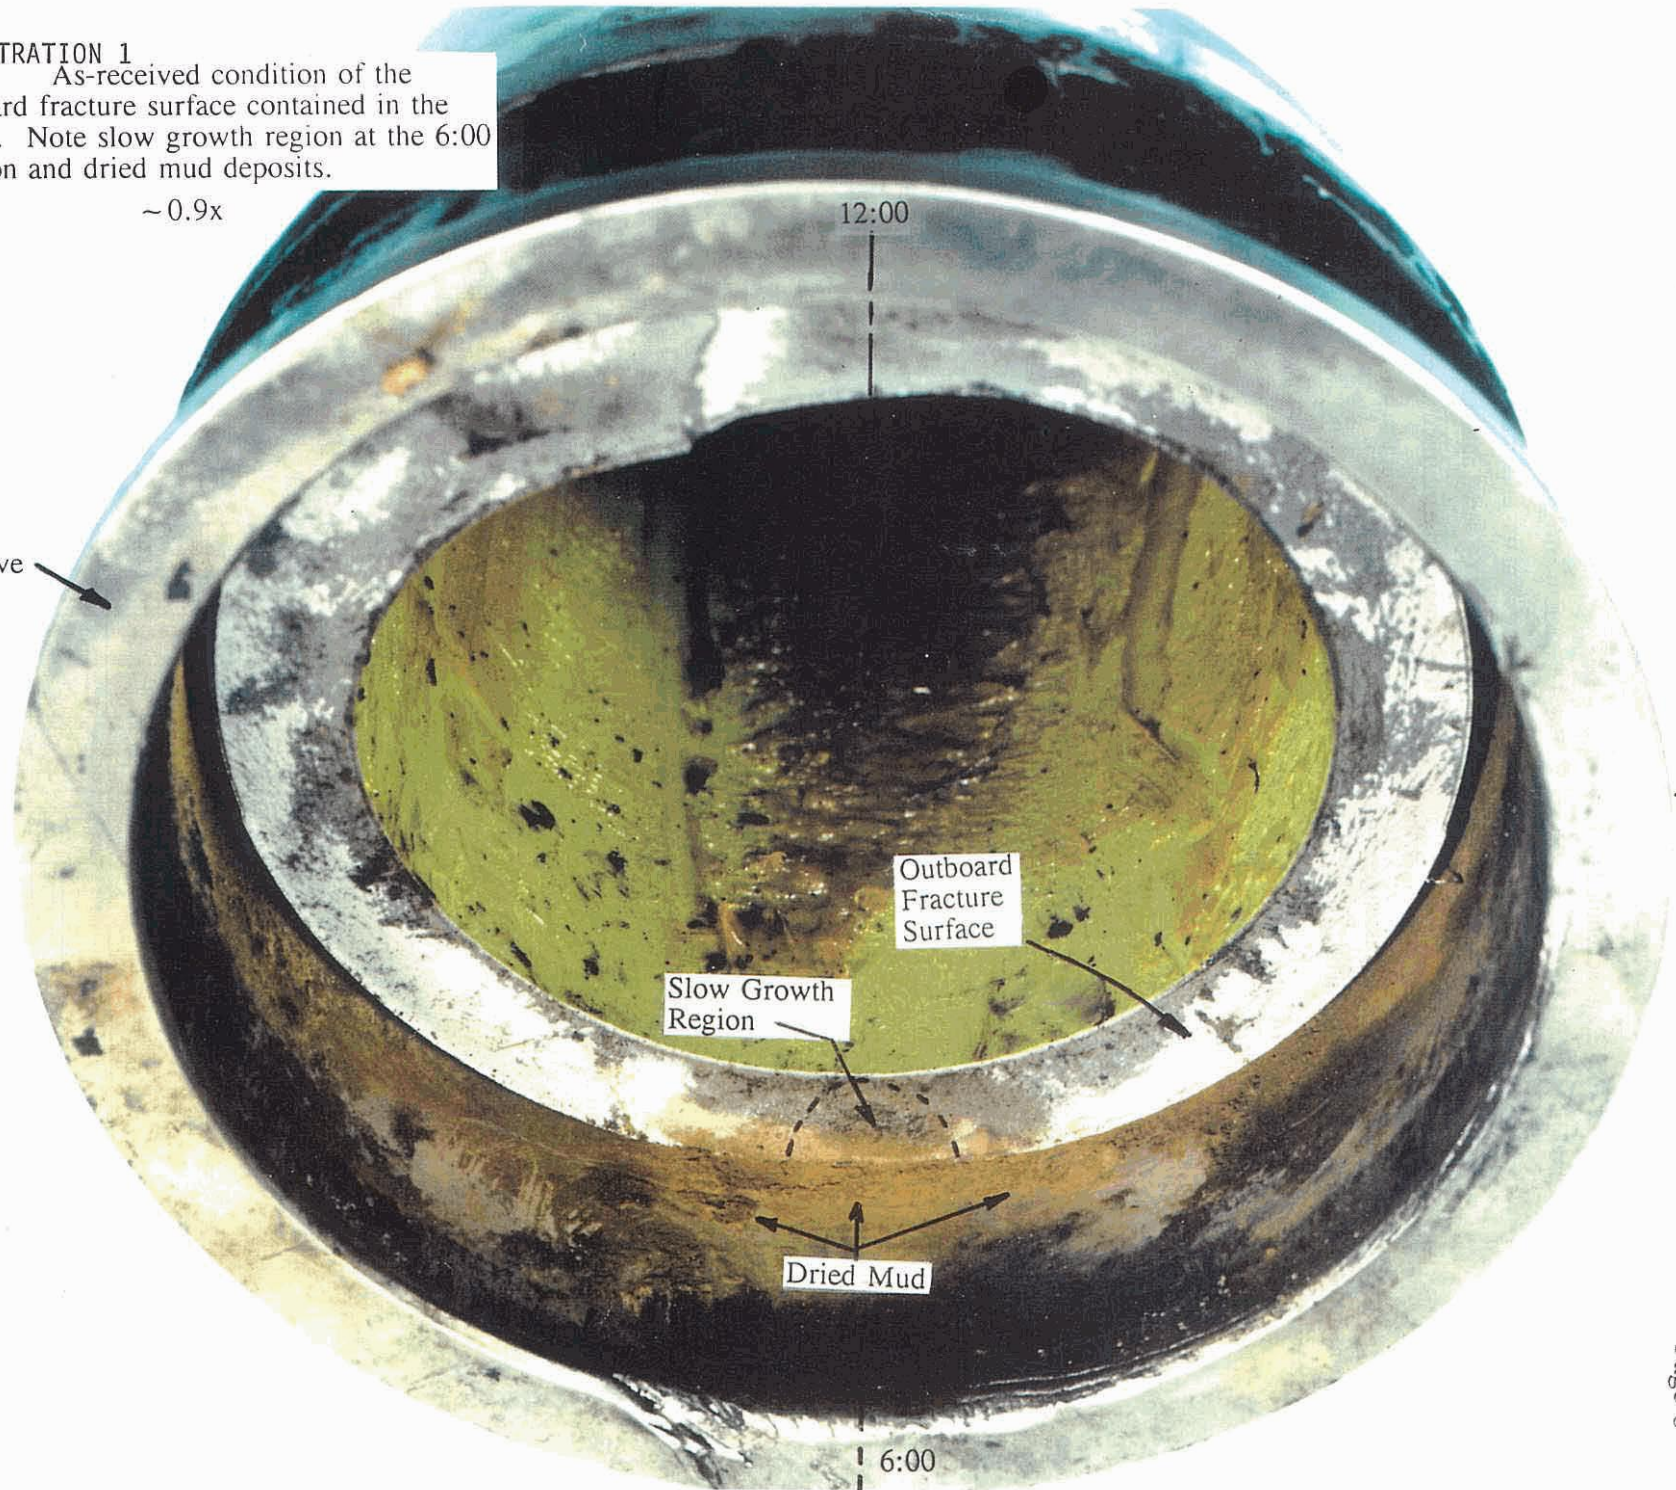
ILLUSTRATION 1

As-received condition of the outboard fracture surface contained in the sleeve. Note slow growth region at the 6:00 position and dried mud deposits.

1.7 A visual inspection of the fracture area while the assembly was in Auckland revealed that a quantity of mud had become trapped outside the axle near the point of origin of the failure and there was no apparent evidence of the protective grease which was intended to be applied to the axle in that area during the assembly of the components. (See Illustration 1).

1.13 The point of origin was in a corrosion pit adjacent to a quantity of soil and vegetable matter on the underside of the axle. This foreign matter was trapped in an annular void between the tubular axle and the sleeve fitted to the axle outwards from the point at which it emerged from the main undercarriage truck.

2.5 Mud had penetrated into the void between the axle and its sleeves and between the mating faces of the axle and the truck.

Review the current Maintenance Manual Inspections required for Boeing 767 undercarriage components which have been involved in "hard landings or high drag/side load landing conditions" on unprepared surfaces with a view to ensure the inspections provide for the removal of any foreign matter which may have become lodged between components of the assemblies (064/93), and

Consider the need to advise any B767 operator who has main undercarriage assemblies in service that have been involved in runway excursions onto unprepared surfaces to dismantle such assemblies and test them for evidence of corrosion and/or cracking (065/93), and

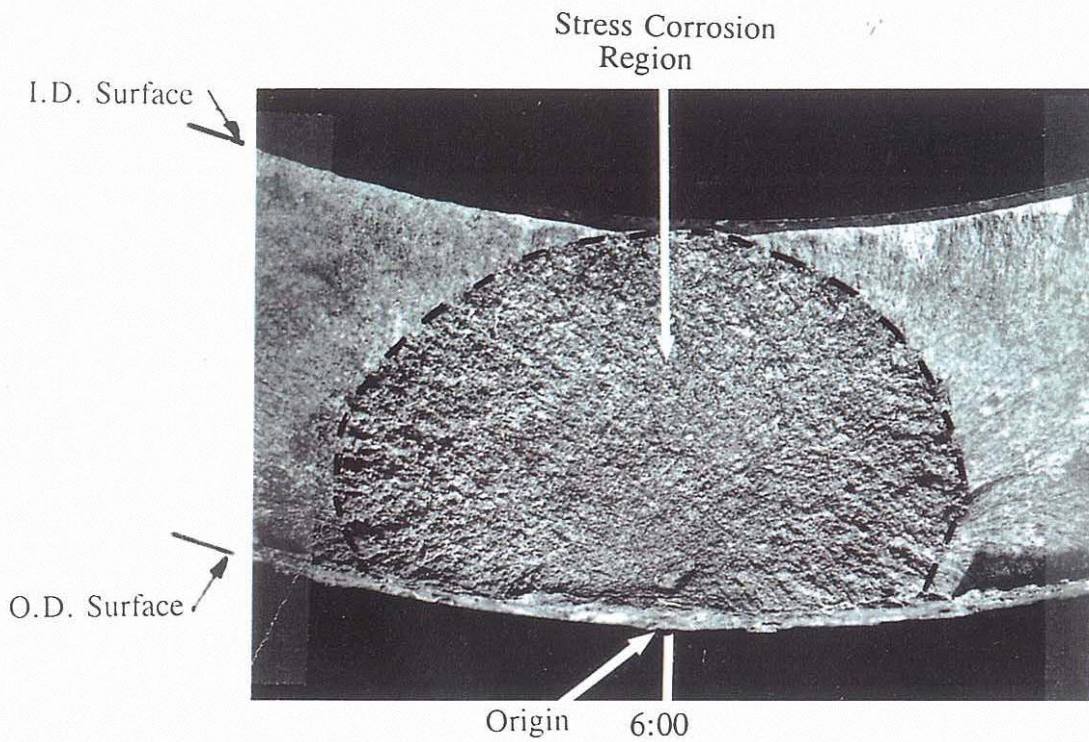
ILLUSTRATION 2

Photographs of the outboard side fracture surface showing the stress corrosion cracking region at the 6:00 position, and the corrosion/pitting on the O.D. surface of the axle.

1.12 The axle failure resulted from a ductile fracture propagating from a pre-existing crack, which had resulted from stress corrosion, through the thickness of the axle wall at the time of final separation. The pre-existing stress corrosion crack formed a semicircular pattern with a base of 23 mm (0.9 inches). (See Illustrations 2 and 3).

1.14 Metallographic cross sections through the origin of the stress corrosion region showed pits into the outer surface of the axle up to 0.055 inches in depth.

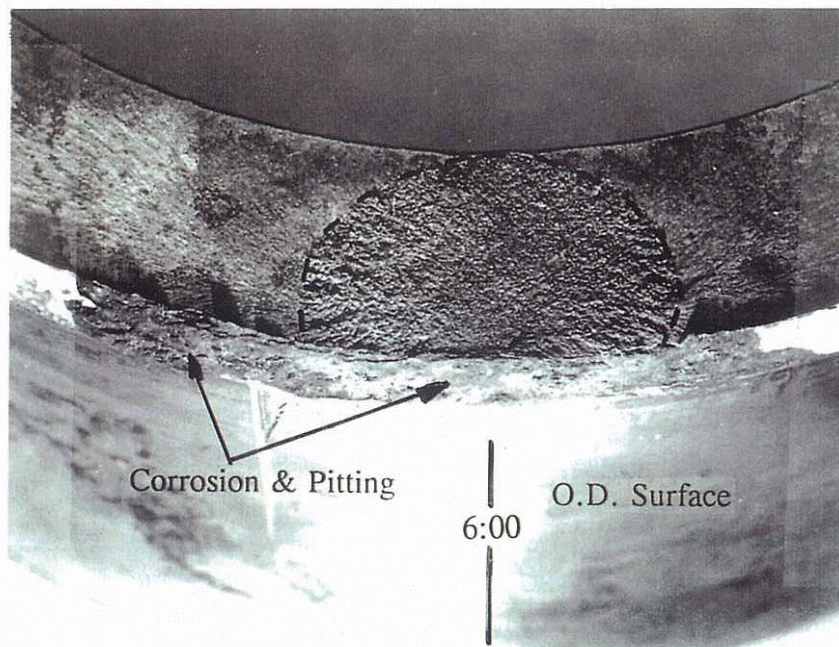
ILLUSTRATION 3

2.7 Stress corrosion cracking had initiated in the area of corrosion pits and one of the stress corrosion cracks had *propagated through the thickness of the axle wall prior to the axle's ultimate failure.*
