Electrical fire, Incident involving aircraft OY-KIK, 22 March 1998, Kiruna airport, BD county, Sweden

Report C 1999:8e
Incident involving aircraft OY-KIK,
22 March 1998,
Kiruna airport, BD county, Sweden

L-14/98

<i>Aircraft: registration and type</i>	OY-KIK , Douglas DC-9-81
<i>Owner/Operator</i>	Finova Capital Ltd./SAS
<i>Time of incident</i>	22-03-1998 at 12:23 p.m. in daylight (alarm to the Kiruna tower)
	<i>Note:</i> All times in the report are given in Swedish normal time (SNT) = UTC + 1 hour.
<i>Place</i>	In the airspace approximately 130 NM ¹ south of Kiruna, BD County, Sweden.
<i>Type of flight</i>	Scheduled traffic
<i>Weather</i>	Kiruna airport at time 12.20 p.m.: Wind 220°/9 knots, visibility >10 kilometers, no clouds below 5 000 feet, temp/dewpoint +5/-1 °C, QNH 1026 hPa, braking action good.
<i>Numbers on board: crew</i>	2/3
<i>passengers</i>	98 including 3 children between the ages of 2 and 12 years.
<i>Personal injury</i>	Two passengers were slightly injured during the evacuation.
<i>Damage to aircraft</i>	Limited
<i>Other damage</i>	None
<i>Captain's age and license</i>	37 years, Airline Transport Pilot's License, (Swedish)

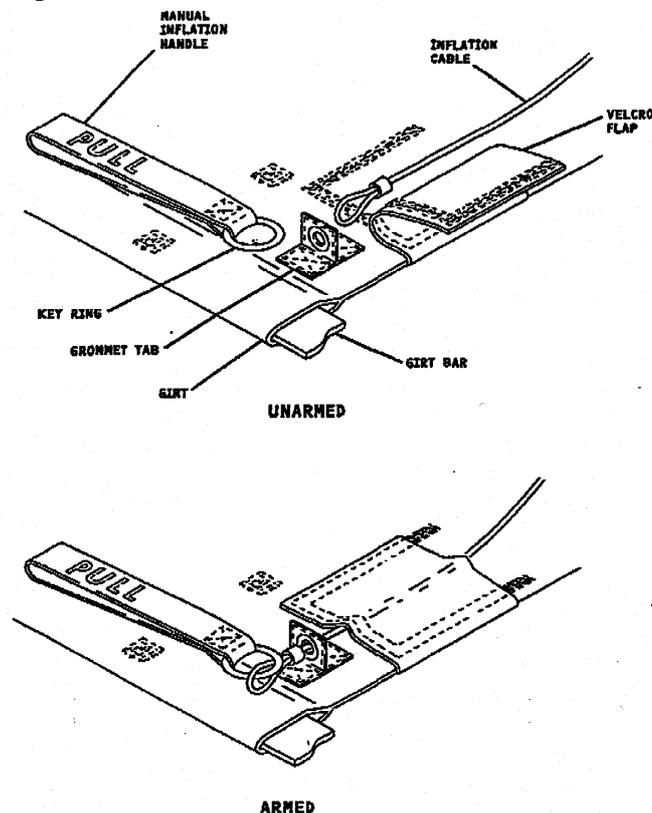
For emergency evacuation purposes, four of the aircraft’s exits are equipped with a slide (Emergency Escape Slide) which is inflated by compressed gas. These are mounted on the aircraft doors and during flight a special slide bar (Girt Bar) on the slide shall be hooked securely to the floor in front of the respective door so that inflation occurs automatically when the door is opened. Inflation can also be accomplished manually by pulling on a cloth handle (Manual Inflation Handle).

Both the cloth handle and the slide bar are connected at one end to a wire (Inflation Cable) whose other end is inserted into the inflation valve of the compressed gas tube. To prevent accidental inflation of the slide during transportation to and from an aircraft the inflation cable shall be removed from the cloth handle and slide bar and “parked” under a cloth flap (Velcro Flap).

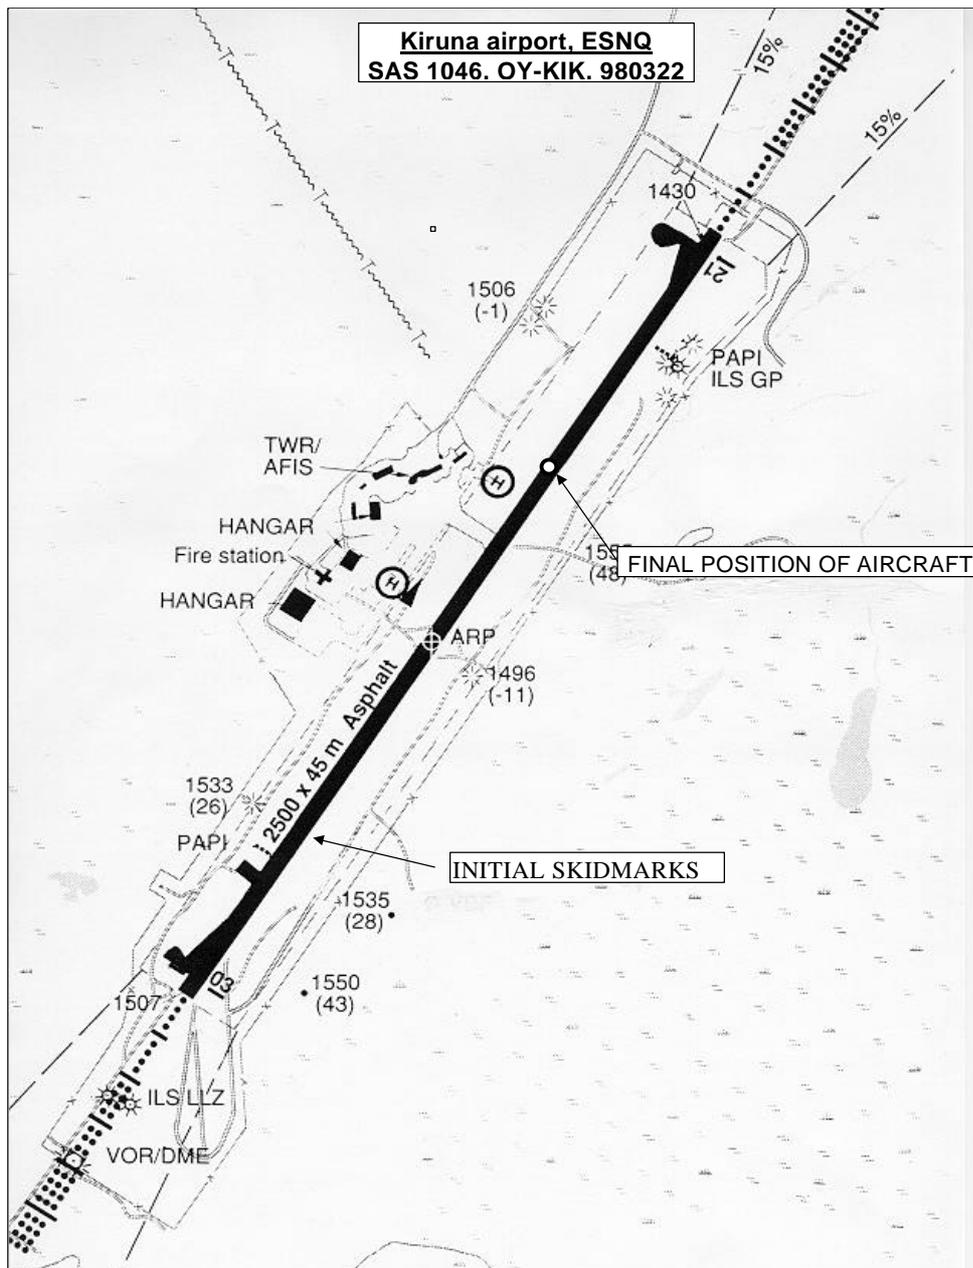
The smell of fire was discerned when the aircraft was in the airspace approximately 130 NM south of Kiruna. The incident lasted until such time as the emergency evacuation had been completed at Kiruna airport. The aircraft's touchdown took place about 300 meters down the runway and the skidmarks began on the runway centerline 537 meters from the runway threshold. The aircraft came to a stop 1744 meters from the threshold and slightly left of the runway centerline (ref. illustration).

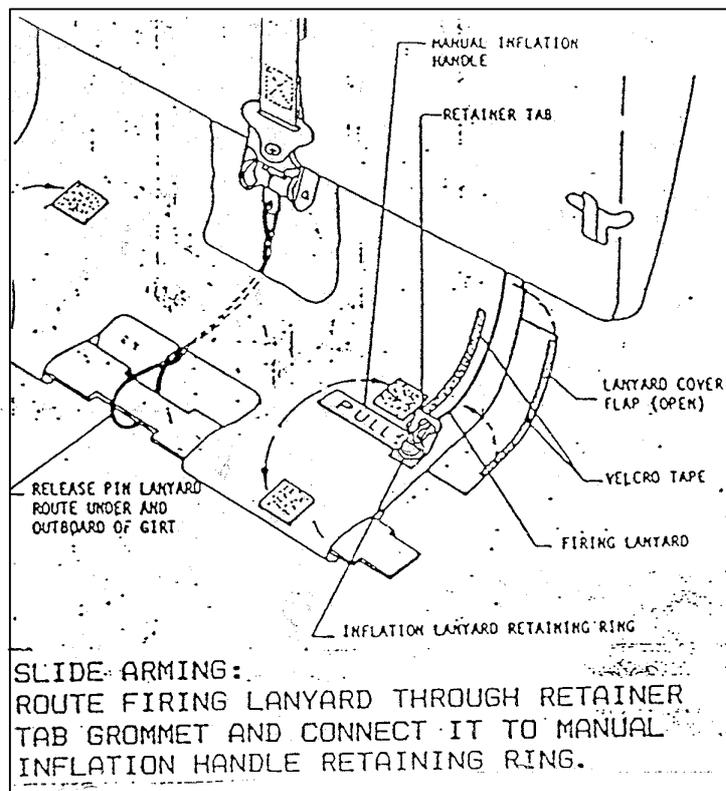
deploy automatically when the door was opened was, according to the investigation, that the firing lanyard was not attached correctly to the slide bar (Girt Bar). This has not been possible to verify subsequent to the occurrence as the lanyard was “completely extracted” in connection with the manual deployment.

The instruction illustration shown below (full size), concerning the installation of the firing mechanism, is included in the shipping carton of the emergency evacuation slide.

The emergency evacuation in this case took place under favorable conditions and the malfunction of one of the emergency evacuation slides had, in and of itself, minimal influence on the chain of events. In a similar but more critical situation the absence of automatic deployment of a slide could have serious consequences. It was therefore a serious deficiency in the installation of the slide if the firing lanyard was not correctly connected. The instruction illustration as to how the cable should be connected after it has been secured for transportation is physically small and it is not sufficiently evident therein how the cable shall be connected to both the retainer tab and the manual inflation handle. It is the opinion of SHK that the illustration should be made clearer.
