Aircraft incident to SE-LKB in the Hudiksvall airspace, X county, Sweden, on February 23, 2001

Report RL 2001:23e

*Aircraft incident to SE-LKB
in the Hudiksvall airspace, X county,
Sweden, on February 23, 2001*

Case L-007/01

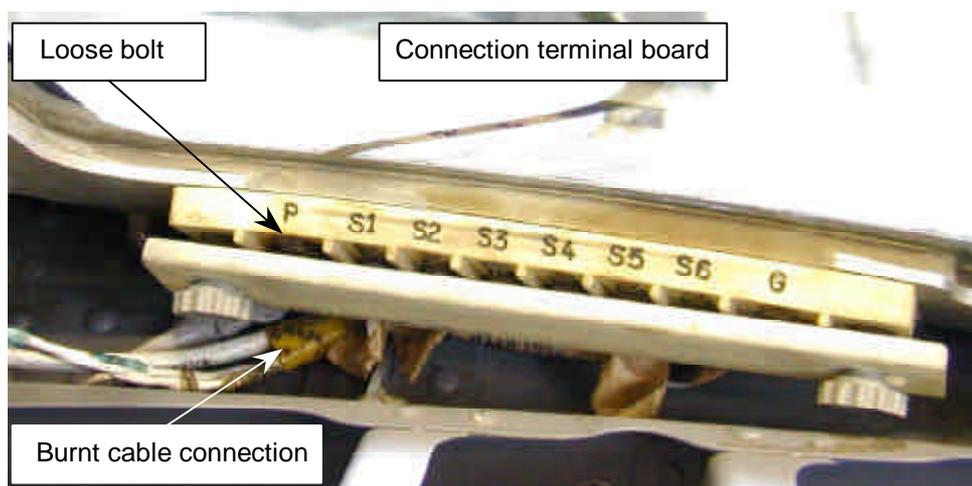
Company personnel carried out an inspection of the aircraft after the incident, which revealed a loose bolt on the terminal board for the right windshield heating system. The purpose of the bolt is to fasten one of two cable shoes that are connected to the electrical cables (W110-2834-8) that supply electrical power to the windshield heating element. Carbonization and heat damage to the cable insulation and the connection terminal board indicated that overheating had taken place.

As indicated in section 1.16 one of the bolts situated on the terminal board for the right windshield heat system was loose. The electrical cable and the terminal board in this area had suffered burn damage. This indicates that the loose connection had caused arcing, generating a heat build up and overheat the area, which in turn manifested itself in the form of a burning smell and smoke. As the electrical current in the heating element did not exceed normal values even with the system selected to maximum heating, the system circuit breaker did not trip. The arcing most probably ceased spontaneously.

The investigation has not been able to ascertain when the bolt became loose. It is possible that the bolt had been loose for quite a period of time, giving no noticeable indications of intermittent dis-connection or arcing.

- a) The pilots were qualified to perform the flight.
- b) The aircraft had a valid Certificate of Airworthiness.
- c) A bolt on the terminal board for the heating element for the right windshield was loose.
- d) A loose contact and arcing caused overheating in the area.

The incident was caused by a loose contact and arcing across a loose bolt on a connection terminal board. This in turn caused overheating in the area and the smell of smoke on-board.
