**Crash on a partially closed runway during takeoff, Singapore Airlines Flight 006, Boeing 747-400, 9V-SPK, CKS Airport, Taoyuan, Taiwan, October 31, 2000**

**Investigative Body: Aviation Safety Council (ASC), Taiwan**

ASC-AAR-02-04-001

**CRASHED ON A PARTIALLY  
CLOSED RUNWAY DURING TAKEOFF  
SINGAPORE AIRLINES FLIGHT 006  
BOEING 747-400, 9V-SPK  
CKS AIRPORT, TAOYUAN, TAIWAN  
OCTOBER 31, 2000**

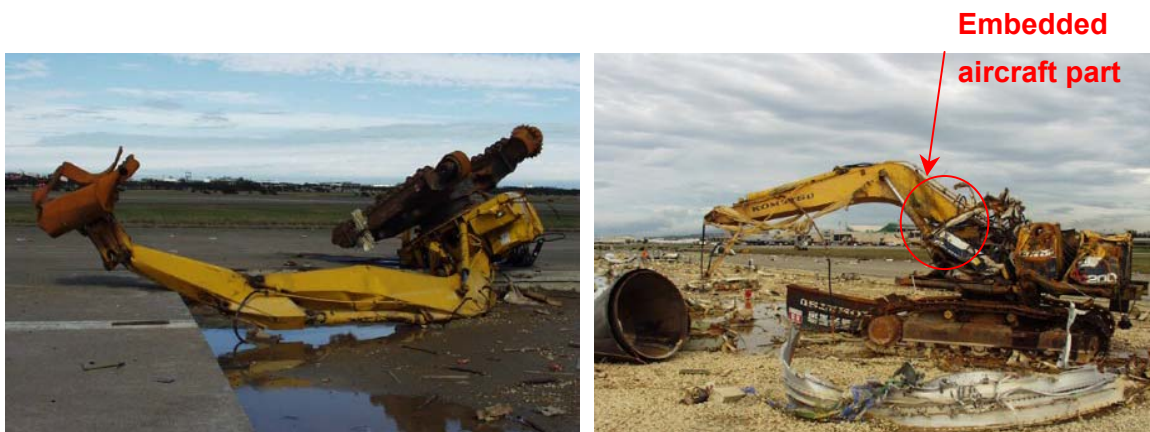
The construction crew had left six units of ground equipment on Runway 05R, specifically two excavators (Figures 1.4-1), two vibrating rollers (Figures 1.4-2), one small bulldozer (Figure 1.4-3) and one air compressor. All six units suffered serious impact damage. There were 11 pits at the construction site. With the exception of one excavator and the bulldozer, the rest of the units were scattered during the impact from their original positions in the various pits.

**Figure 1.4-1** The excavator in No.5 pit (left) and the excavator in No.11 pit (right)

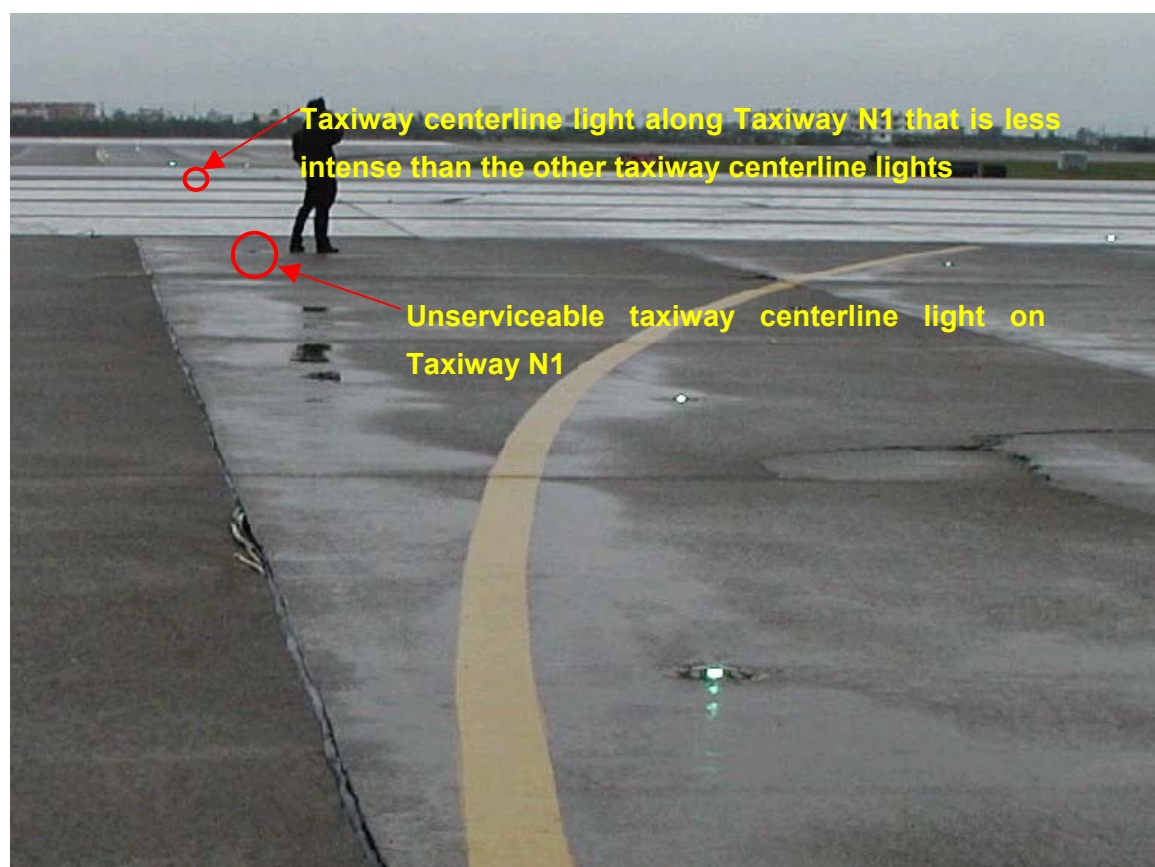
- Four days after the accident, the investigation team found that a green centerline light immediately after the Runway 05R entry point along Taxiway N1 leading to Runway 05L was un-serviceable and the following light was dim. It could not be determined what the status of those lights was on the night of the accident. (1.10.3.2.4; 2.3.1.2.3)

During the site survey (on November 4, 2000), it was noted that the first taxiway centerline light after the point of tangency was unserviceable while the second light was less intense than the other lights. (See Figure 1.10-10)

**Figure 1.10-10 Status of Taxiway N1 centerline lights close to the threshold of Runway 05R  
(picture taken on November 4, 2000)**

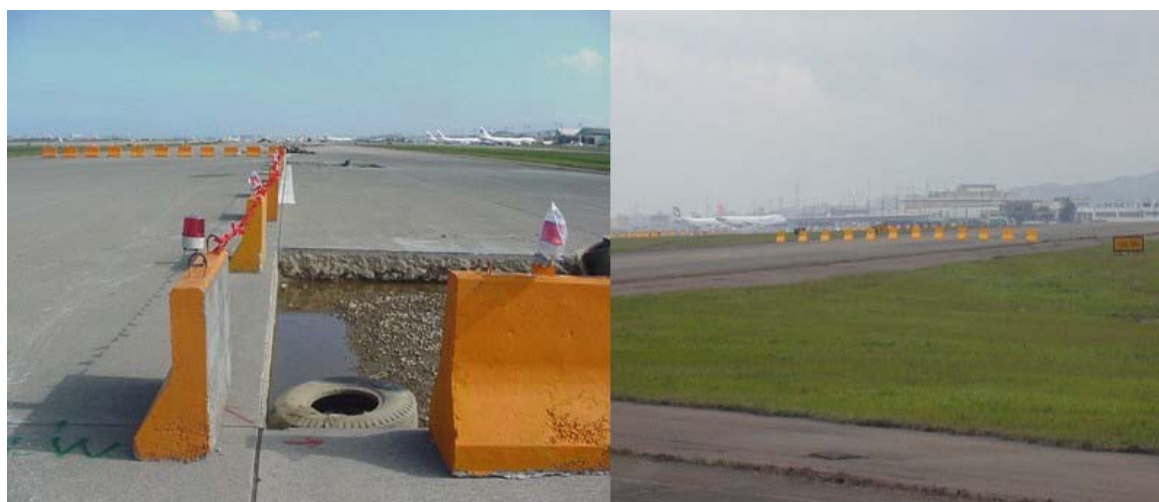
According to information provided by the CKS Airport, due to the high wind conditions and heavy rain associated with Typhoons at CKS Airport, the light plastic, frangible markers with red obstruction light markers may be either washed away or blown away, therefore posing a risk of foreign object damage (FOD) to aircraft. To prevent such occurrences, CKS Airport used concrete jersey barriers, about 0.8 meters high, and 1 meter long, placed in close proximity to construction zones. The blocks were painted yellow, orange, or a combination of yellow and black stripes. Battery-powered, flashing red warning lights spaced at a distance of two to five meters were installed on top of the blocks for night time use (See Figure 1.10-11).

**Figure 1.10-11 Closed working area along Runway 05R/23L and Taxiway viewed from Runway 05L/23R**

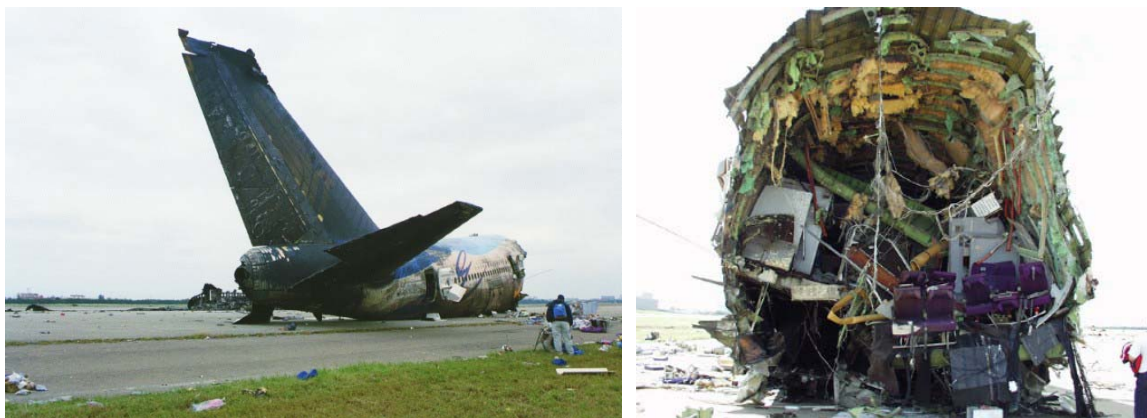
There were no longitudinal scrape marks on the lower skin on Body Section 48.

**Figure 1.12-8 Aft portion of the aircraft**

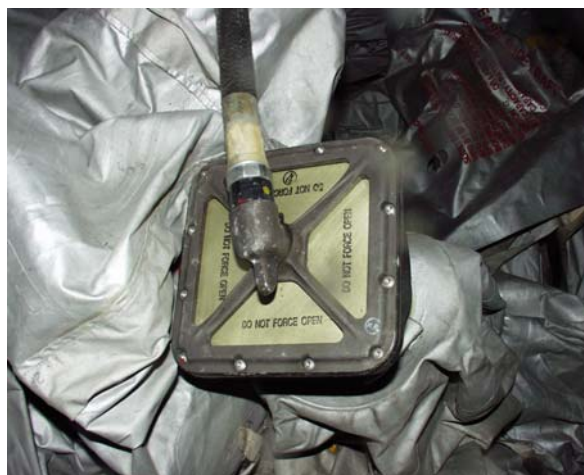
Door 2L was found intact and in the “open” position. Its mode selection lever was in “Automatic” (Armed) position. The slide was found partially deployed outside the aircraft. The fuse pins remained connected near the base of the girt skirts preventing the slide from fully deploying. There was significant fire burn damage to the slide and it had burnt away from the girt bar. No soot or fire damage was found at the inlet of the slide aspirators. See Figure 1.12-10 below.

**Figure 1.12-10 The aspirator of Door 2L slide**

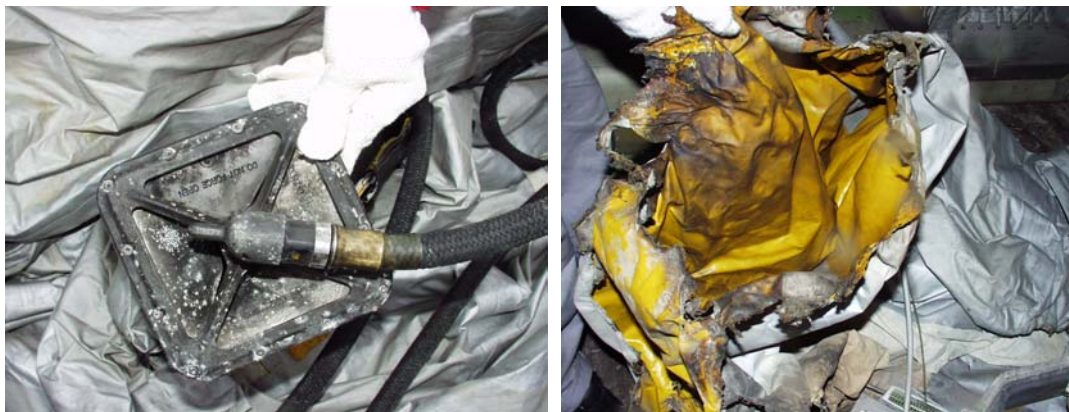
Door 4R remained intact and was not opened. Its mode selection lever was found in “Automatic” (i.e. Armed) position. The slide was deployed (deflated) inside the aircraft and it extended laterally through the cabin to Door 4L. Soot and fire burn damage were found on the slide skin at the inlet of the slide aspirators. See Figure 1.12-11.

**Figure 1.12-11 The aspirator inlet (left) and the inner fire damage of 4R slide (right)**

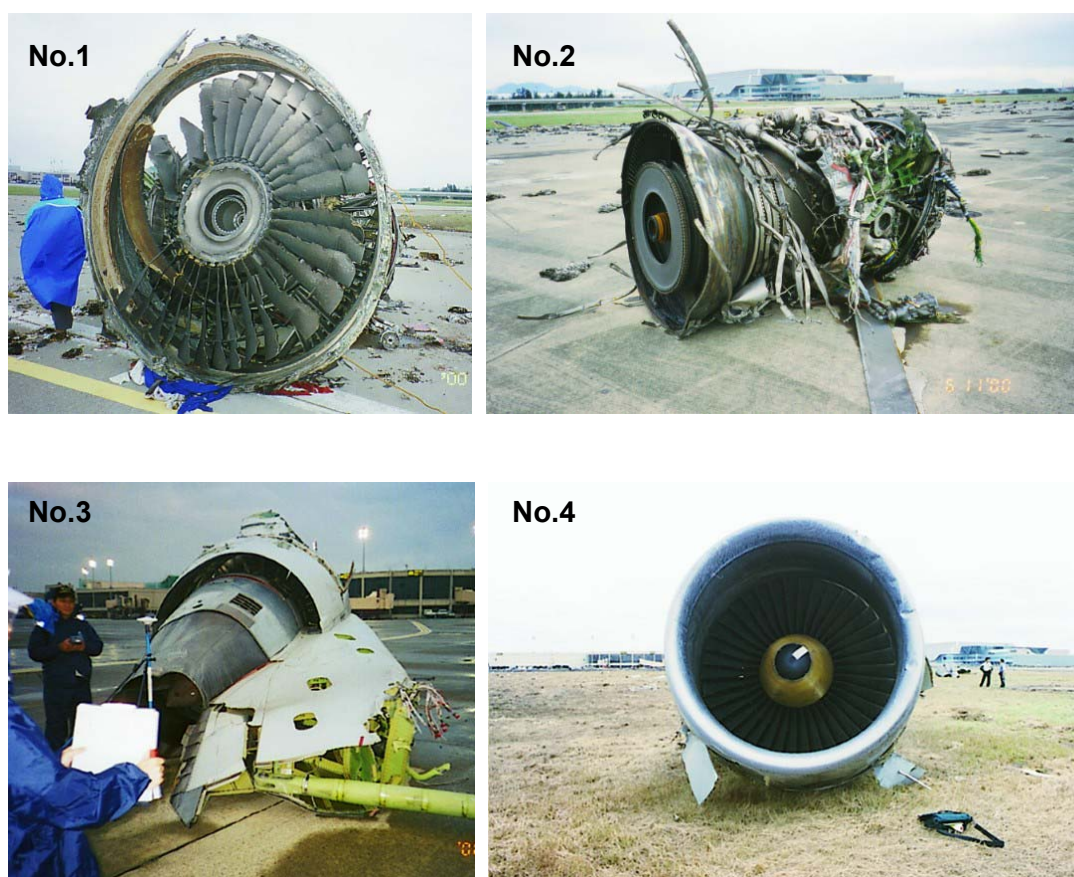
All four engines had separated from the aircraft during the impact sequence. None of the four engines exhibited any indication of an uncontained disk/blade separation, or of fire prior to impact. (See Figure 1.12-12)

Figure 1.12-12 The four engines

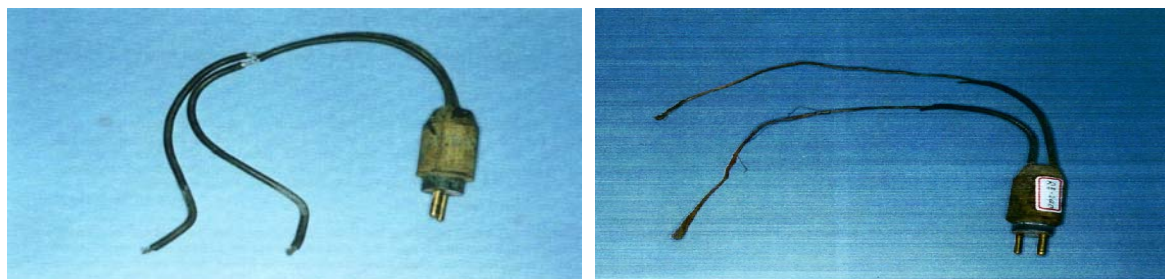
remained bolted in place, but the upper portion was not located. No fragments of metal or glass were found in the immediate area. Two wires were observed protruding approximately 5 to 15 cm from the remaining portion of the light base. When the wires were lifted, the plug was found still connected to the mating receptacle under the ground. The wire was disconnected and tagged for identification purposes (Figure 1.12-15).

**Figure 1.12-15 RE239 (left) and RE240 (right)**

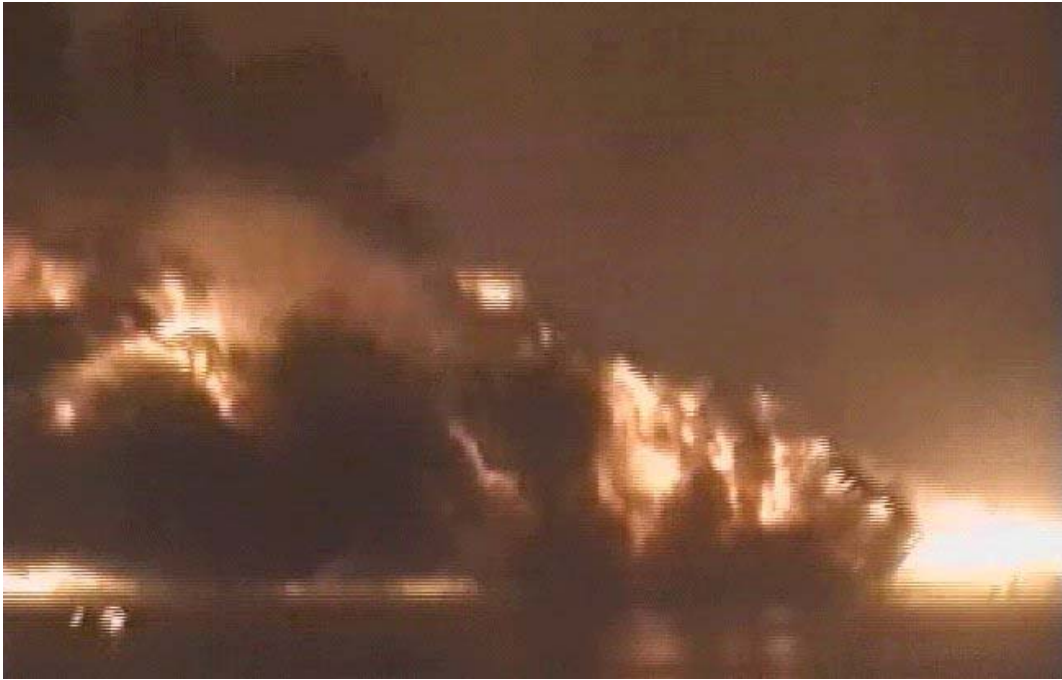
According to interviews with CKS ARFF personnel, after the fire engines had arrived at the accident site, four fire fighters formed a rescue team. These rescue personnel had received Level 1 or basic Emergency Medical Training (EMT 1). Initially, they rescued three passengers near the 1L slide and the 1L door. Those three passengers sustained severe burn injuries and were sent to the hospital in ARFF ambulances. There was no record of any other rescue operations at the early stage of the fire fighting effort, either by fire hose operators, or by any rescue personnel entering the forward fuselage. The wind-whipped fire burnt fiercely around the front fuselage (Figure1.15-1). In contrast, the separated rear fuselage was relatively unaffected by fire. The fire fighters did not use breathing apparatus during the initial rescue attempt. The CFO explained that breathing apparatus was not used for a number of reasons; first, the heat of the fire was too intense for the fire fighters to approach and enter the forward cabin, the fire fighters needed to maintain a safe distance from the unexpected explosion and intense heat; second, all the fire fighters were positioned upwind of the flames and therefore, had no difficulty breathing unaided. Finally, the CFO commented that the breathing apparatus hood would fog up during the fire suppression and rescue activities and restrict the fire fighters field of vision.

**Figure 1.15-1 The heavy fire areas of the front fuselage about 30 seconds after the aircraft came to rest<sup>19</sup>**

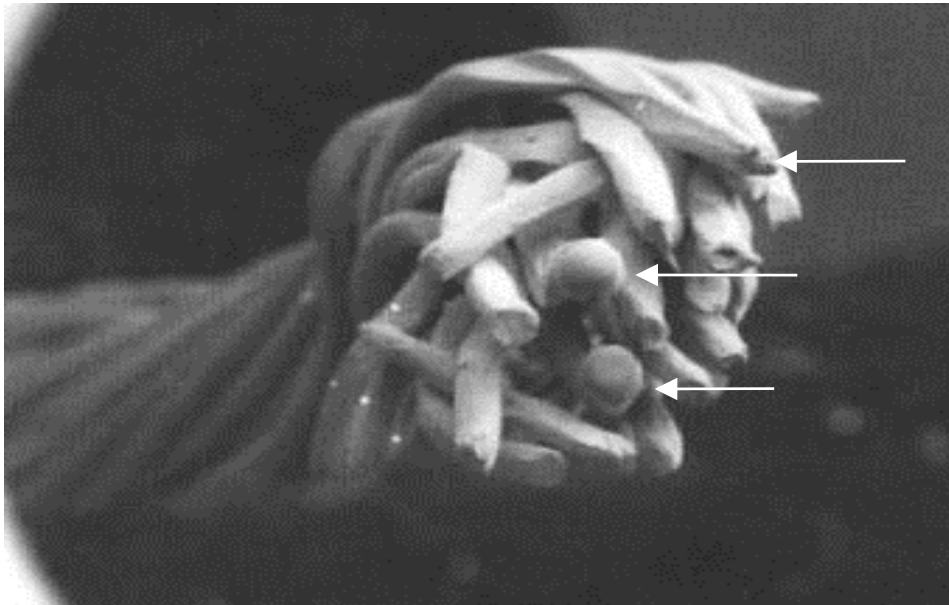
Three beads were found on the RE240-1 strand ends (Figure 1.16-4). According to the CSIST report, these beads indicate that local melting occurred, which was most likely the result of electrical arcing. The CSIST report also mentions that SEM/EDS analysis of the contaminative deposition on the strand ends indicates that the three beads were formed after all of the other strand ends had been contaminated. There was a "crater" on the surface of the melted bead of the RE240-1 wire end which was cleaner than the fracture surfaces of the strands without localized melting (Figure 1.16-5).

**Figure 1.16-4 Three beads on the RE240-1**

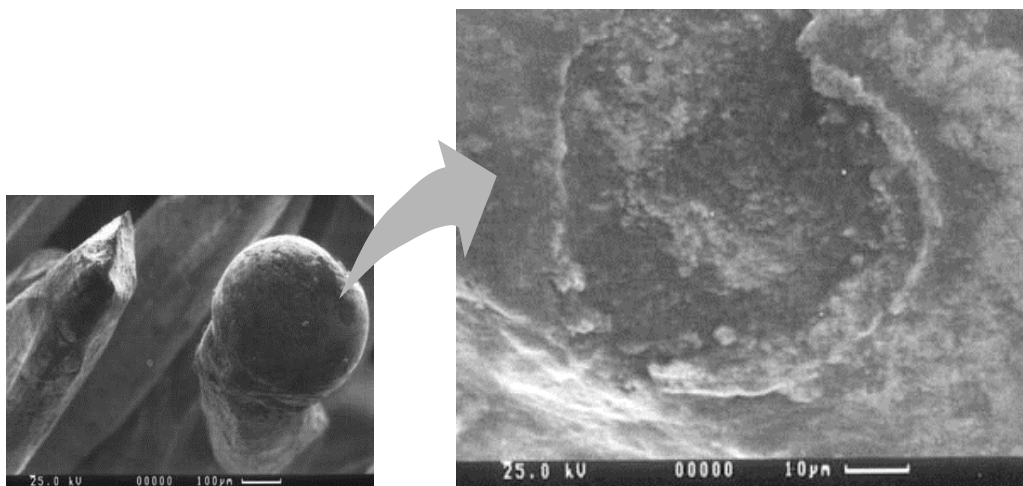
**Figure 1.16-5 "crater" on the surface of the melted bead of the RE240-1 wire end**

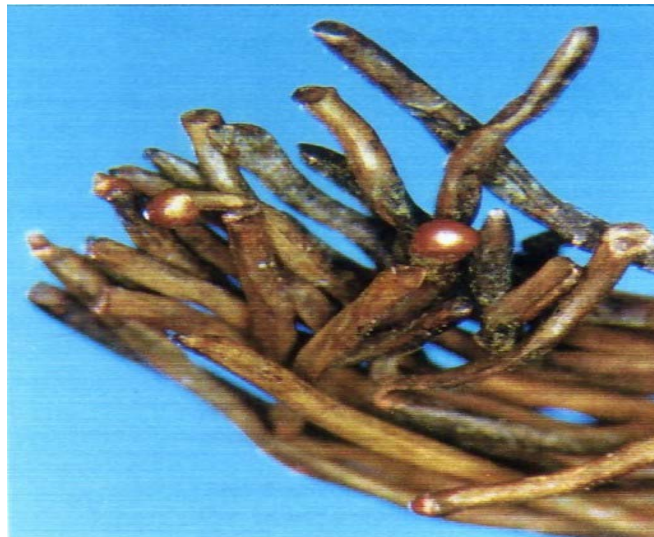
The ATSB report identified localized melting indicative of electrical arcing at the RE240 wire strand ends and about 9.5 cm from the end of the plug moulding, near the remnants of the insulation (Figure 1.16-7), but there was no arcing (melting) evidence found on the wire strands of RE239.

**Figure 1.16-6 RE240-1, some of the melting beads formed at wire ends.**

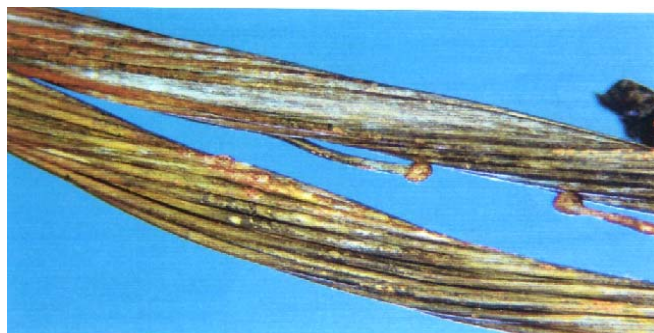
**Figure 1.16-7 RE240-1, localized melting near the boundary of insulation that was lost.**

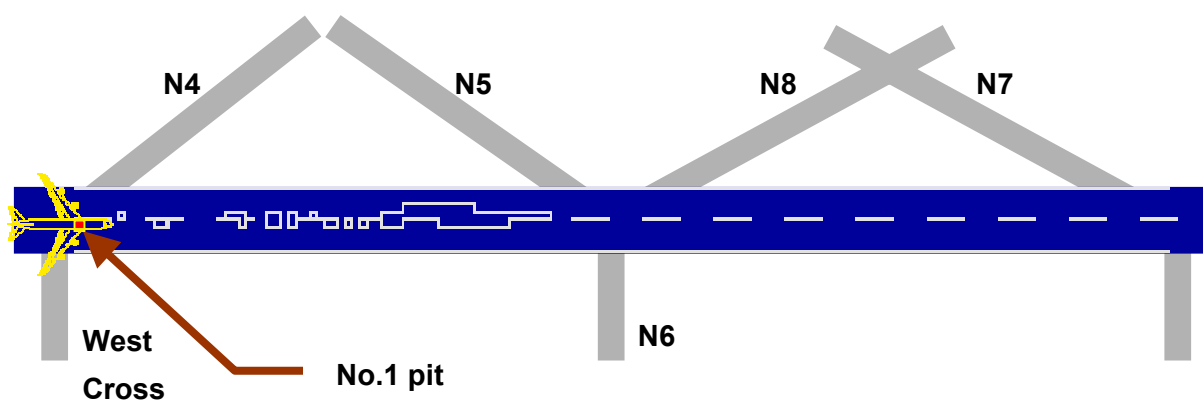
1. The right body gear strut door (most likely the right side) impacted, and knocked over a jersey barrier. The left body gear traveled over pit #1 and the forward tires impacted the north edge of the pit, causing at least one tire to fail. (#1 pit as shown in red).

Figure 2.2-1 Structure failure sequence-1

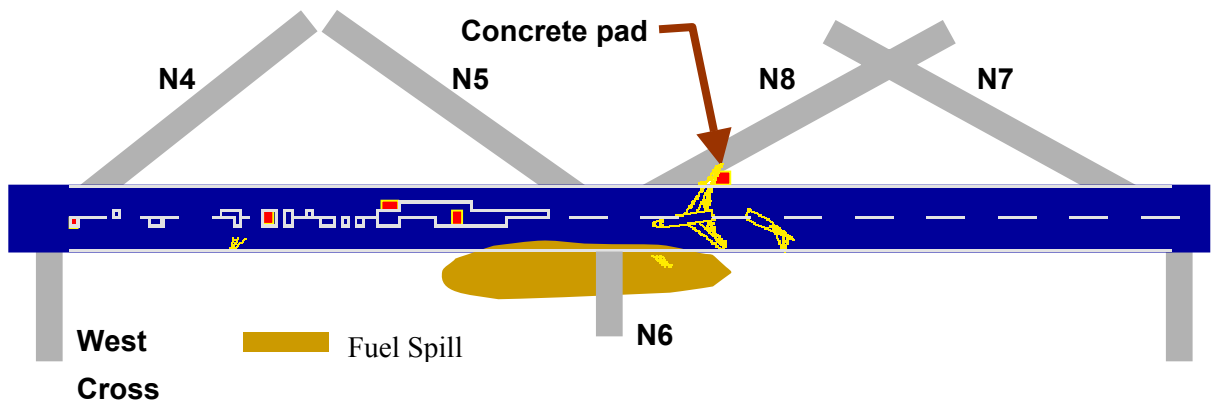
7. As the aircraft was traveling backwards, the #4 engine impacted the concrete pad (as shown in red), separating it from the right wing.

**Figure 2.2-7 Structure failure sequence-7**

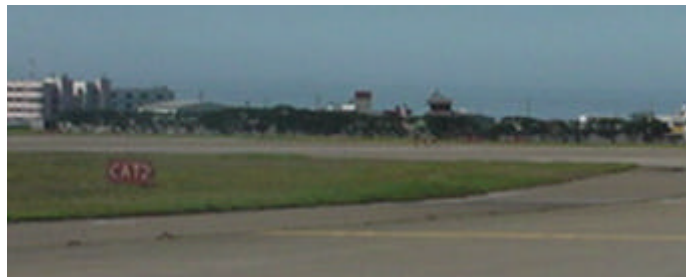
Figure 10-22 Mandatory CAT II sign found only at the left side of N1 taxiway leading to Runway 05L/23R

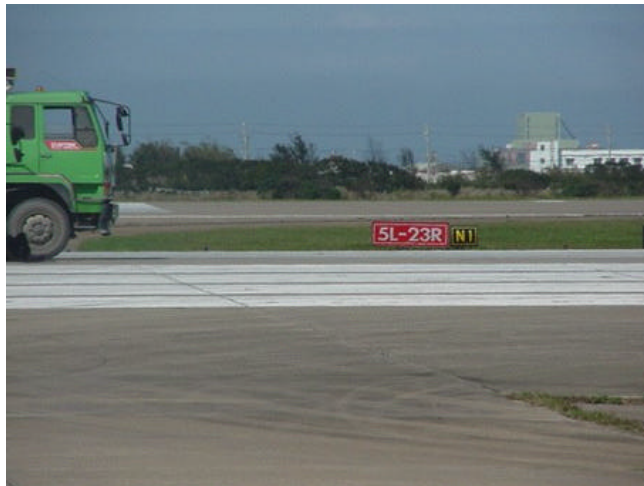
Figure 10-23 Mandatory runway designation sign found only at the right side of Taxiway N1 leading to Runway 05L/23R
