Loss of directional control, Trans World Airlines, Inc., Boeing 707-331C, N787TW, National Aviation Facilities Experimental Center, Atlantic City Airport, Pomona, New Jersey, July 26, 1969

AIRCRAFT ACCIDENT REPORT

**TRANS WORLD AIRLINES, INC.
BOEING 707-331C, N787TW
NATIONAL AVIATION FACILITIES
EXPERIMENTAL CENTER
ATLANTIC CITY AIRPORT
POMONA, NEW JERSEY
JULY 26, 1969**

**NATIONAL TRANSPORTATION SAFETY BOARD
Bureau of Aviation Safety
Washington, D. C. 20591**

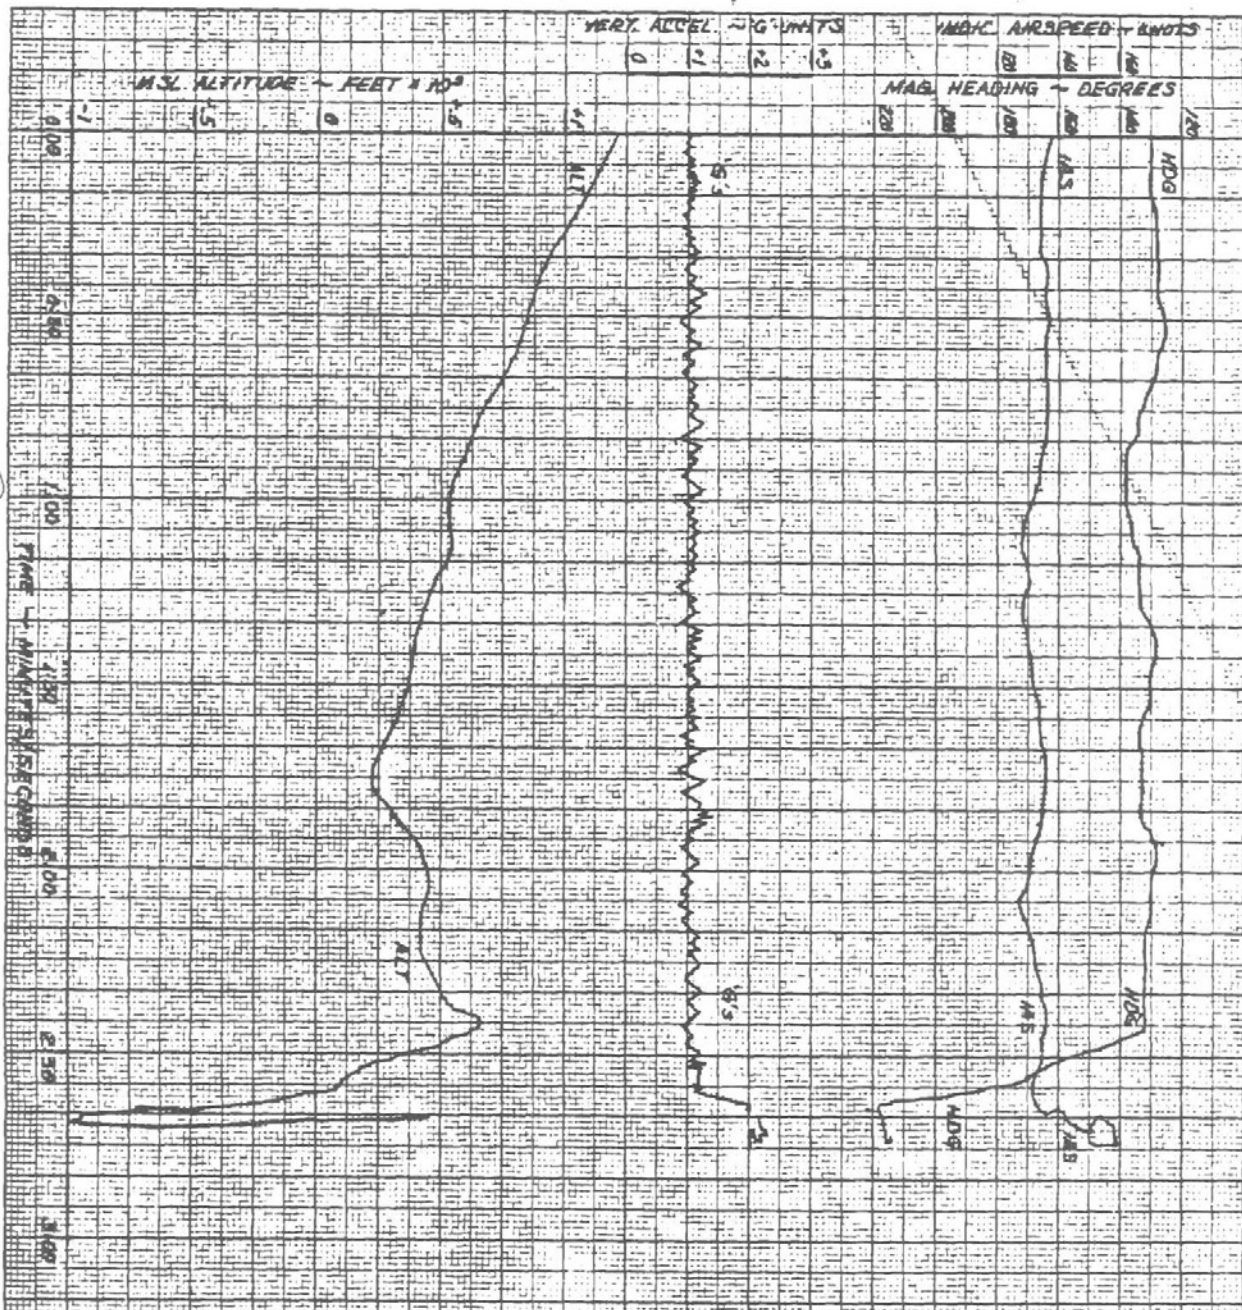
NATIONAL TRANSPORTATION SAFETY BOARD
 BUREAU OF AVIATION SAFETY
 WASHINGTON, D. C.
 TRANS WORLD AIRLINES, BOEING MODEL B-27, N7877N
 TRAINING FLIGHT, ATLANTIC OCEAN
 JULY 26, 1969
 SIMULATED MISSED APPROACH ACCIDENT
 FLIGHT DATA RECORDER GRAPH
 LES MODEL 109-CR, SIN 899

N787TW was equipped with a Lockheed 109CR flight data recorder. The recorder was recovered with superficial dents and smoke damage. The recording was in good condition. The recording produced the following in-flight information: pressure altitude, magnetic heading indicated airspeed, and vertical accelerations, against a time base. An examination of the recording was made covering a period from 2:45 minutes prior to impact. This time period covers the flight of TWA 5787 from just inside the outer marker on the ILS approach through the missed-approach procedure to impact. The altitude readout shows a descent to 230 feet m.s.l. at 50 seconds prior to impact, then a climb reaching a maximum altitude of 666 feet m.s.l. at 11 seconds prior to impact. At 10 seconds prior to impact, the altitude reading was 650 feet, at 5 seconds it was 250 feet, and at impact, 81 feet.

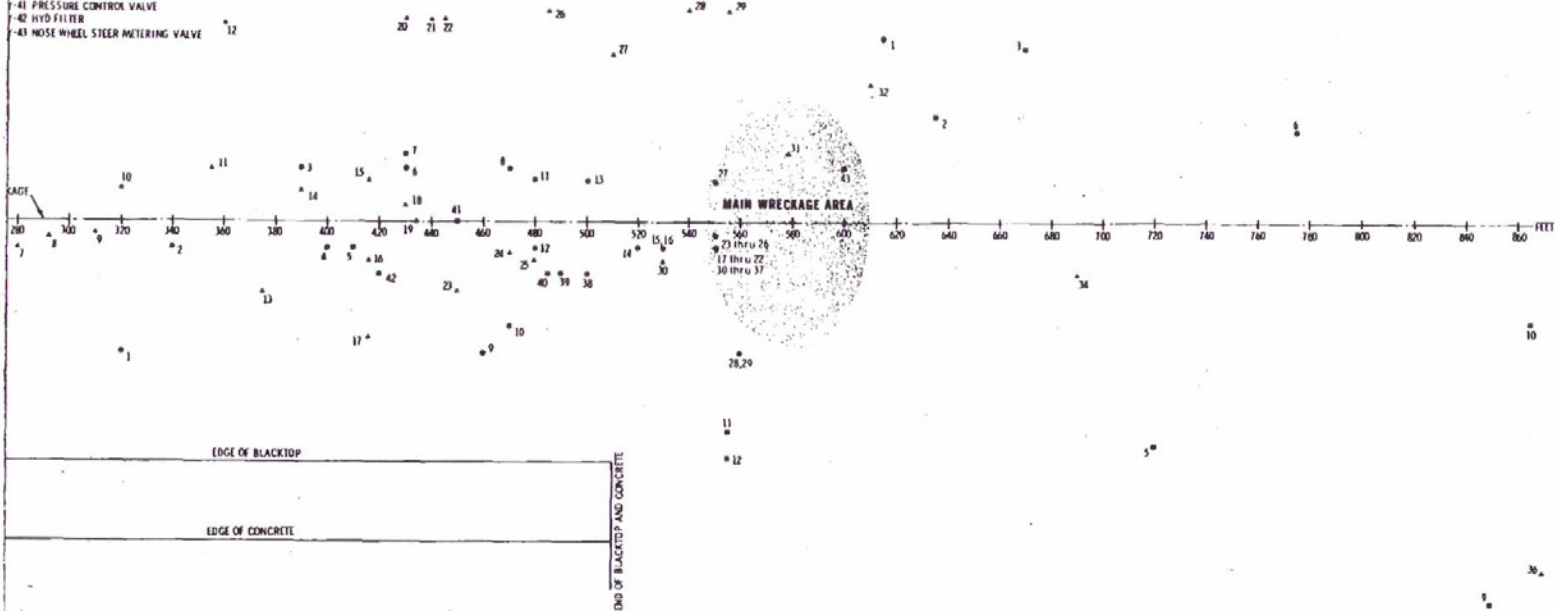
WRECKAGE DISTRIBUTION CHART
 TRANS WORLD AIRLINES, INC. B707-331C, N-787TW
 NAFEC, POMONA, N.J.
 JULY 26, 1968

The fuselage had separated into three large sections: The forward fuselage, including the cockpit area; the fuselage center; and the vertical stabilizer and rudder section. Each was heavily damaged by ground impact and the subsequent ground fire. The horizontal stabilizer and tail cone section had separated from the empennage and was found near the main wreckage. (See Appendix C, Wreckage Distribution Chart.)

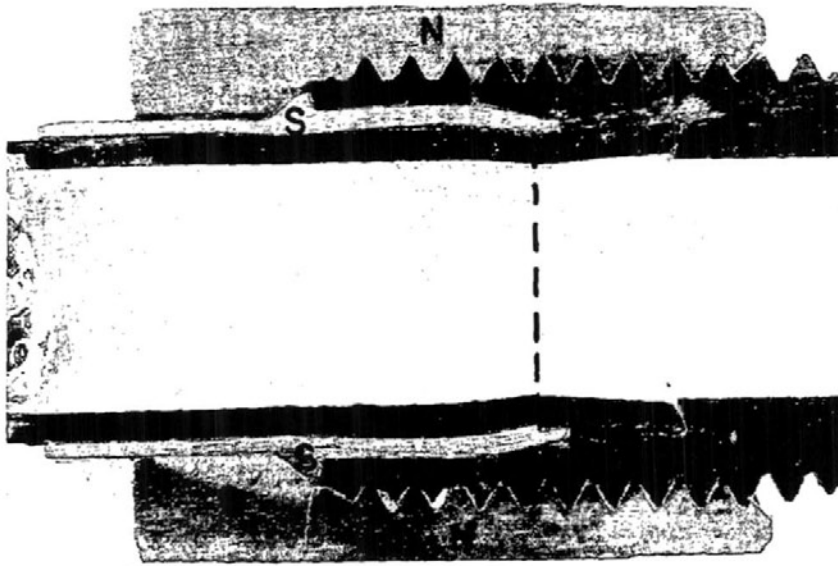
The hydraulic pressure line to the downside of the left outboard spoiler actuator had failed at the bottom of the sharp notch cut in the outside surface of the tube by the edge of the flareless coupling sleeve. Metallurgical examination of the break indicated that the failure was due to metal fatigue. (See Appendix D.)

Longitudinal section through an assembled flareless coupling, illustrating the location of the fracture (dashed line) indicated by arrow "a", Fig. 1. X 4
