Hard landing, Delta Air Lines, Inc., Douglas DC-9-32, N3329L, Louisville, Kentucky, September 8, 1970

Investigative Body: National Transportation Safety Board (NTSB), USA

DELTA AIR LINES, INC.
DOUGLAS DC 9-32, N3329L
LOUISVILLE, KENTUCKY
SEPTEMBER 8, 1970

NATIONAL TRANSPORTATION SAFETY BOARD
WASHINGTON, D. C. 20591
AIRCRAFT ACCIDENT REPORT

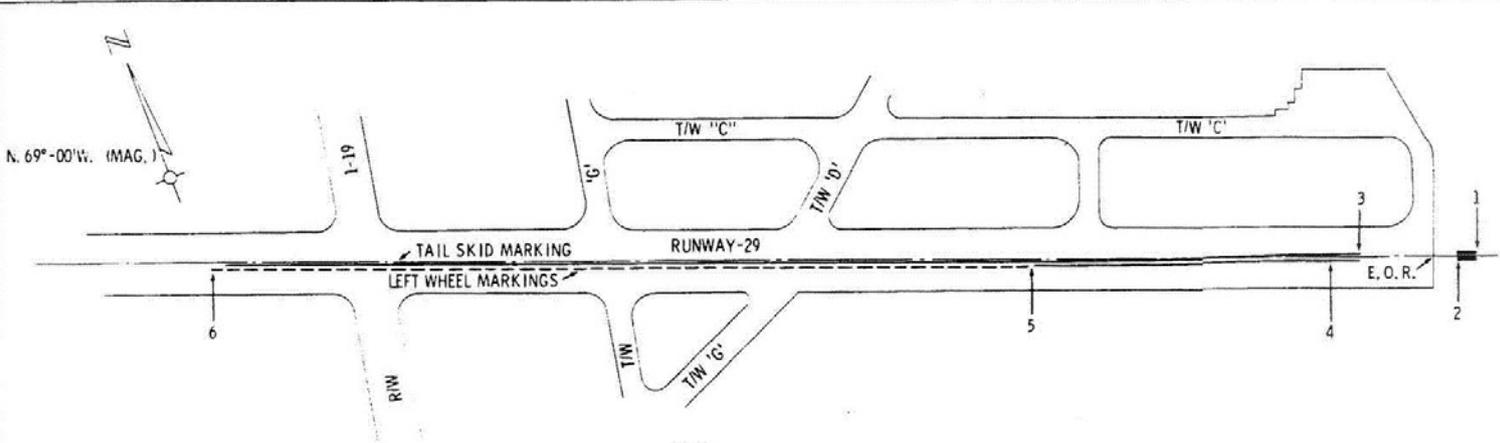
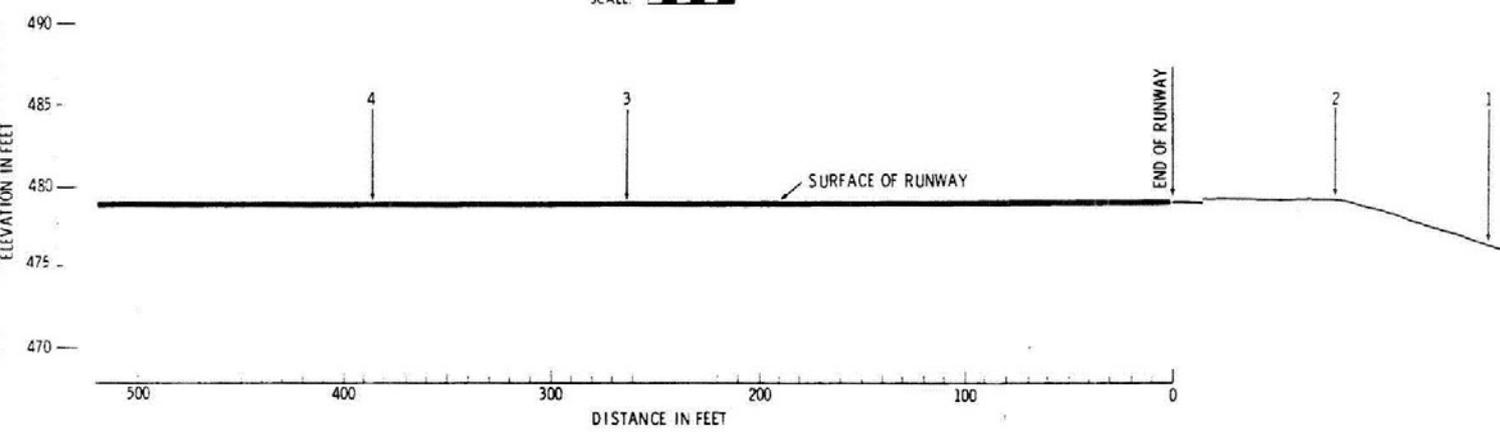
PLAN AND PROFILE VIEW OF
RUNWAY 29
DELTA AIR LINES, INC. DC-9-32, N3329L
STANDIFORD FIELD, LOUISVILLE, KENTUCKY
September 8, 1970

Flight 439 made initial ground contact on this incline 156 feet short of the threshold of the runway, rolled forward 73 feet, and became airborne. The aircraft then contacted the runway 262 feet beyond the threshold and continued to roll/skid on the runway before it came to rest 4,457 feet beyond the threshold. (See Attachment 2.)

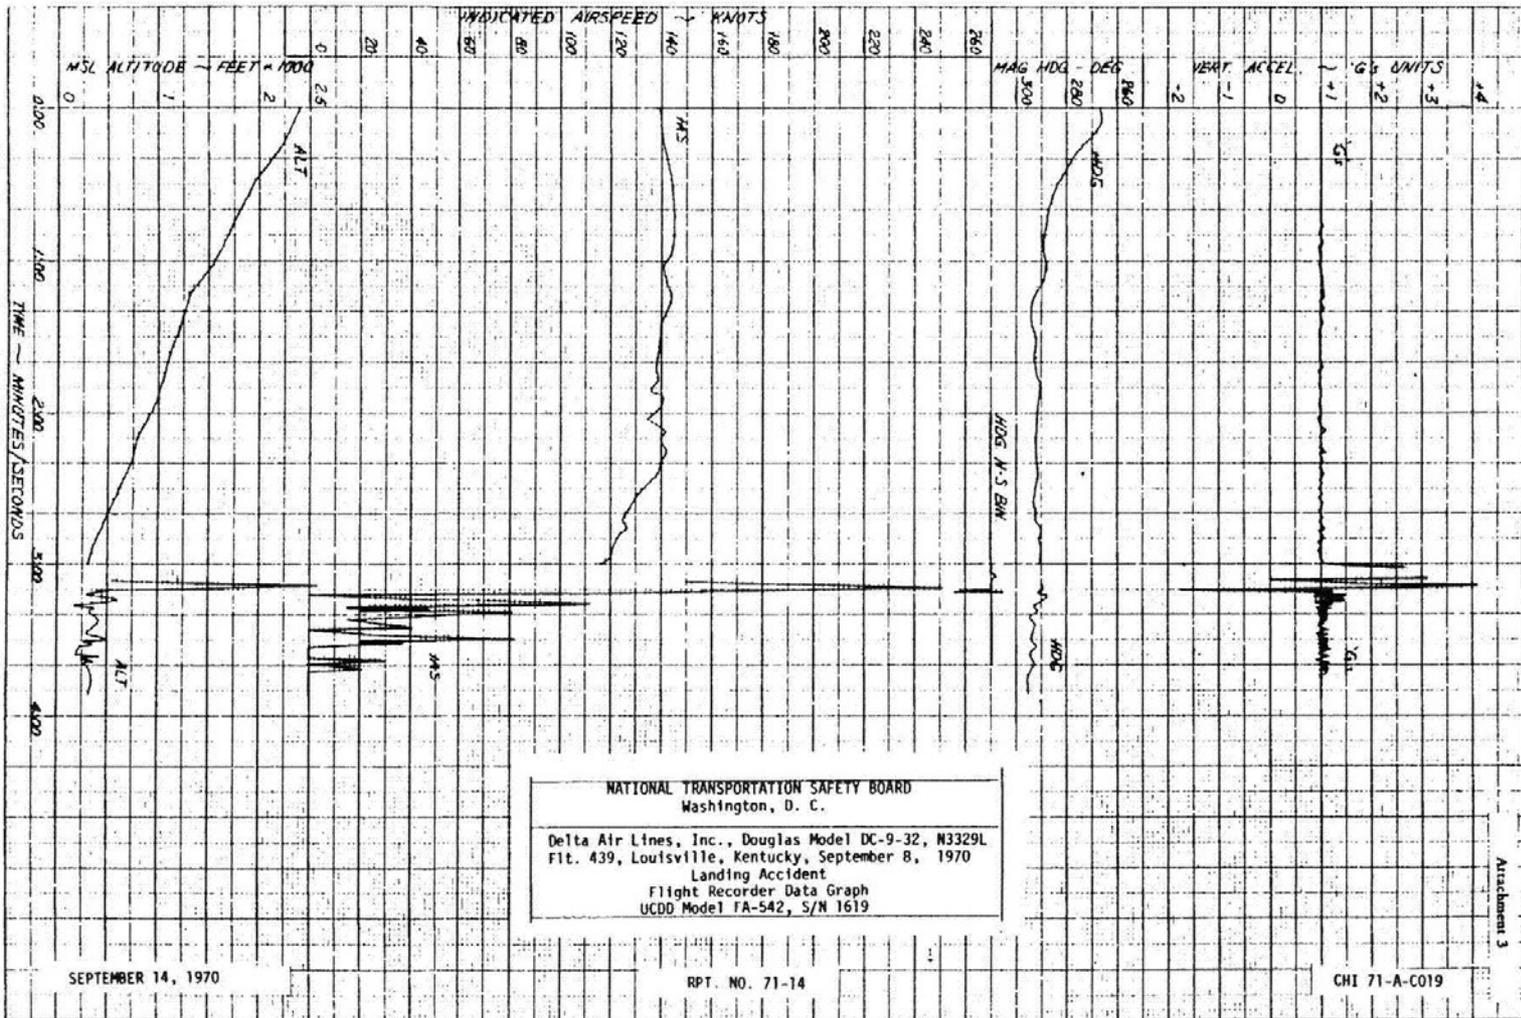
level altitude using the reported altimeter setting of 29.90 inches of mercury. No other corrections were made to any parameter. (See Attachment 3.)

The altitude shown at the point where all recorder traces became aberrant is 300 feet mean sea level. The actual altitude at point of impact is 472 feet mean sea level.
