Crashed short, Delta Air Lines, Inc., Douglas DC-9-31, N975NE, Boston, Massachusetts, July 31, 1973

AIRCRAFT ACCIDENT REPORT

DOUGLAS DC-9-31, N975NE

REPORT NUMBER: NTSB-AAR-74-3

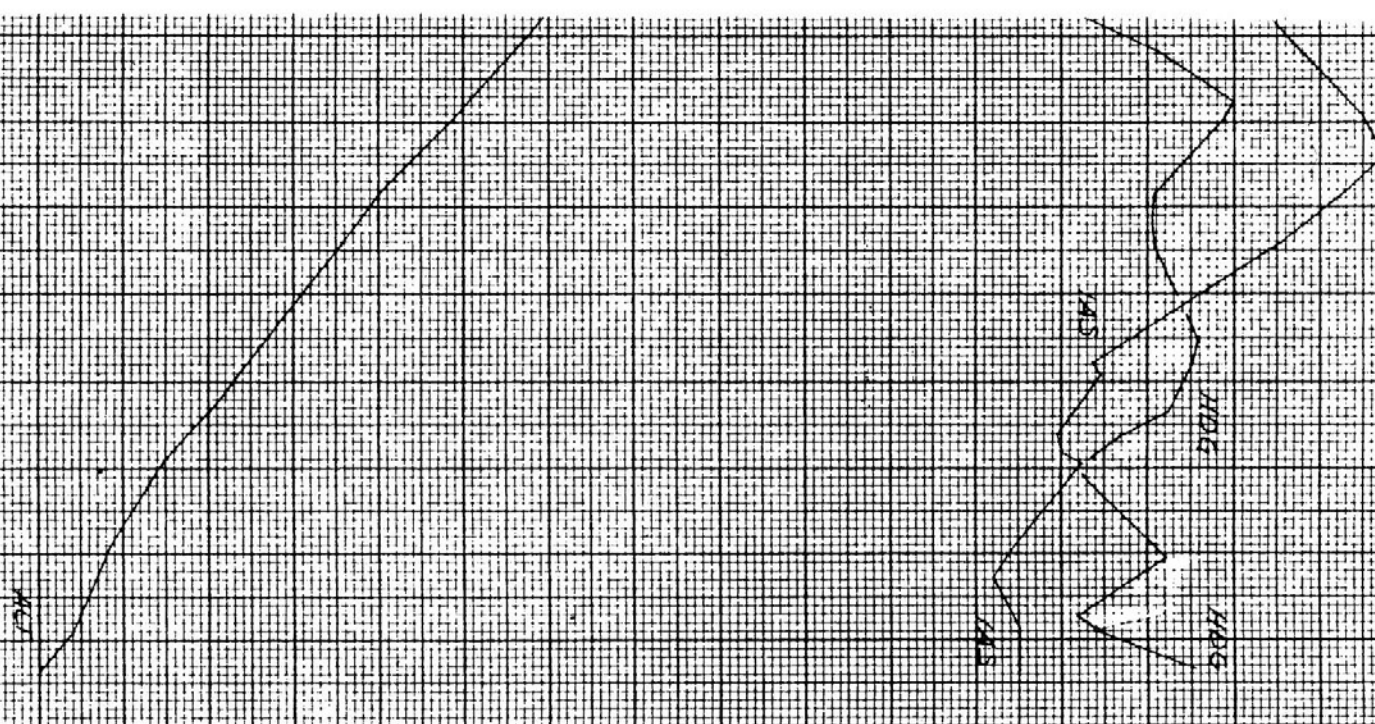
NATIONAL TRANSPORTATION SAFETY BOARD
BUREAU OF AVIATION SAFETY
WASHINGTON, D. C.
DELTA AIR LINES, DOUGLAS MODEL DC-9, N911NE
FLT 123, BOSTON, MASS, JULY 31, 1973
LANDING APPROACH ACCIDENT
FLIGHT DATA RECORDER GRAPH
TKDD (SUNDSTRAND) MODEL FA 342, S/N 1123

N975NE was equipped with a United Control Data Division (Sundstrand) Model FA-542 flight data recorder (FDR) serial No. 1723. After the crash, the recorder was intact with only superficial mechanical damage to its outer case. There was no evidence of fire damage; the recording foil was undamaged. All recorded parameter and binary traces were readable. Examination disclosed gaps in all parameter traces, which appeared on each parameter trace at the same point in time. Although the gaps caused difficulty with the readouts, they did not measurably affect the overall timing. (See Appendix E.)

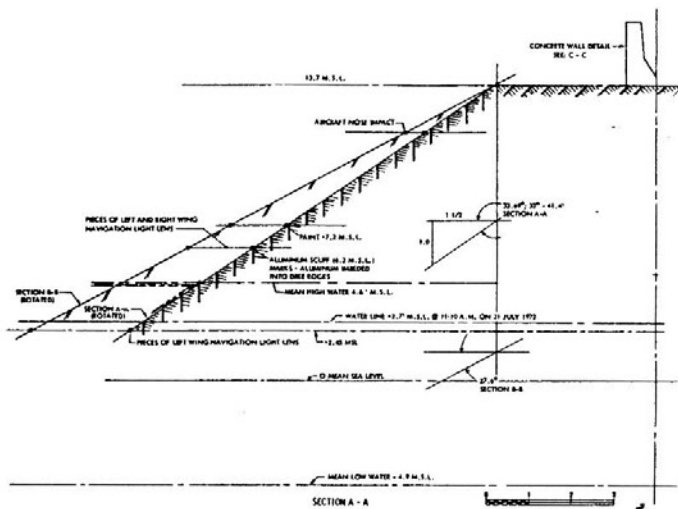
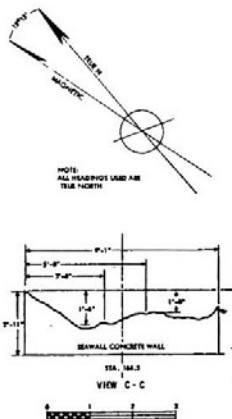
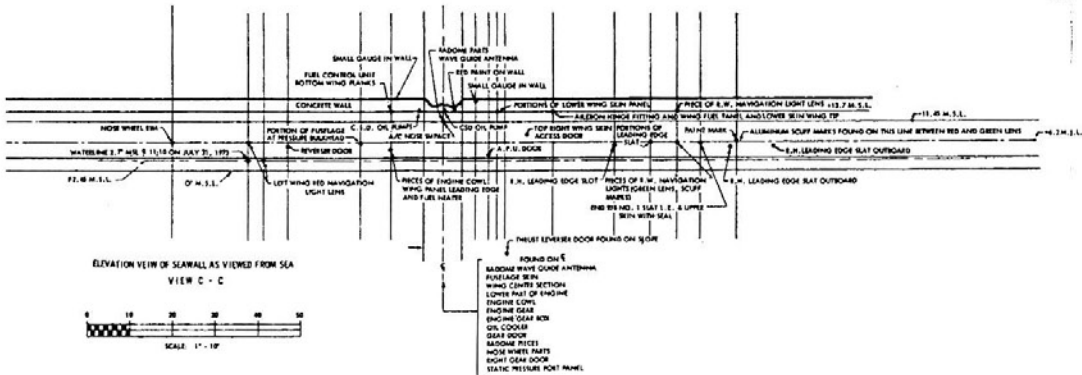
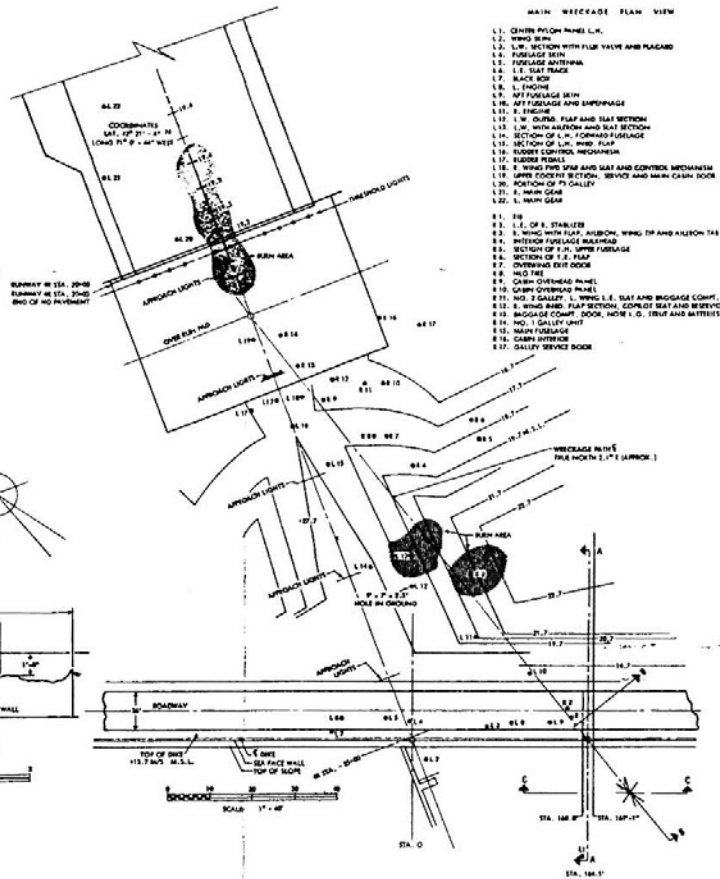
APPENDIX H

The aircraft struck a seawall on the north shore of the Boston Harbor main ship channel. The seawall forms the south boundary of the airport. The elevation of the impact point was 11.45 feet; the elevation of the intended touchdown point was 16 feet. Aluminum scuff marks were found on the rocks 6.2 feet up the seawall. Pieces of wing tip navigation lights were found at each end of the scuff marks. Portions of wing and fuselage structure were found between the edge of the water and the base of the wall. The aircraft wreckage was scattered along a magnetic heading of 017° in an area about 250 feet wide and 790 feet long. (See Appendix H.)
