**CFIT, World Airways, Inc., DC-8-63F, N802WA, King Cove, Alaska,  
September 8, 1973**

# AIRCRAFT ACCIDENT REPORT

WORLD AIRWAYS, INC.  
DC-8-63F, N802WA  
KING COVE, ALASKA  
SEPTEMBER 8, 1973

NATIONAL TRANSPORTATION SAFETY BOARD  
Washington, D.C. 20591  
Report Number: NTSB-AAR-74-6

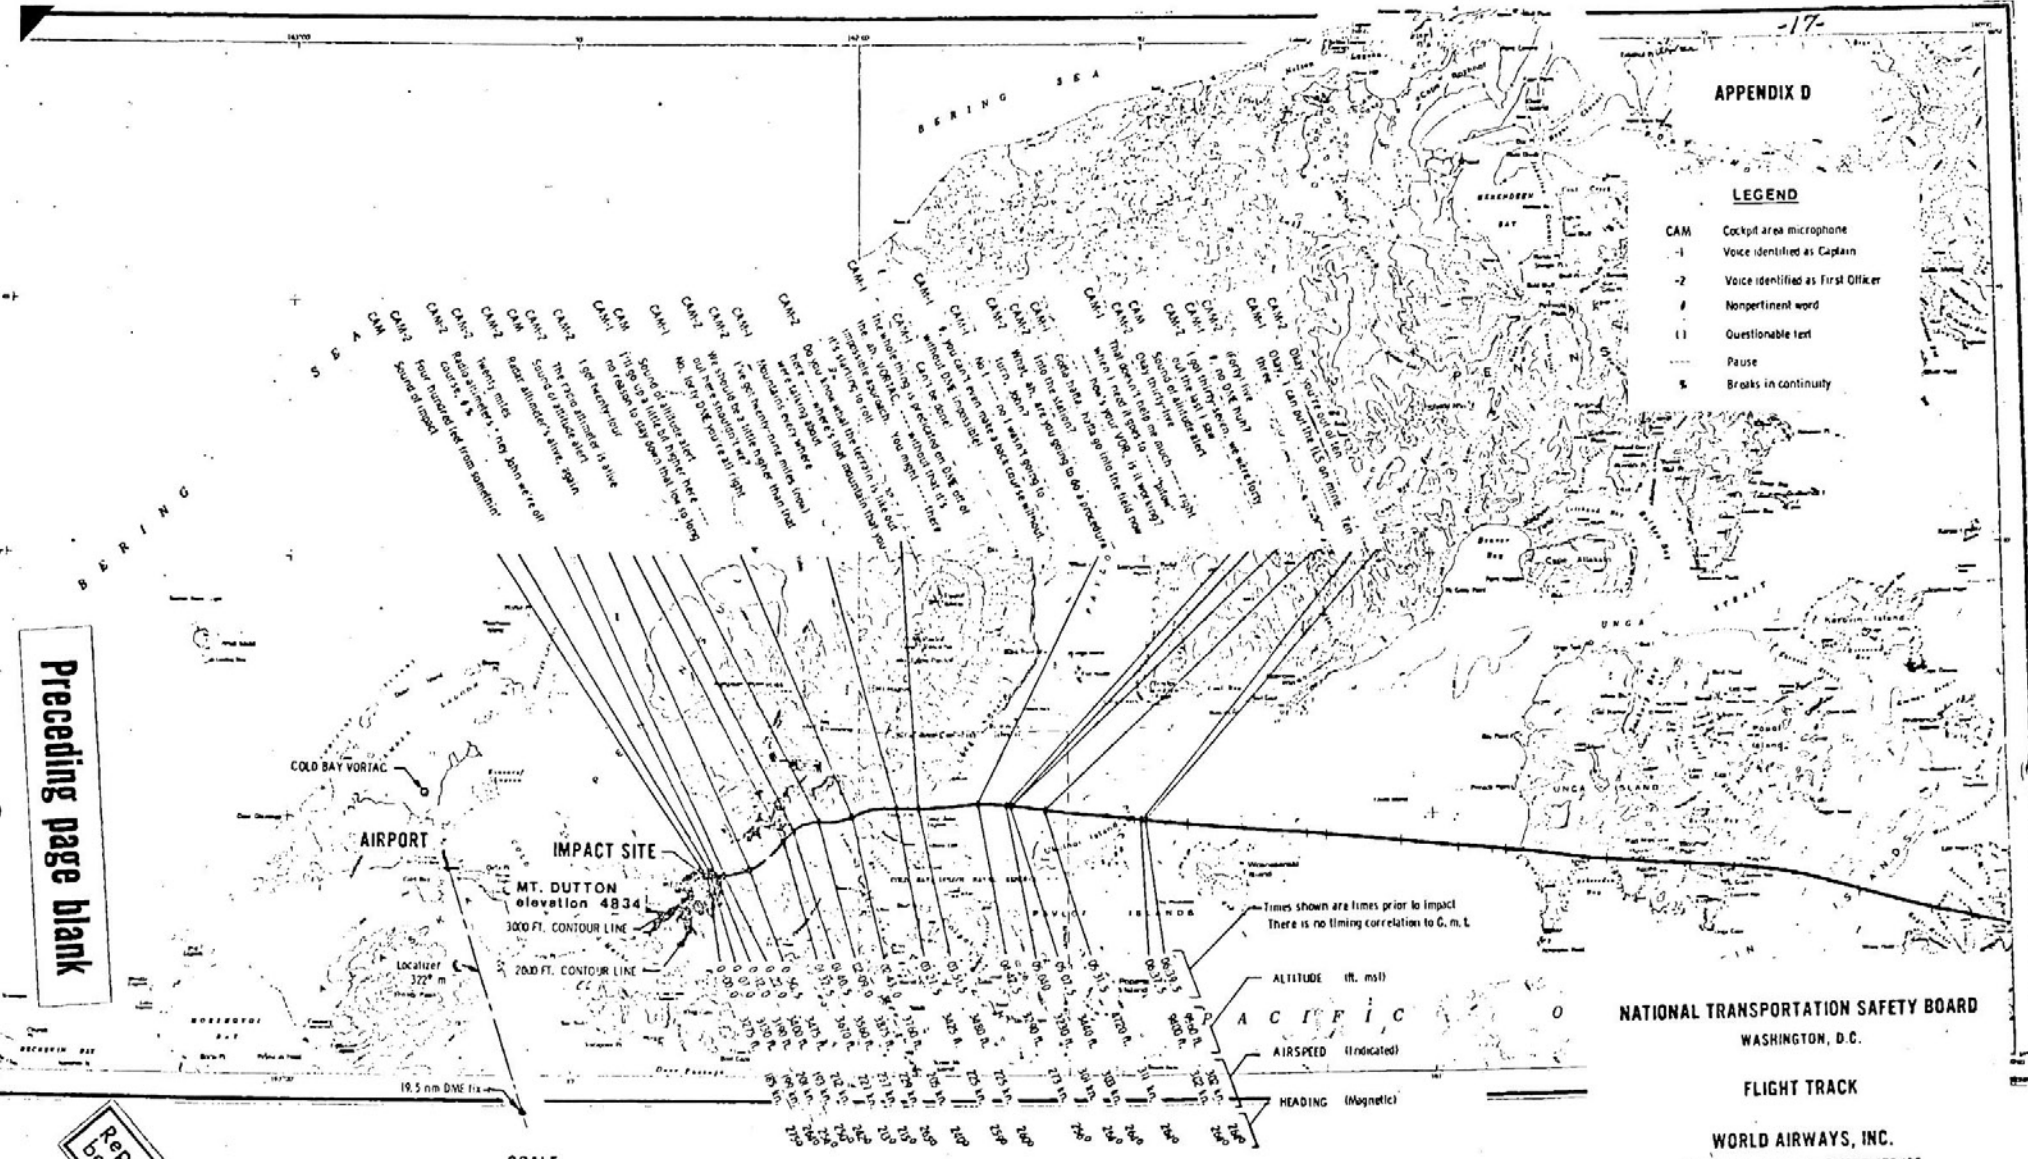
FLIGHT TRACK

At 0527 Flight 802 was cleared for an approach to the Cold Bay Airport. Both transmissions were acknowledged. At 0529, the flight reported it was leaving 31,000 feet (FL 310). This was the last recorded transmission from Flight 802. According to flight data recorder (FDR) information, the flight descended continuously and leveled off at 3,500 feet 2/. (See Appendix D.)

At 0540, the captain said, "I'll go up a little bit higher here . . . no reason to stay down that low so long." However, after climbing to 4,000 feet momentarily, he again descended. A few seconds after the first officer reported, "I got twenty-four," the aircraft's heading was changed to 215°. This southwesterly heading was maintained for 30 seconds. During the remaining 70 seconds of the flight, the aircraft's heading was changed from 215° to 275°.

After his 24 DME callout, the first officer reported twice that the radio altimeter was "alive". About 22 seconds before impact, he reported "Twenty miles," and the captain responded, "Okay, what's the inbound? One forty-one." The first officer then stated, "Radio altimeters . . . hey John, we're off course . . . ." Four seconds later, power was increased, and the first officer said, "Four hundred feet from something." Six seconds later, at 0542, the aircraft struck rising terrain, at 3,500 feet, on the 087° radial, and 18 nmi east of the Cold Bay VORTAC.

The captain's only authorized alternative was to intercept the 40-mile DME fix on the back course of the localizer and descend, inbound, to 3,500 feet before he reached the 19.5-mile DME fix. There is no indication, however, that the captain planned to adhere precisely to this procedure. He maintained a westerly heading toward the VORTAC until the aircraft was about 25 DME-miles from the VORTAC, despite his remarks indicating that he realized he was within the 40-mile range. The first significant heading change, which indicated an attempt to intercept the back course of the localizer, was not made until shortly after the first officer reported a 24-mile DME reading. For the sake of expediency, the captain probably intended to position the aircraft inbound on the back course of the localizer, between the 40-mile and the 19.5-mile DME fixes. If he had maintained the southwesterly heading, which he initiated about 2 minutes before impact, until he received reliable indications that the aircraft was about 30° from the localizer centerline, he would have avoided a collision with the mountain. Actually, he maintained the southwesterly heading for only 30 seconds before he made a right turn to a westerly heading. Therefore, the captain must have received indications that led him to believe that he was southeast of the VORTAC instead of east-southeast of it.
