## Smoke emergency, Pan American World Airways, Inc., Boeing 707-321C, N458PA, Boston, Massachusetts, November 3, 1973

# AIRCRAFT ACCIDENT REPORT

REPORT NUMBER: NTSB-AAR-74-16

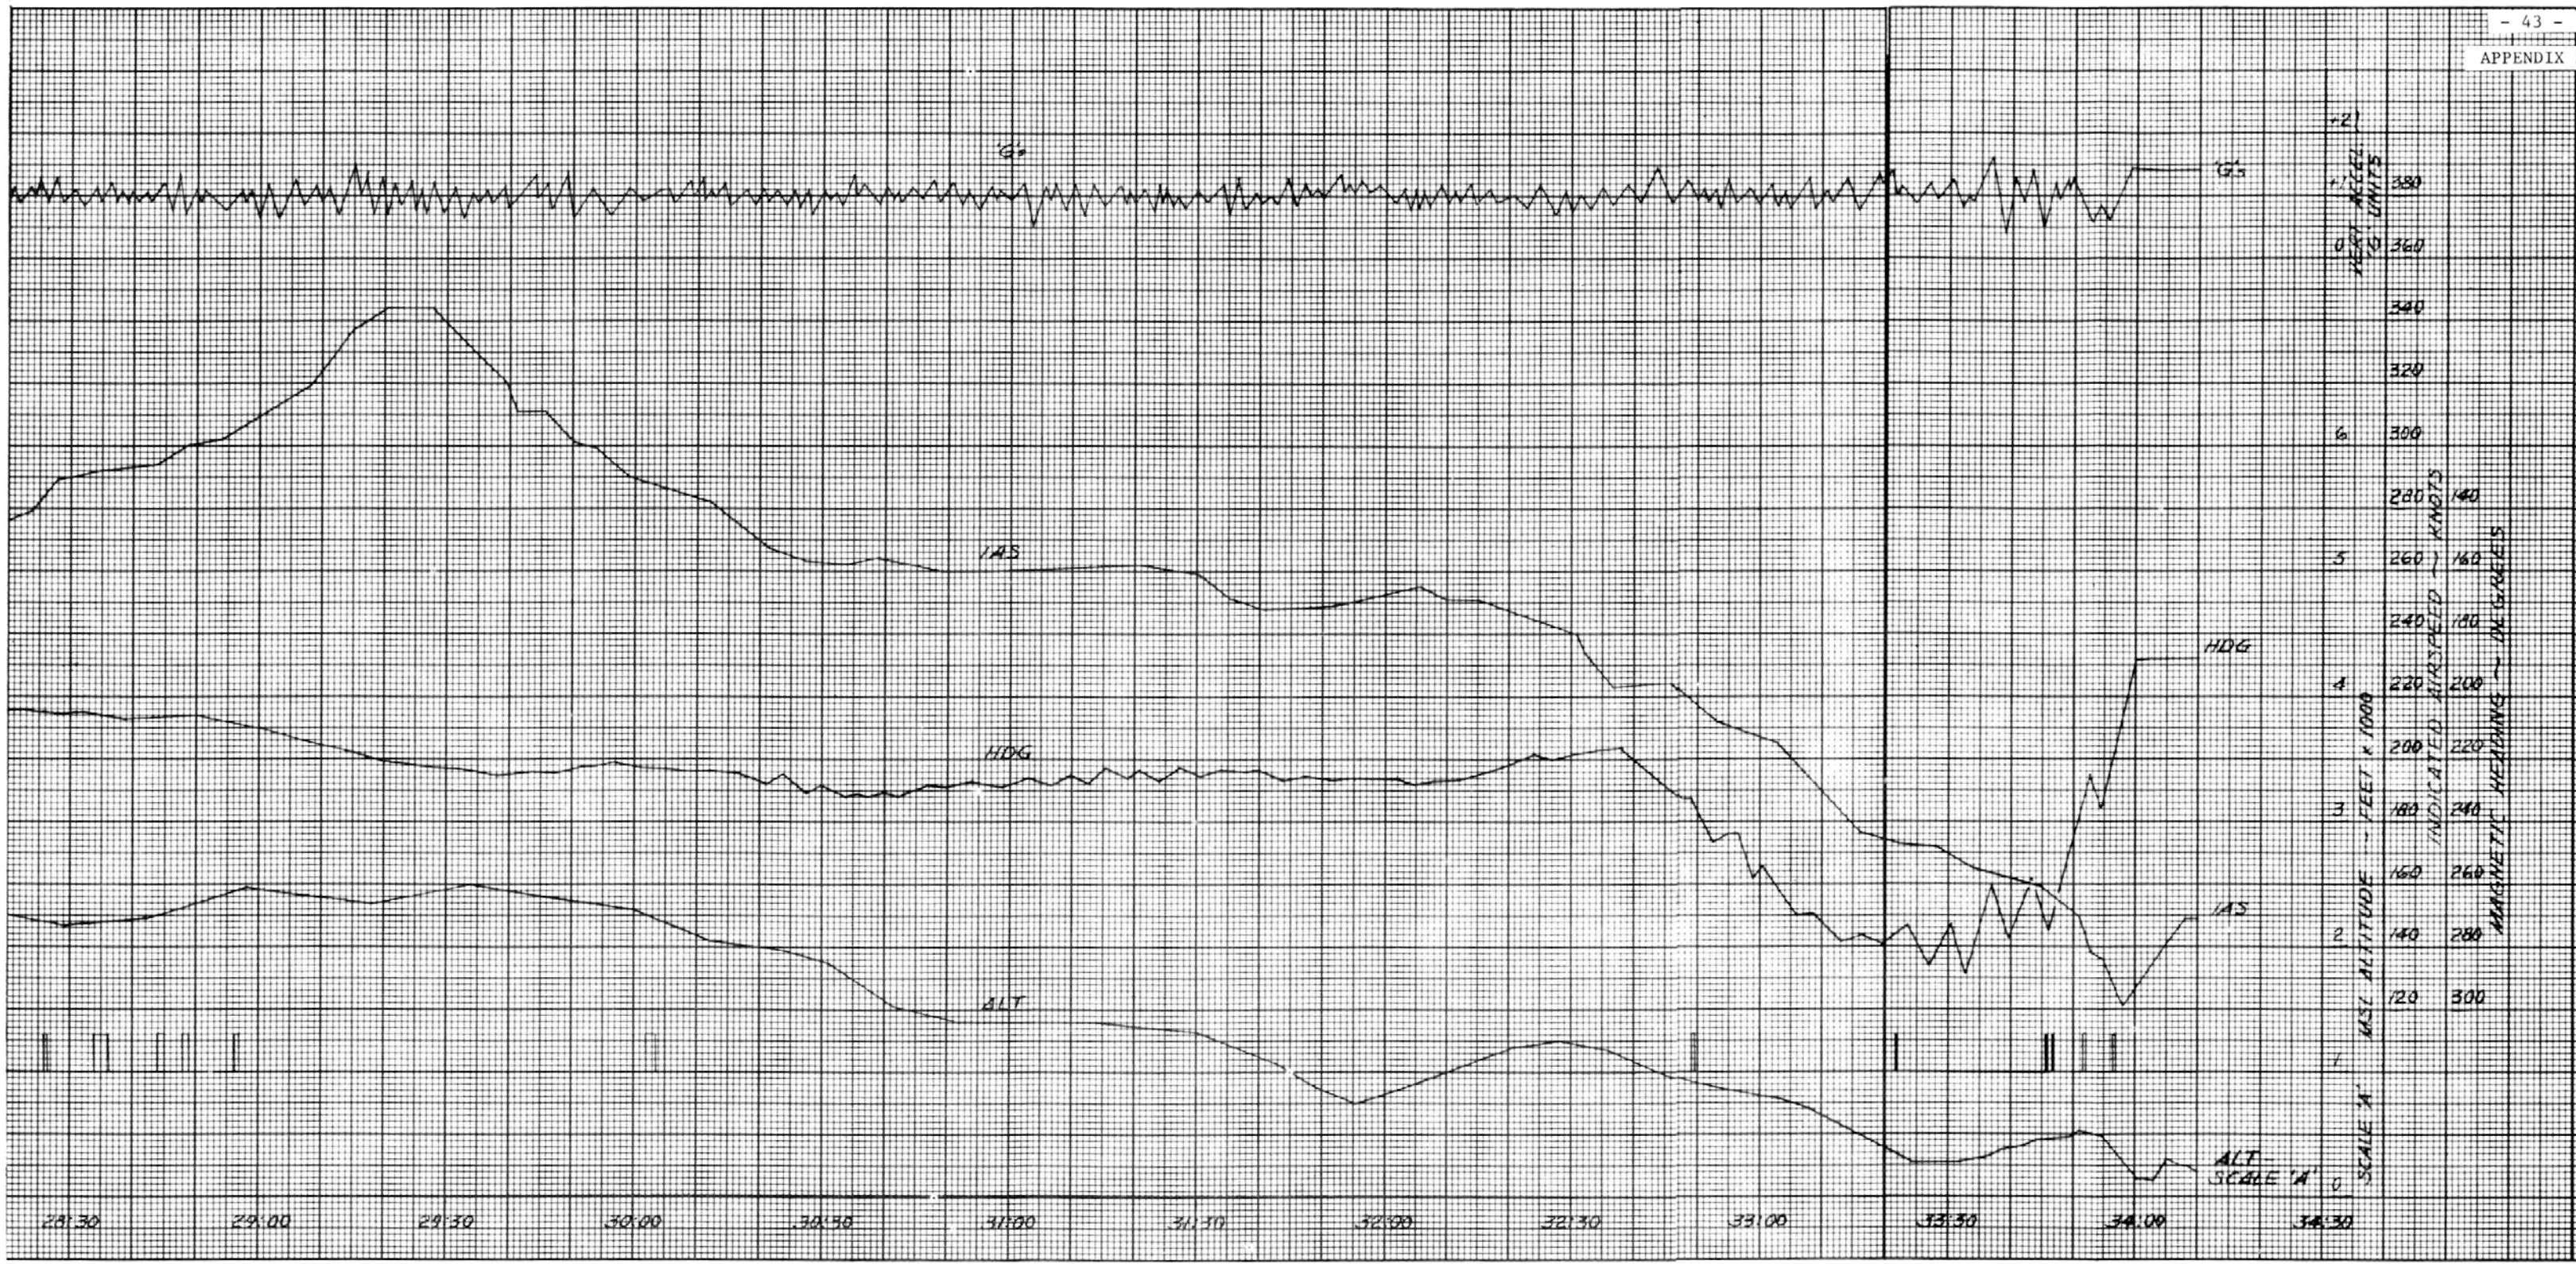
Flight recorder data indicates that a stable approach was never established. The airspeed, altitude, and heading traces fluctuated constantly throughout the approach. Under conditions in which the flight parameters are constantly changing, careful monitoring by the crew is necessary in order to avoid entering a dangerous flight regime. However, since the crew of Clipper 160 could not communicate verbally with each other and probably could not see the instruments because of dense smoke, they could not monitor airspeed and altitude during the final phase of the approach. This could easily lead to a stall or an uncontrollable maneuver at an altitude too low for recovery. Heading excursions during the final moments of flight also indicate that the crew may have had difficulty seeing the runway because of the dense smoke in the cockpit.

According to FDR traces, the airspeed deteriorated from about 160 to 122 kn. during the last portion of the flight. Stall speed for the aircraft's configuration at the time of the accident was 118 kn. in wings level, unaccelerated flight. Since the FDR indicates a continuous heading change, the aircraft must have been in a bank or a yaw. If the aircraft stalled during such a maneuver, considerable altitude would have been required to recover safely.

The FDR reading of 344 KIAS, 5 minutes before impact could possibly be explained by either exposure to or severance from heat on air data sensors which lead to the FDR unit. Although high speeds were observed by ground witnesses, the aircraft's performance characteristics suggest that an IAS of 344 knots would not have been possible.

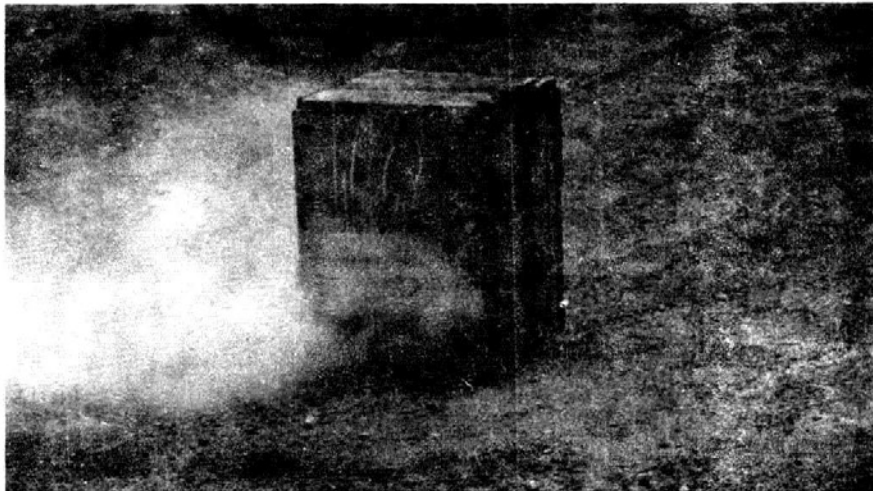
0 + 11 min.

<u>Time Lapse</u>	<u>Reaction</u>
7 min:	Bluish-white smoke was observed from around the lower surface on the container.
11 min:	The smoke downwind had an odor similar to that of burning wood.
13 min:	The white smoke flared profusely around the box and was orange momentarily.
15 min:	The quantity of smoke reduced.

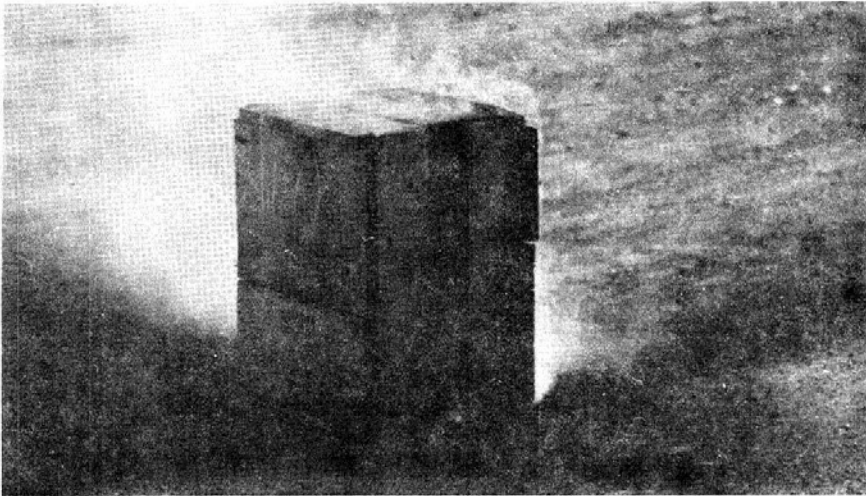
0 + 19 min.

<u>Time Lapse</u>	<u>Reaction</u>
17 min:	The odor of the smoke was similiar to that of burning wood.
19 1/2 min:	Flames were visible near the bottom of the box.
21 1/2 min:	Flames penetrated the top of the container.

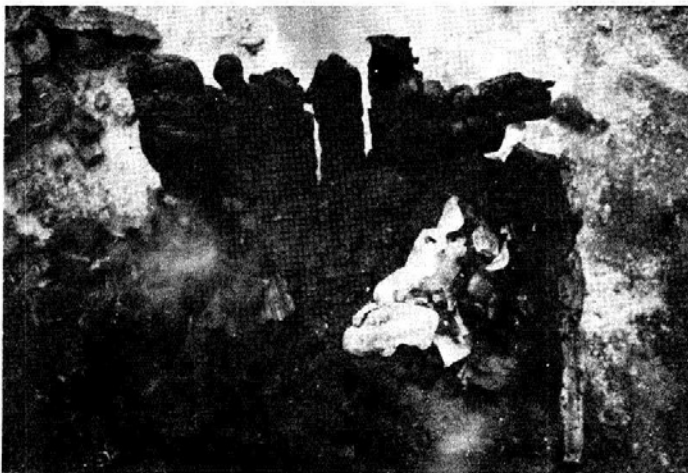
Remains of box & bottle.
