Taxiway excursion in icing, Japan Air Lines Co., Ltd., Boeing 747-246, JA8122, Anchorage, Alaska December 16, 1975

AIRCRAFT ACCIDENT REPORT

**JAPAN AIR LINES CO., LTD.
BOEING 747-246, JA8122**

REPORT NUMBER: NTSB-AAR-76-12

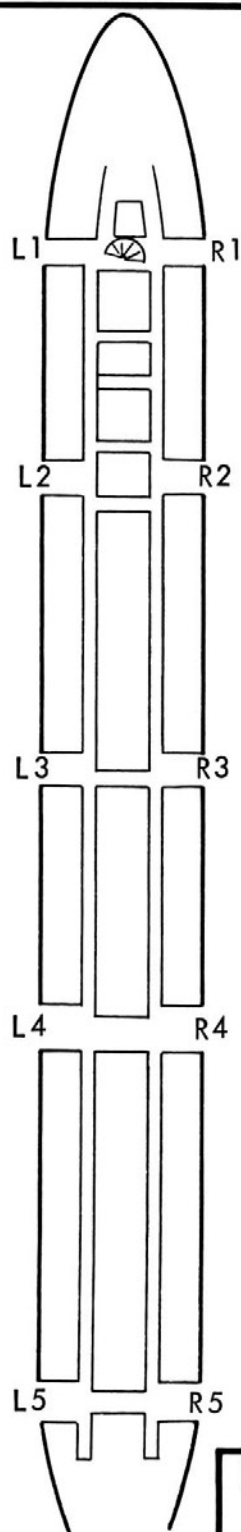
EXIT DIAGRAM
JAPAN AIRLINES BOEING 747, JA8122
ANCHORAGE INTERNATIONAL AIRPORT
ANCHORAGE, ALASKA
DECEMBER 16, 1975
ANC 76-AA-052

At exit R5, two flight attendants had difficulties rotating the handle, but managed to open the door. The slide did not inflate; however, the door sill was only 20 inches from the ground and several passengers used the exit. At some point during the evacuation, one passenger stepped on part of the slide which caused it to inflate.
