## **Runway overrun, American Air Lines, Inc., Boeing 727-95, N1963, St. Thomas, Virgin Islands, April 27, 1976**

**AMERICAN AIRLINES, INC.,  
BOEING 727-95, N1963**

**REPORT NUMBER: NTSB-AAR-77-1**

AMERICAN AIR LINES, INC.  
BOEING 727-95, N1963  
ST. THOMAS, VIRGIN ISLANDS  
APRIL 27, 1976

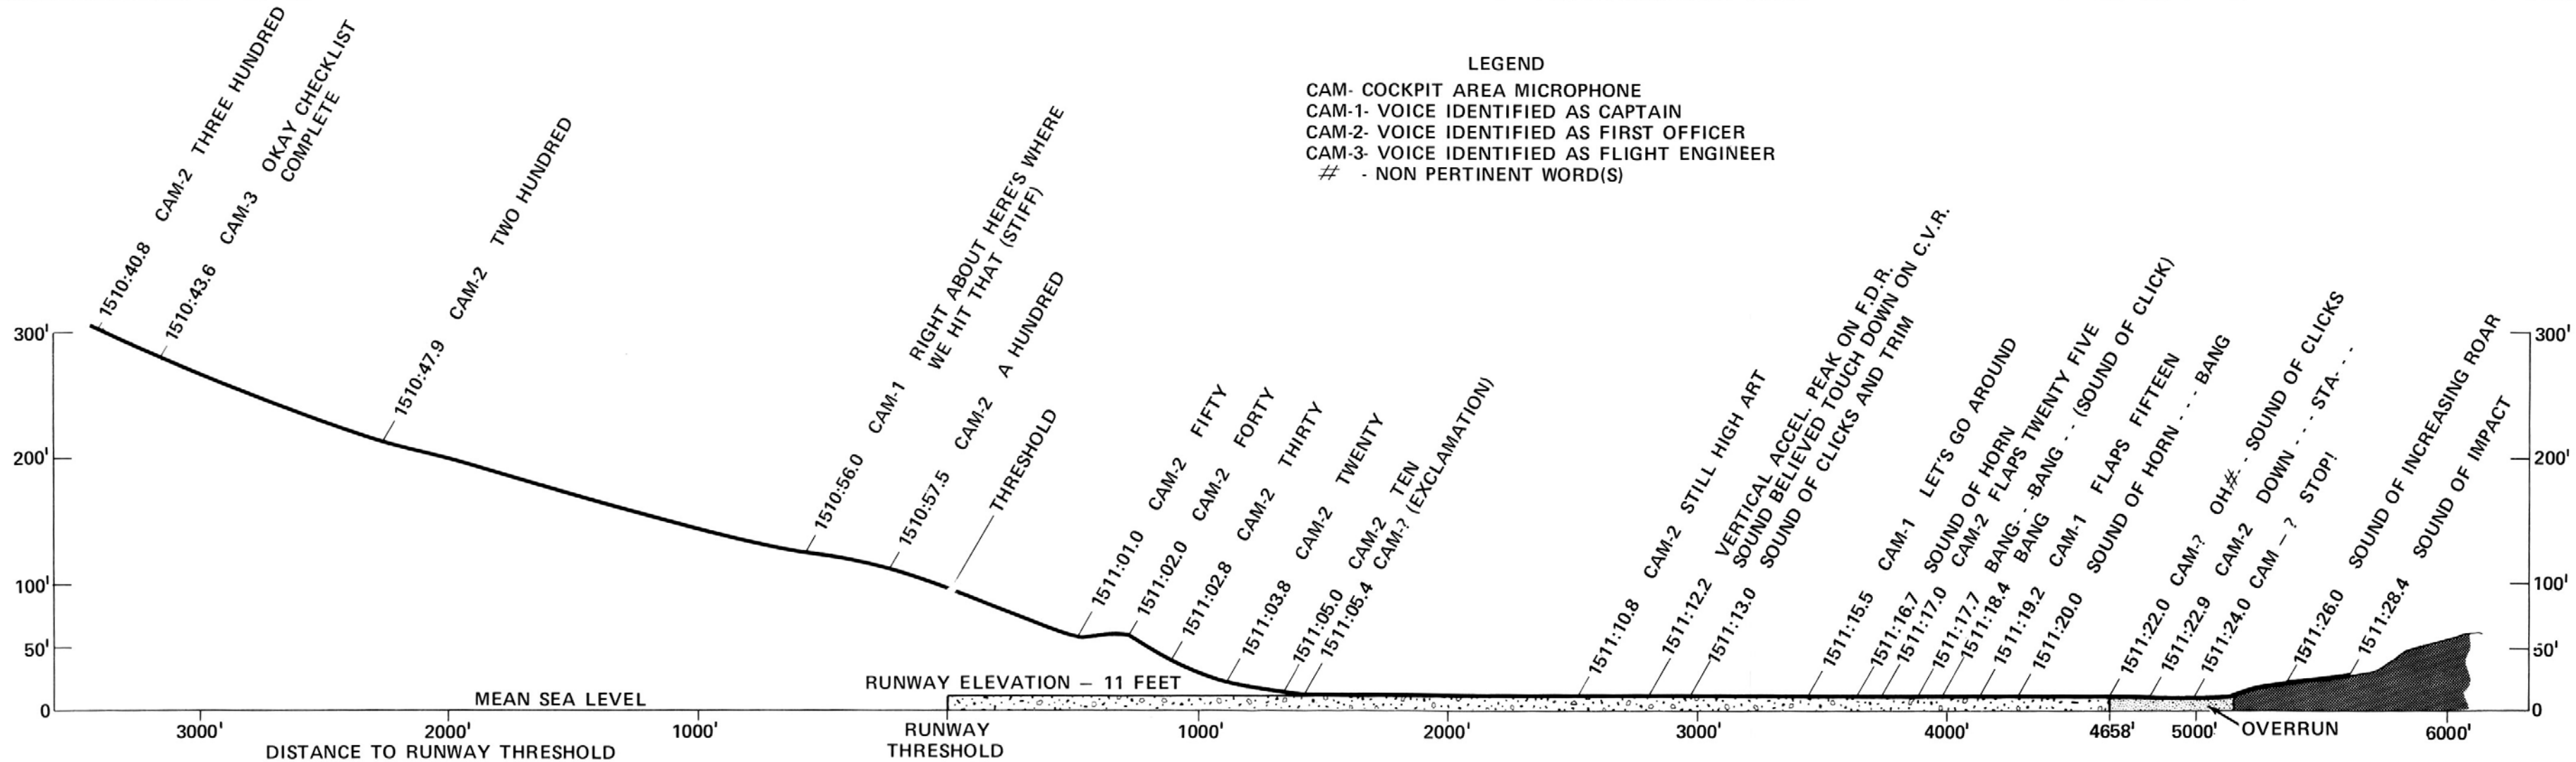
**APPROACH PROFILE**  
**AMERICAN AIRLINES, BOEING 727-95 N1963**  
**HARRY S TRUMAN AIRPORT, ST. THOMAS, VIRGIN ISLANDS**  
**APRIL 27, 1976**

The profile shown in Appendix D was prepared using assumptions which seemed to be most logical to the investigators. These assumptions are noted thereon. This profile shows that the aircraft crossed the threshold at an airspeed of 131 knots and an altitude of about 80 feet. The touchdown was calculated to be about 2,800 feet beyond the threshold. At touchdown, about 1,850 feet of runway and 500 feet of overrun were available on which to stop the aircraft. When the captain stated "Let's go around," the aircraft was about 3,450 feet beyond the threshold, or 1,200 feet of runway and 500 feet of overrun remained.

1. THE DISTANCE PLOT WAS DEVELOPED FROM THE F.D.R. AIRSPEED MEASUREMENT CORRECTED FOR DENSITY ALTITUDE AND WIND. THE FOLLOWING ASSUMPTIONS WERE USED:  
 -SEA LEVEL BAROMETRIC PRESSURE - 30.00 IN. HG.  
 -SEA LEVEL TEMPERATURE - 84° F.  
 -WIND - CONSTANT - 120° TRUE/ 10 KNOTS
2. THE TIME CORRELATION BETWEEN THE FLIGHT RECORDER DATA AND THE C.V.R. TRANSCRIPT IS BASED UPON THE ASSUMPTION THAT A VERTICAL ACCELERATION PEAK THREE SECONDS BEFORE THE END OF THE F.D.R. TRACE CORRESPONDS WITH A SOUND OF THE INCREASING ROAR RECORDED ON THE C.V.R.
3. THE CORRELATION OF THE PLOT TO THE RUNWAY THRESHOLD IS BASED UPON THE ASSUMPTION THAT THE PREVIOUSLY MENTIONED ACCELERATION PEAK AND SOUND OF ROAR OCCURRED WHEN THE AIRCRAFT STRUCK AN EMBANKMENT 5369 FEET BEYOND THE RUNWAY THRESHOLD.

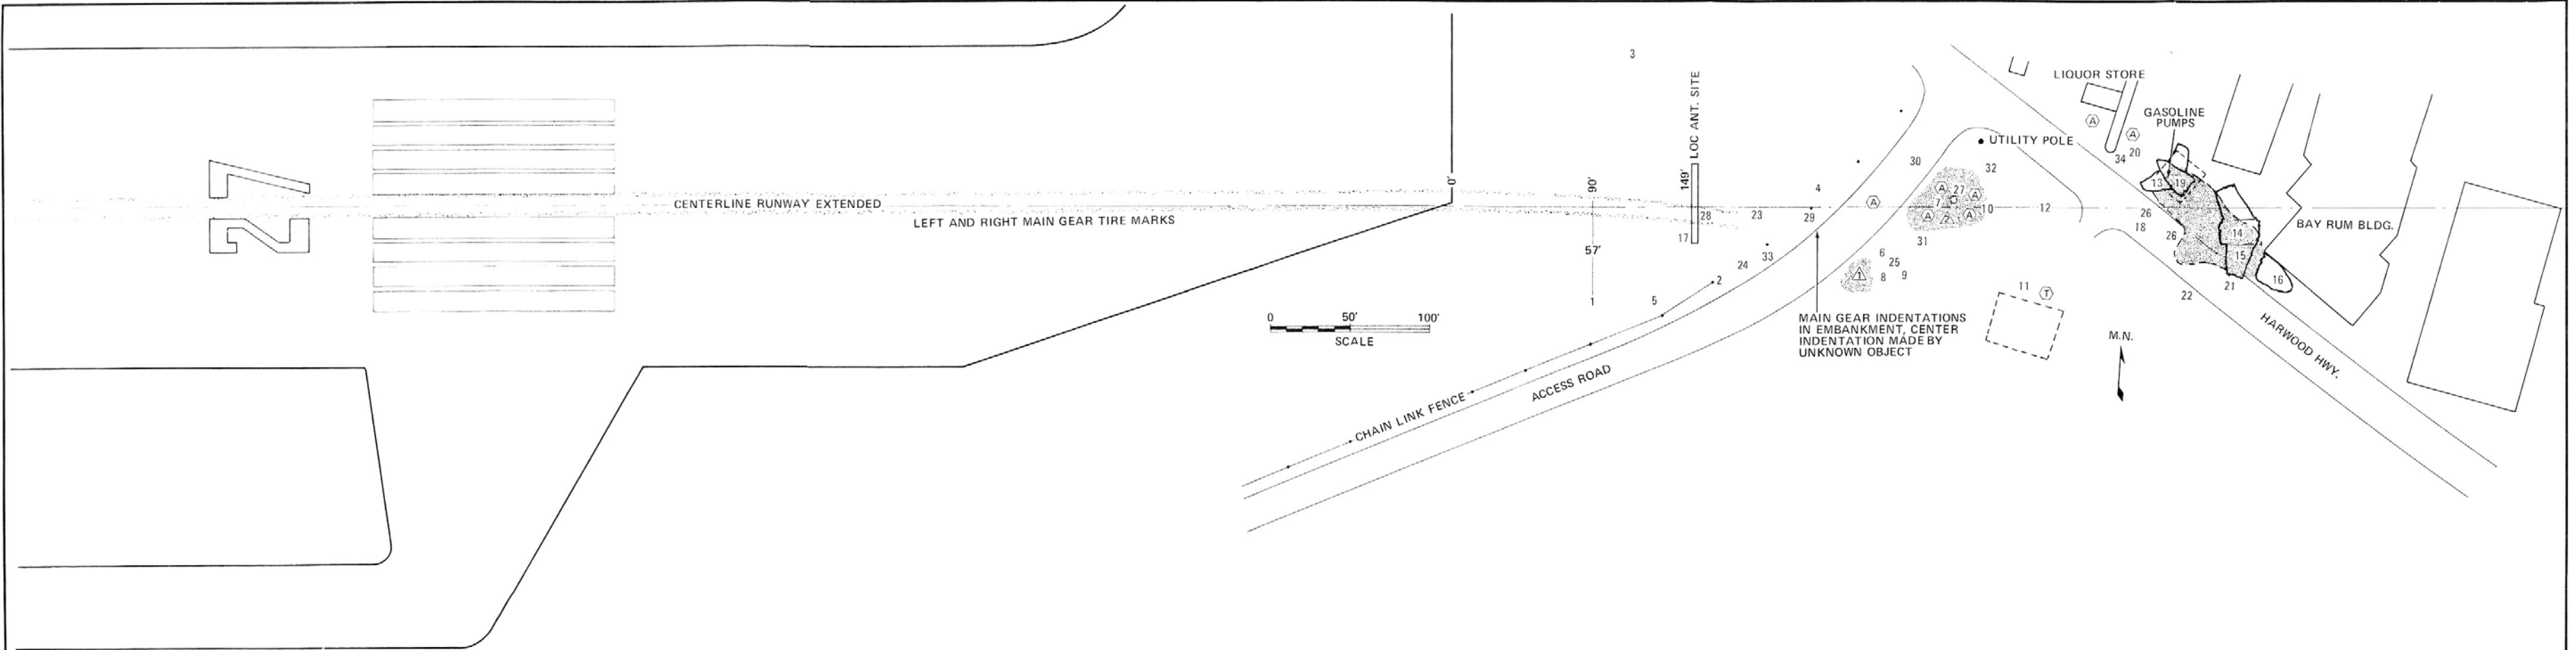
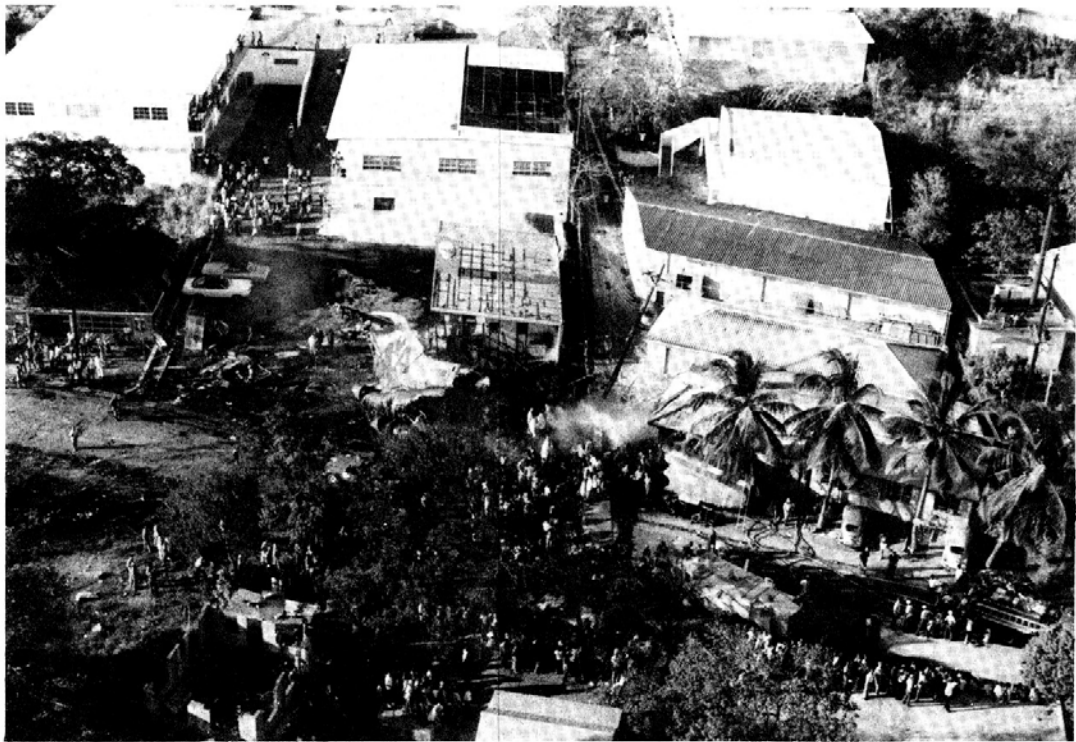
WRECKAGE DISTRIBUTION CHART  
AMERICAN AIRLINES, BOEING 727-N1963  
HARRY S TRUMAN AIRPORT  
CHARLOTTE AMALIE, ST. THOMAS, VIRGIN ISLANDS  
APRIL 27, 1976

- LEGEND:
1. PIECES OF RIGHT WING TIP NAV. LIGHT PLEXIGLASS, BLUE AND CLEAR – FIRST POINT OF FUSELAGE IMPACT APPROX. 8 FEET ABOVE OVERRUN ELEVATION
  2. IMPACT WITH CHAIN LINK FENCE

3. PIECE OF LEFT TRAILING EDGE FLAP
  4. LEFT MAIN LANDING GEAR DOOR AND SIDE STRUT
  5. RIGHT TRAILING EDGE FLAP TRACK FAIRING – LEADING EDGE DEVICE WITH FENCE – PIECES OF AFT OUTBOARD TRAILING EDGE FLAP

25. FORWARD DRAIN MAST
  26. HEAVY GOUGES AND SCRAPE MARKS ON STREET IN LINE WITH AIRCRAFT DIRECTION OF TRAVEL
  27. TREE BROKEN APPROX. 8 FEET ABOVE GROUND

28. HONYCOMB FOUND IN LOCALIZER ANTENNA SUPPORT STRUCTURE
  29. PIECES OF LEADING EDGE SLAT TRACK
  30. LEFT MAIN LANDING GEAR AFT TRUNION BEARING SLEEVE

34. THRUST REVERSER DOOR – NOs. 2 AND 3 LEADING EDGE SLATS
- SYMBOL KEY:
- (A) AUTOMOBILE
  - (T) TRUCK
  - △ FIRST INDICATION OF FIRE LOCALIZED
  - △ AREA OF FIRE DAMAGE (INCLUDES 4 AUTOMOBILES AND 1 TREE)
