Crash on takeoff, Japan Air Lines Co., Ltd., McDonnell-Douglas DC-8-62F, JA 8054, Anchorage, Alaska, January 13, 1977

Investigative Body: National Transportation Safety Board (NTSB), USA

AIRCRAFT ACCIDENT REPORT

**JAPAN AIR LINES, COMPANY, LTD.,
McDONNELL-DOUGLAS DC-8-62F, JA 8054
ANCHORAGE, ALASKA
JANUARY 13, 1977**

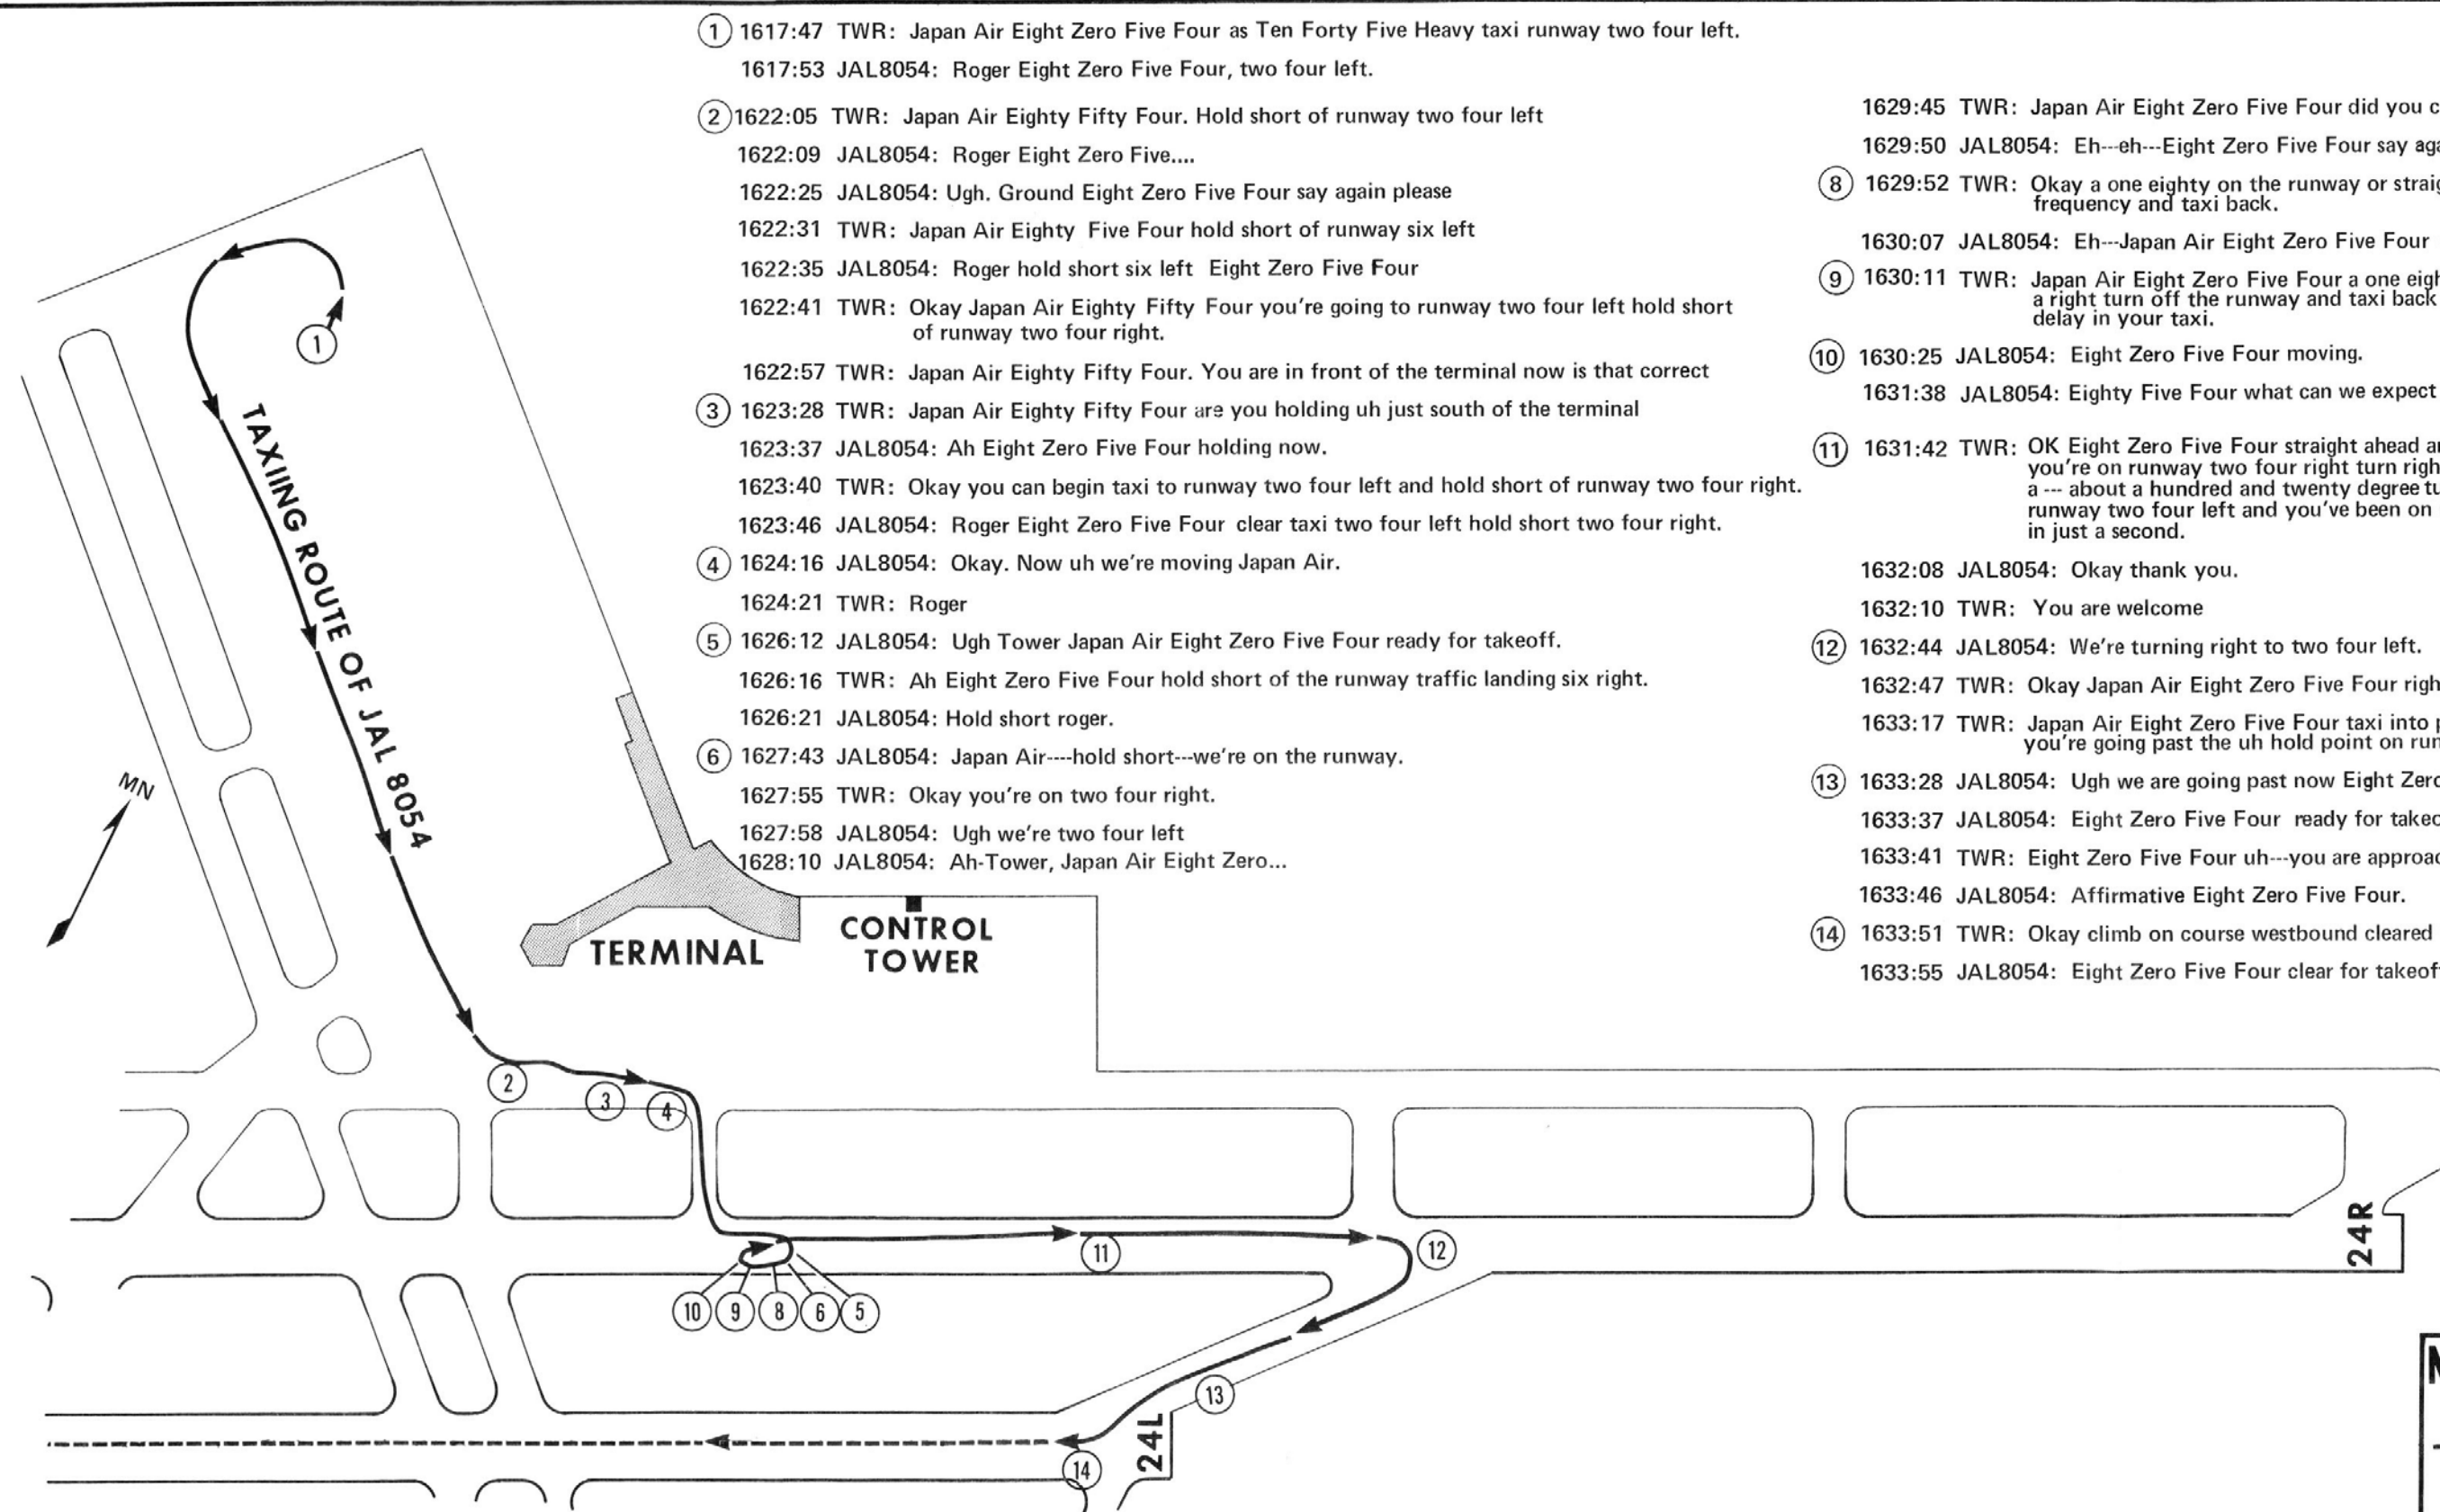
TAXIING ROUTE OF JAL 8054
ANCHORAGE INTERNATIONAL AIRPORT
JANUARY 13, 1977

In order to taxi to runway 24L, the crew had to taxi southeast on the parking ramp, northeast on a taxiway parallel to runway 24R, cross 24R, and taxi down a diagonal taxiway connecting the runways to the arrival end of runway 24L.

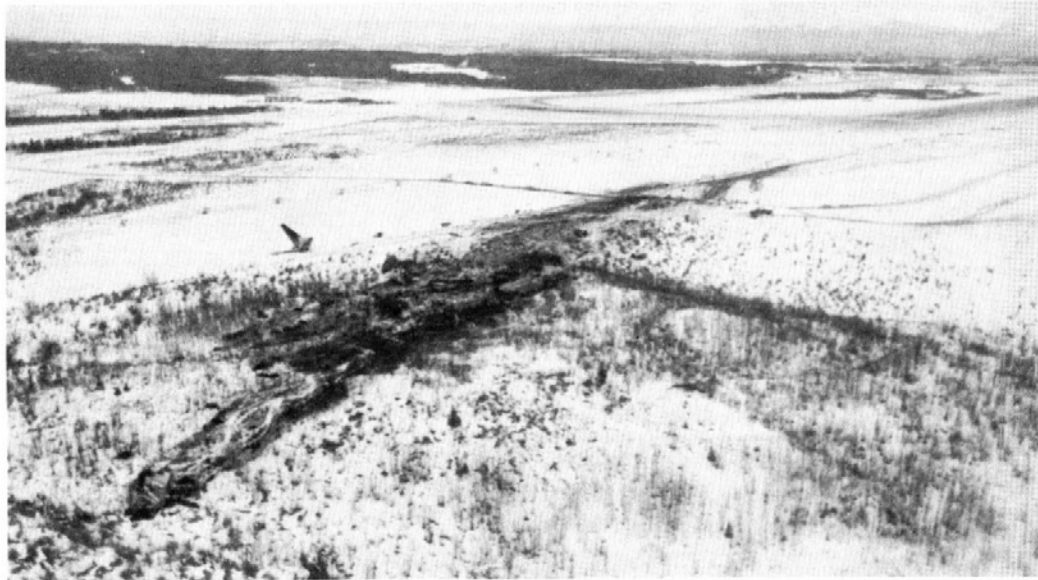
VIEW OF WRECKAGE SITE

The aircraft first struck the ground about 1,031 ft past the departure threshold of runway 24L and about 179 ft left of the extended runway centerline at an elevation of 124 ft. After initial impact, the aircraft continued to travel on a southwesterly heading which diverged to the left of the extended runway centerline. The aircraft crossed the airport access road without marking it and struck rising terrain at an elevation of about 140 ft. The aircraft broke up at that point.

of the ground marks was about 230°. The wreckage area was about 1,670 ft long and 390 ft wide. No aircraft components or wreckage were found outside this area.

The fuselage and wings broke into several major sections; the engines separated from the wings; and the landing gears separated from the attaching structures. The flaps were extended 21° to 23°; the leading edge slots were open; the spoiler panels were locked down; the stabilizer was set 4.44° aircraft noseup; the rudder was displaced 7.5° to the right; and the landing gears were retracted.

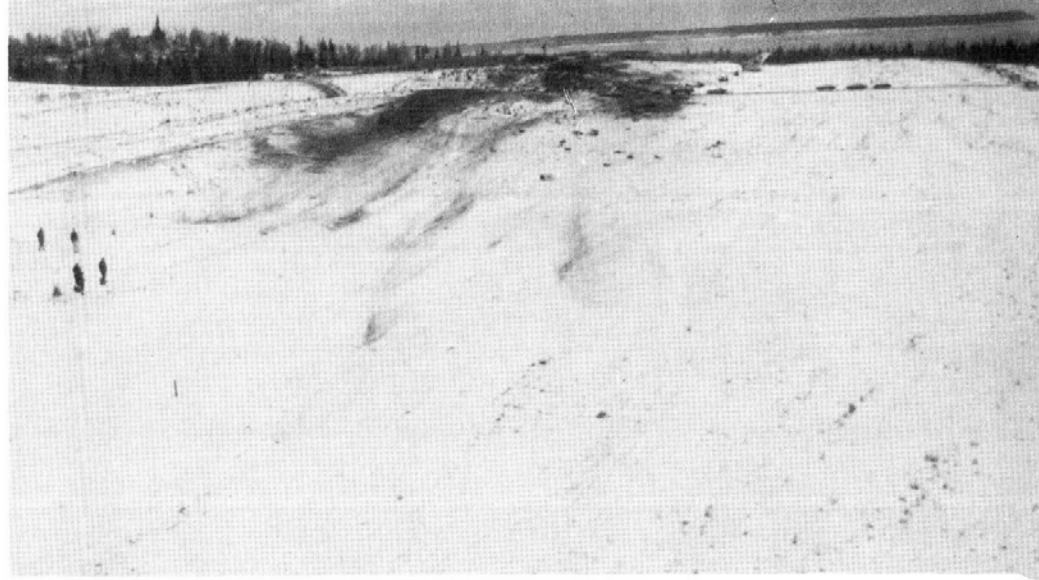
VIEW OF INITIAL IMPACT

The initial impact mark was V shaped which widened to about 12 ft before it lost definition. A short distance past that point a ground scar had been made by the No. 4 engine. A mark made by the No. 3 engine appeared, followed successively by marks from the No. 1 engine, No. 2 engine and the left wingtip. The magnetic bearing of the centerline

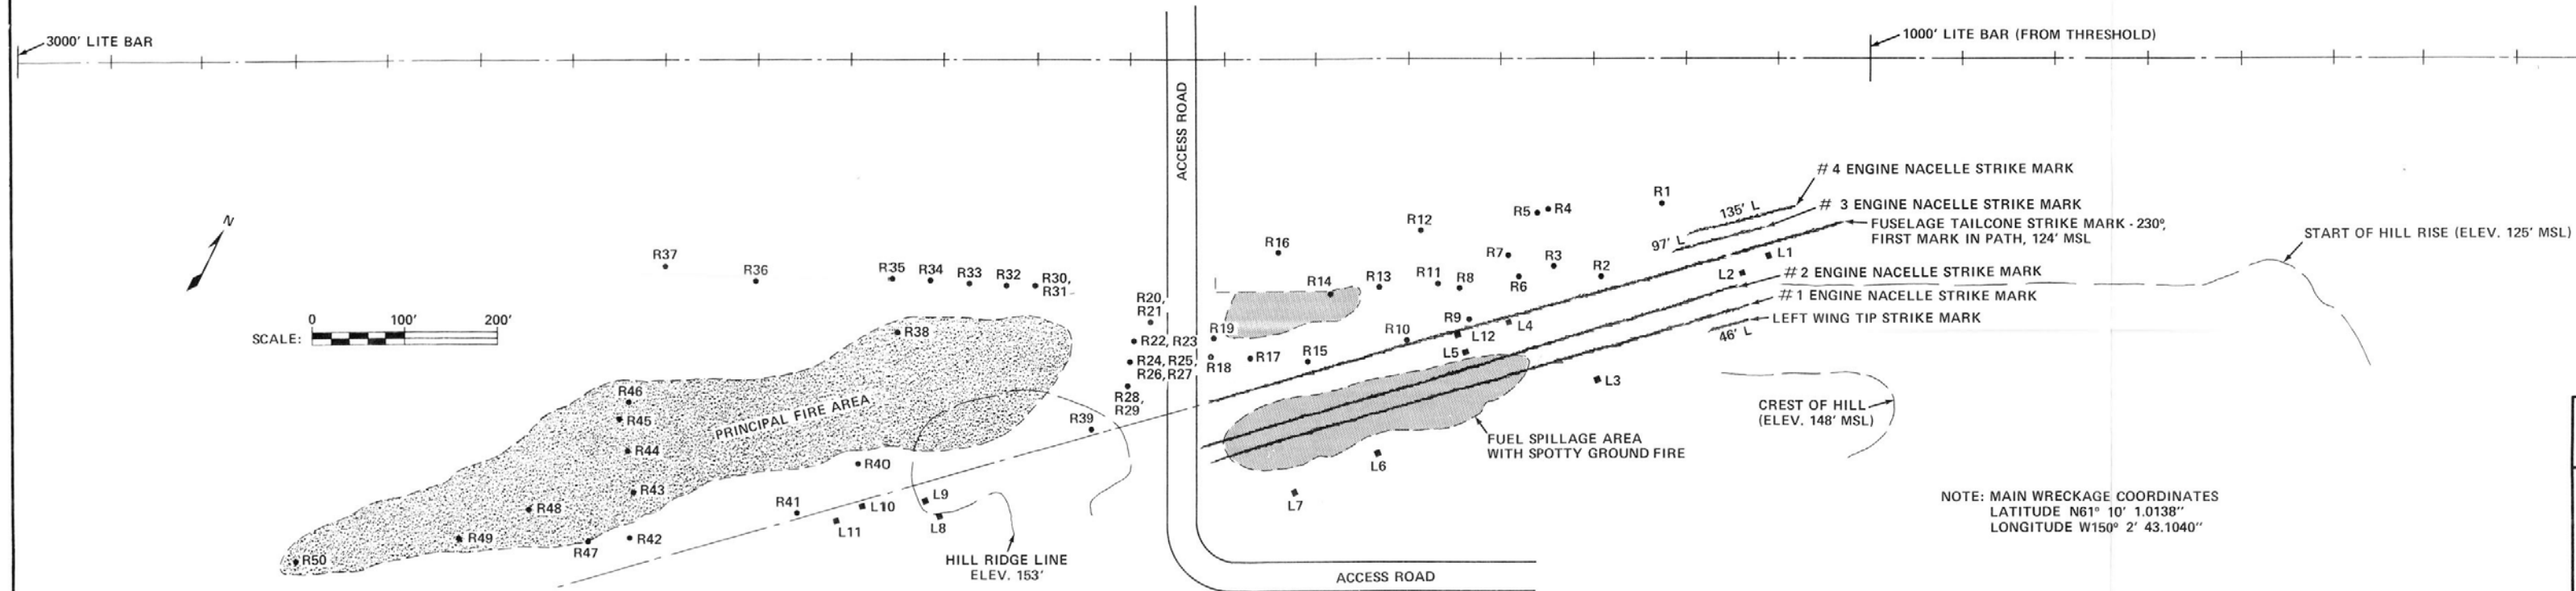
WRECKAGE DISTRIBUTION CHART
JAPAN AIRLINES COMPANY, LTD.
DC-8-62F, JA8054
ANCHORAGE INTERNATIONAL AIRPORT
ANCHORAGE, ALASKA
January 13, 1977

The terrain from the departure end of the runway to the airport perimeter road about 750 ft past the end of the runway was relatively level. About 225 ft left of the threshold lights, the terrain slopes up to a crest of 148 ft about 1,000 ft past the departure end of runway 24L. There is another crest 153 ft high about 1,800 ft past the departure end of the runway and 360 ft left of the extended runway centerline. The aircraft struck both of these crests after initial impact. (See Appendix E.)

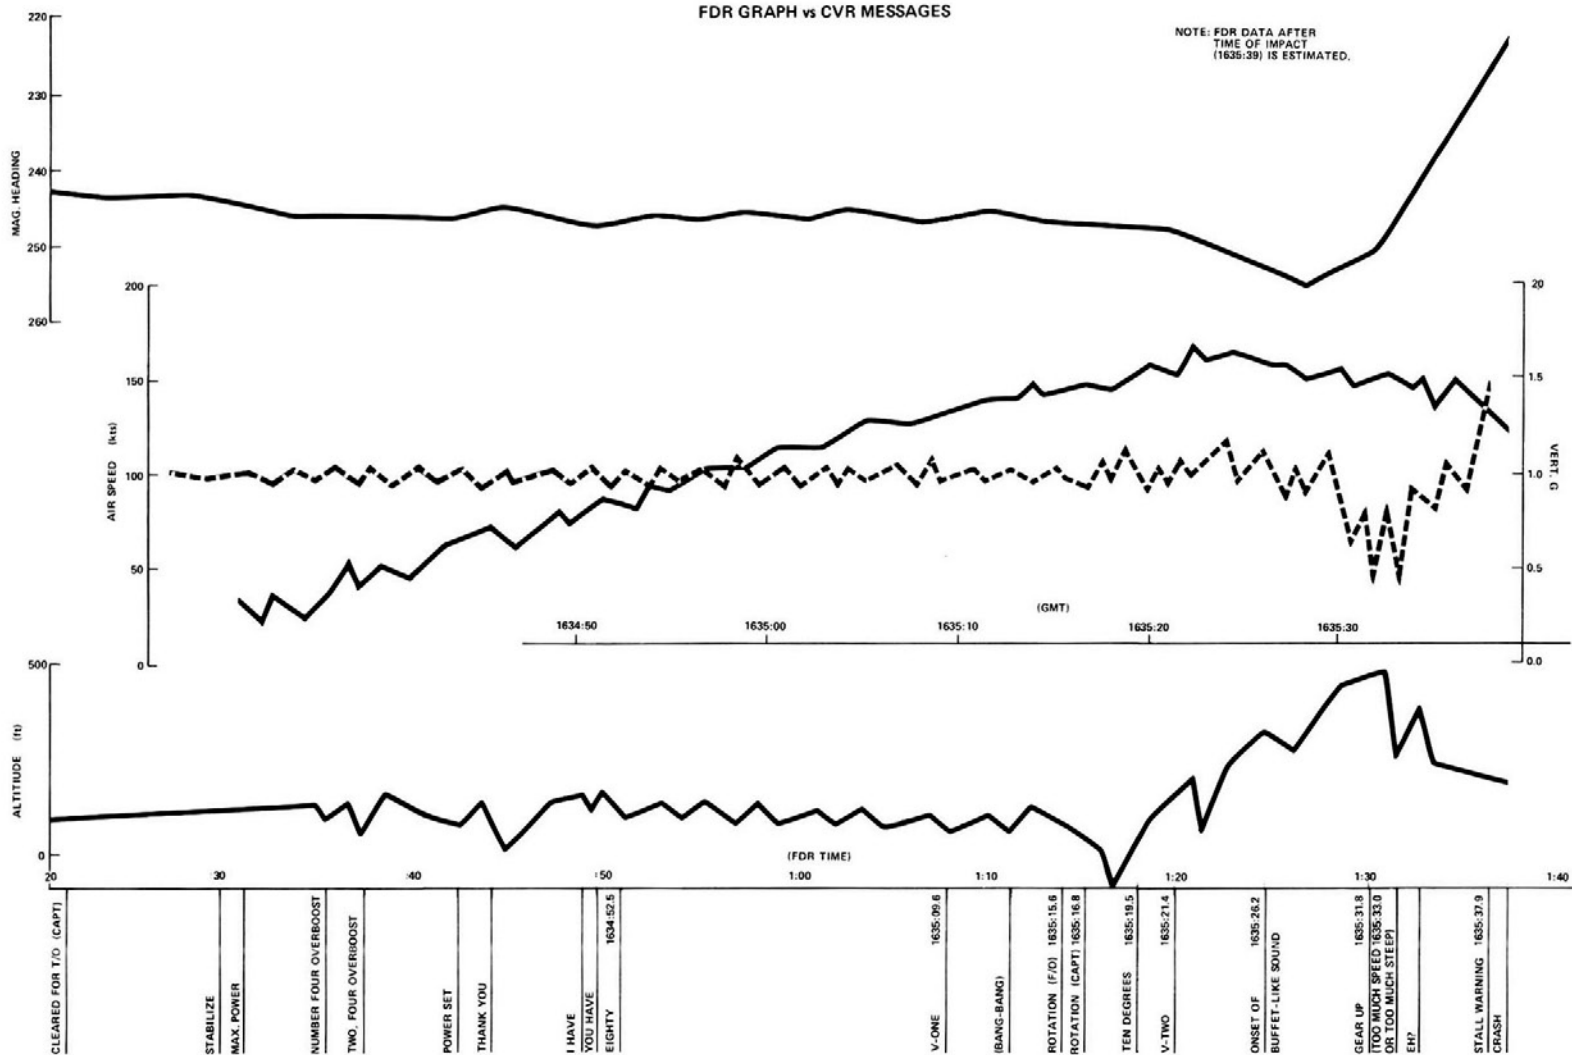
JA8054 ANC ACCIDENT
FDR GRAPH vs CVR MESSAGES

Rotation was probably initiated when the first officer called V_R . Based on the performance evaluation and the computer simulations, the Safety Board believes that the subsequent slow acceleration resulted from rotation to about 15° after liftoff, a higher-than-normal pitch attitude. As aircraft performance deteriorated, the situation was

probably worsened when the angle of attack was increased to about 18°. The subsequent loss of altitude and airspeed, and reduction in aircraft pitch attitude were typical of the performance characteristics of the DC-8-62F in a stalled condition.
