Crashed short, National Airlines, Inc., B-727-235, N47MNA, Escambia Bay, Pensacola, Florida, May 8, 1978

AIRCRAFT ACCIDENT REPORT

**NATIONAL AIRLINES, INC.,
BOEING 727-235, N4744NA
ESCAMBIA BAY
PENSACOLA, FLORIDA**

MAY 8, 1978

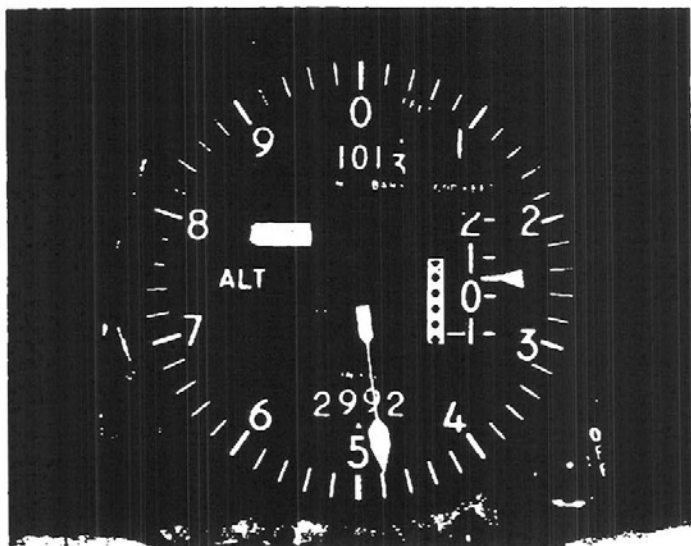
Figure 1. Kollsman Drum Pointer Altimeter

The captain's and first officer's instrument panels were equipped with Kollsman P/NA-41869-10.21 drum-pointer type barometric altimeters. (See figure 1.) This altimeter has a range from +50,000 ft to -1,500 ft. Hundreds of feet are indicated by a radial pointer, and thousands of feet are indicated on a rotating drum visible through a slot on the face of the instrument. A white crosshatch is painted on the left side of the drum adjacent to the numbers from +1,000 ft to -1,500 ft to increase the conspicuity of the lower altitude values.

The captain and first officer testified that they misread their barometric altimeters during the latter stages of the descent after they were cleared to descend from 1,700 ft.

The captain said that he misread his altimeter at 500 ft and believed he saw 1,500 ft. He stated that "When that figure got on my mind as I ran my scan after that, I was seeing 400 and 300 and they were 14 and 13 in my mind. I was looking at the needle instead of looking at the 1,000-foot marker in it. I didn't actually look at the thousand-foot pointer at that time. I just glanced down at the hundred-foot pointer."

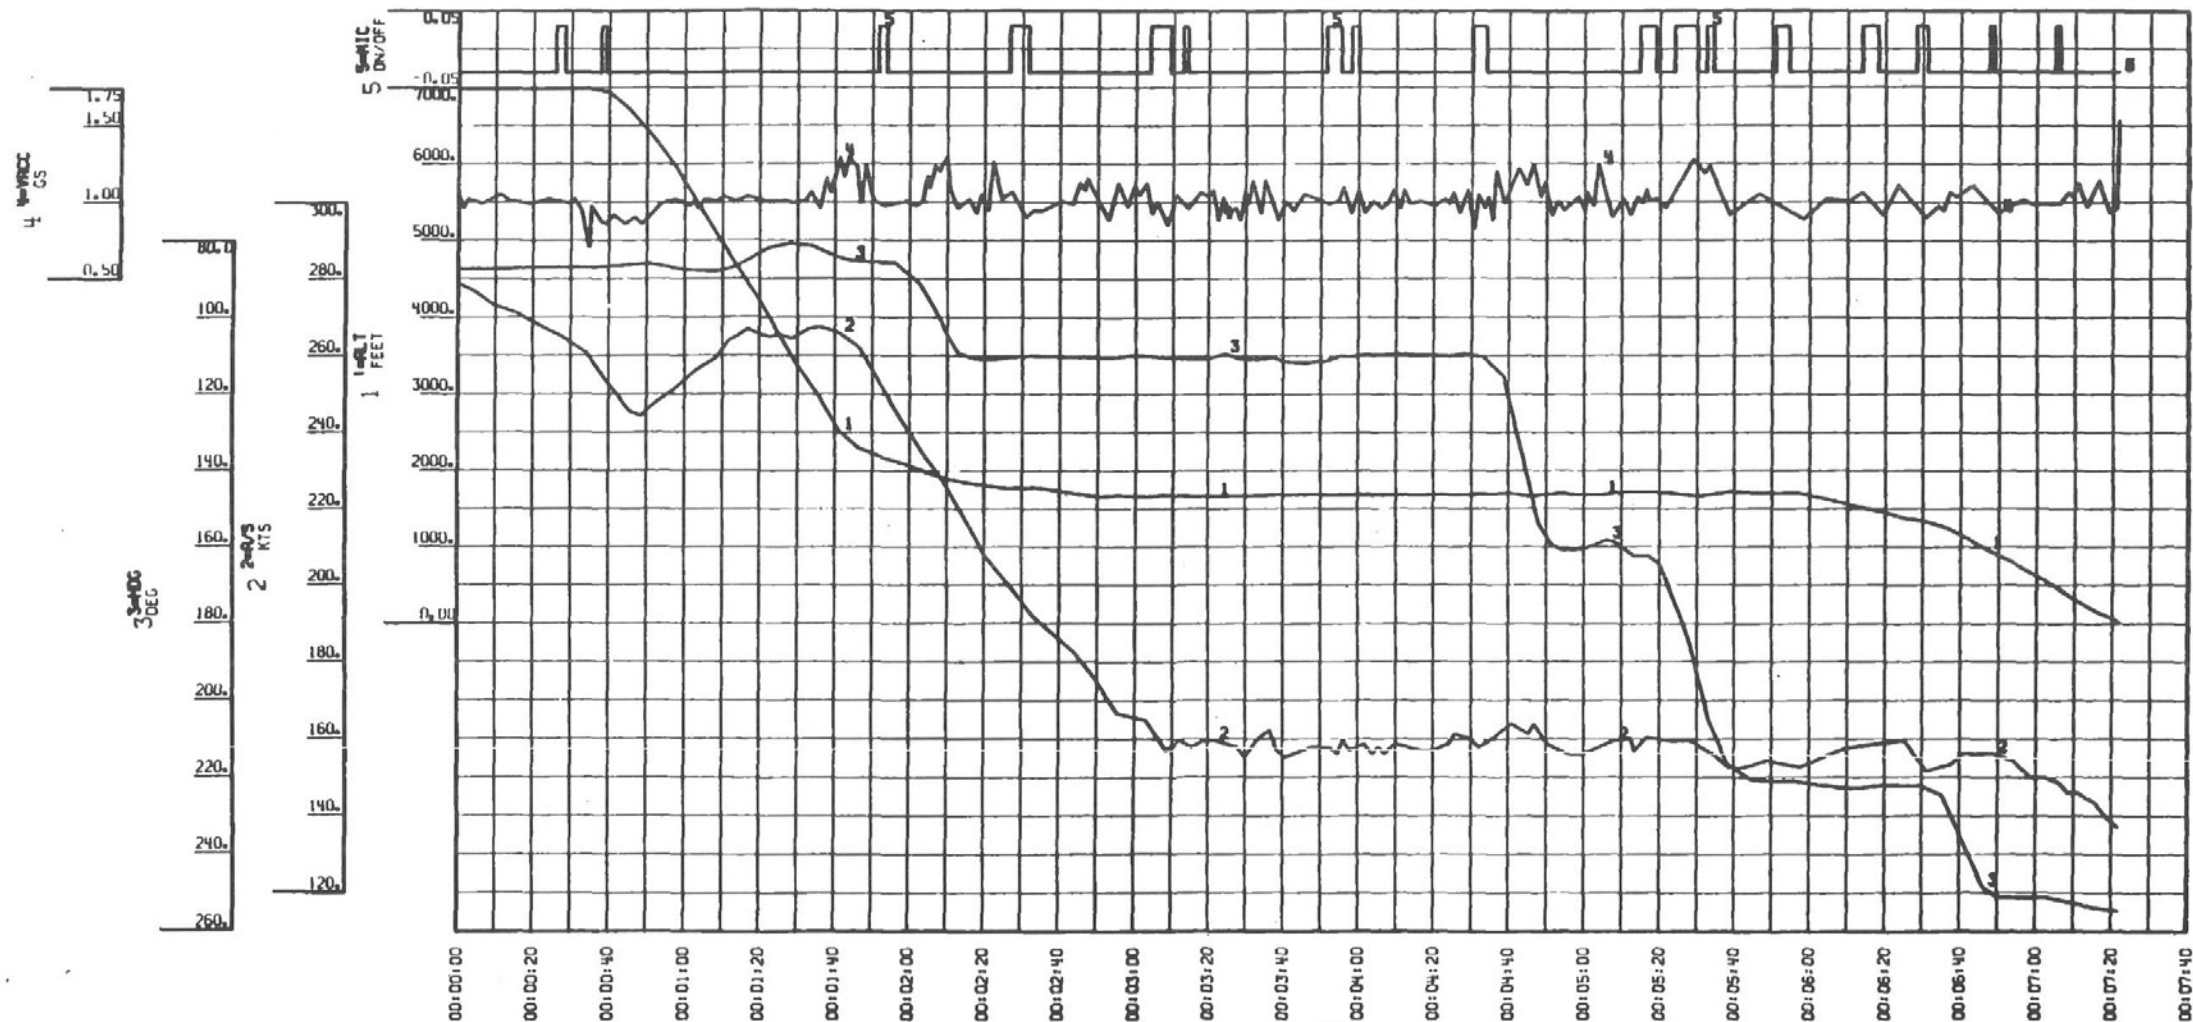
APPENDIX D

N4744 was equipped with a Sundstrand Data Control model F-542 flight data recorder (FDR), serial No. 1044. The recorder showed no outward evidence of damage. The foil recording medium was not damaged; all parameter and binary traces were present and active with no evidence of recorder malfunction or recording abnormalities. A readout was made of the final 7 min 22 sec of the recorded traces beginning at a point 35 sec before the start of descent from 7,000 ft. (See Appendix D.)
