## **In-flight upset, Aeromexico, DC-10-30, XA-DUH, over Luxembourg, Europe, November 11, 1979**

## **AIRCRAFT INCIDENT REPORT**

**AEROMEXICO  
DC-10-30, XA-DUH  
OVER LUXEMBOURG, EUROPE  
NOVEMBER 11, 1979**

**NTSB-AAR-80-10**

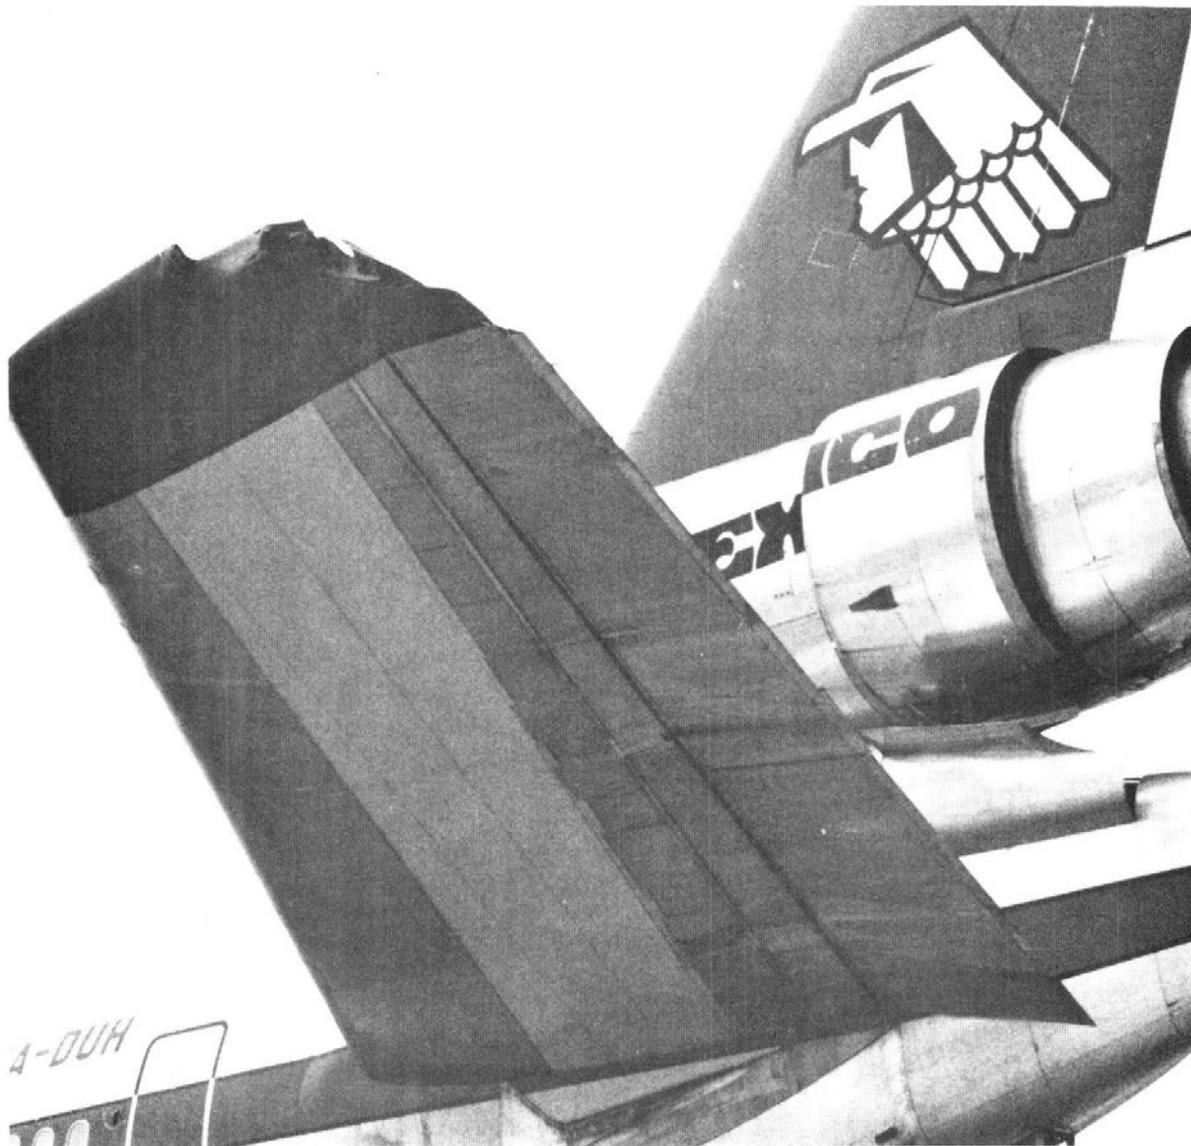
The aircraft damage was confined to both aircraft outboard elevator tips and related counterweights and the tail lower area access door. (See figures 1 and 2.)

Figure 1.--View of left outboard elevator tip.

Approximately 4 ft of the outboard ends of both outboard elevators were missing and had separated at almost identical locations. The approximate line of separation connected the trailing edge channel at Station XE 436 to the elevator spar at Station XE 455. The elevator outboard hinge fitting mounted on the elevator spar and the eyebolt mounted on the hinge fitting had separated with the outboard end of the elevators. Visual examination of the fracture surfaces on the elevator showed no indication of prior cracking. The fracture surfaces were clean and bright with smearing on some portions of the sheet metal surfaces.

The left outboard elevator hinge fail safe "A" frame attached to the horizontal stabilizer sustained minor damage. Scrape marks a few thousandths of an in deep were evident in the bore and flange of the bushing. The outboard lug of the two lugs on the outboard hinge "A" frame was broken about 1 in forward of the elevator hinge line. The inboard lug was bent inboard approximately 1/8 in, and

The tips of both the right and left elevators separated similarly indicating that the failures were produced by a symmetrical loading condition. The evidence indicated a torsional buckling failure of the elevator skin and an aft bending failure of the spar. Smearing on some of the sheet metal fracture surfaces was consistent with a cyclic load application.

12. The stall buffet which was encountered as the aircraft approached and entered the stall produced a dynamic load on the elevator balance weights which resulted in structural overload and failure of the outboard elevator tips.

The aircraft's left and right outboard elevator and the fuselage tail lower area access door were replaced and the aircraft was flown to Mexico City, on November 16, 1979, where it again went through a detailed inspection in accordance with AEROMEXICO's Approved Inspection and Maintenance Program. No discrepancies were found during the examination and testing of the aircraft. Later, it was released for scheduled line flight operations.

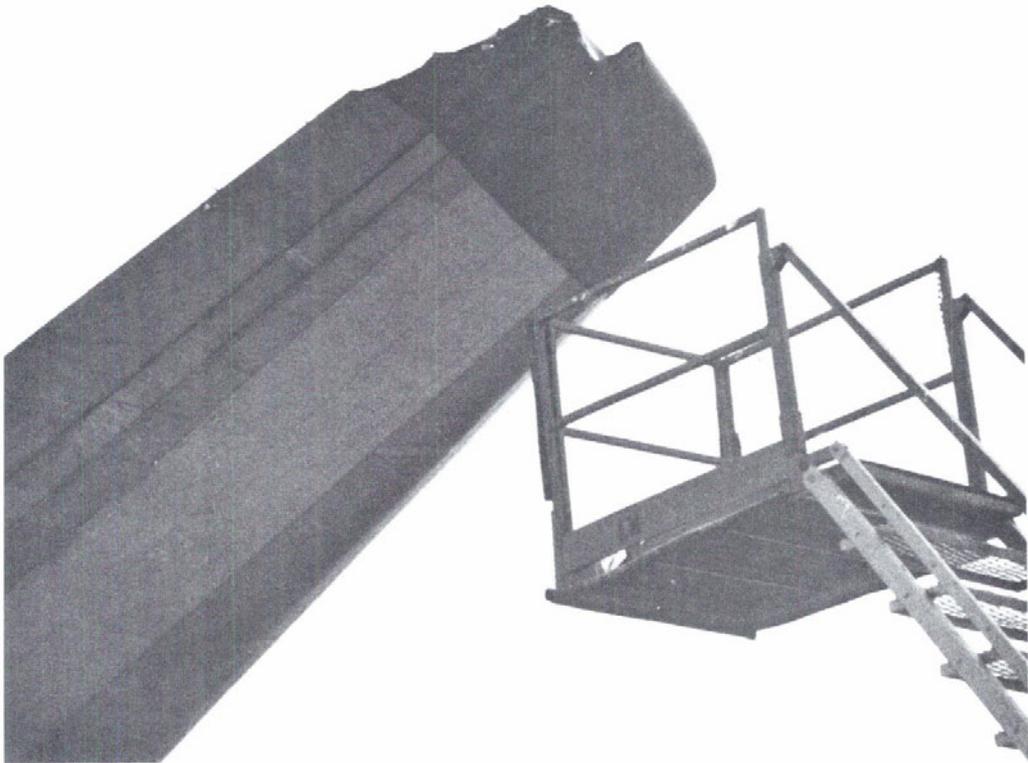
Figure 2.--View of right outboard elevator tip.

The right outboard elevator outboard hinge fail safe "A" frame attached to the horizontal stabilizer was broken about 2 in forward of the hinge line. No indication of prior cracking was evident. The outboard lug of the two lugs on the outboard hinge "A" frame was broken about 2 in forward of the hinge line. No indication of prior cracking was evident. The inboard lug was bent inboard about 1/2 in. A scrape mark approximately .005 in deep was observed on the outboard side of the inboard lug. The scrape mark extended from the edge of the hinge hole to the upper edge of the lug. The horizontal stabilizer tip fairing had two small buckles about .060 in deep and 2 in long located just forward of the aft closing rib. The aft edge of the fairing was bent outboard approximately 1/16 in and an impact mark was evident on the aft edge of the fairing.
