# **NATIONAL TRANSPORTATION SAFETY BOARD**

## **AIRCRAFT ACCIDENT REPORT**

**WORLD AIRWAYS INC., FLIGHT 32,  
MCDONNELL DOUGLAS DC-10-30CF, N112WA,  
OVER NORTH ATLANTIC OCEAN  
SEPTEMBER 20, 1981**

**NTSB-AAR-82-1**

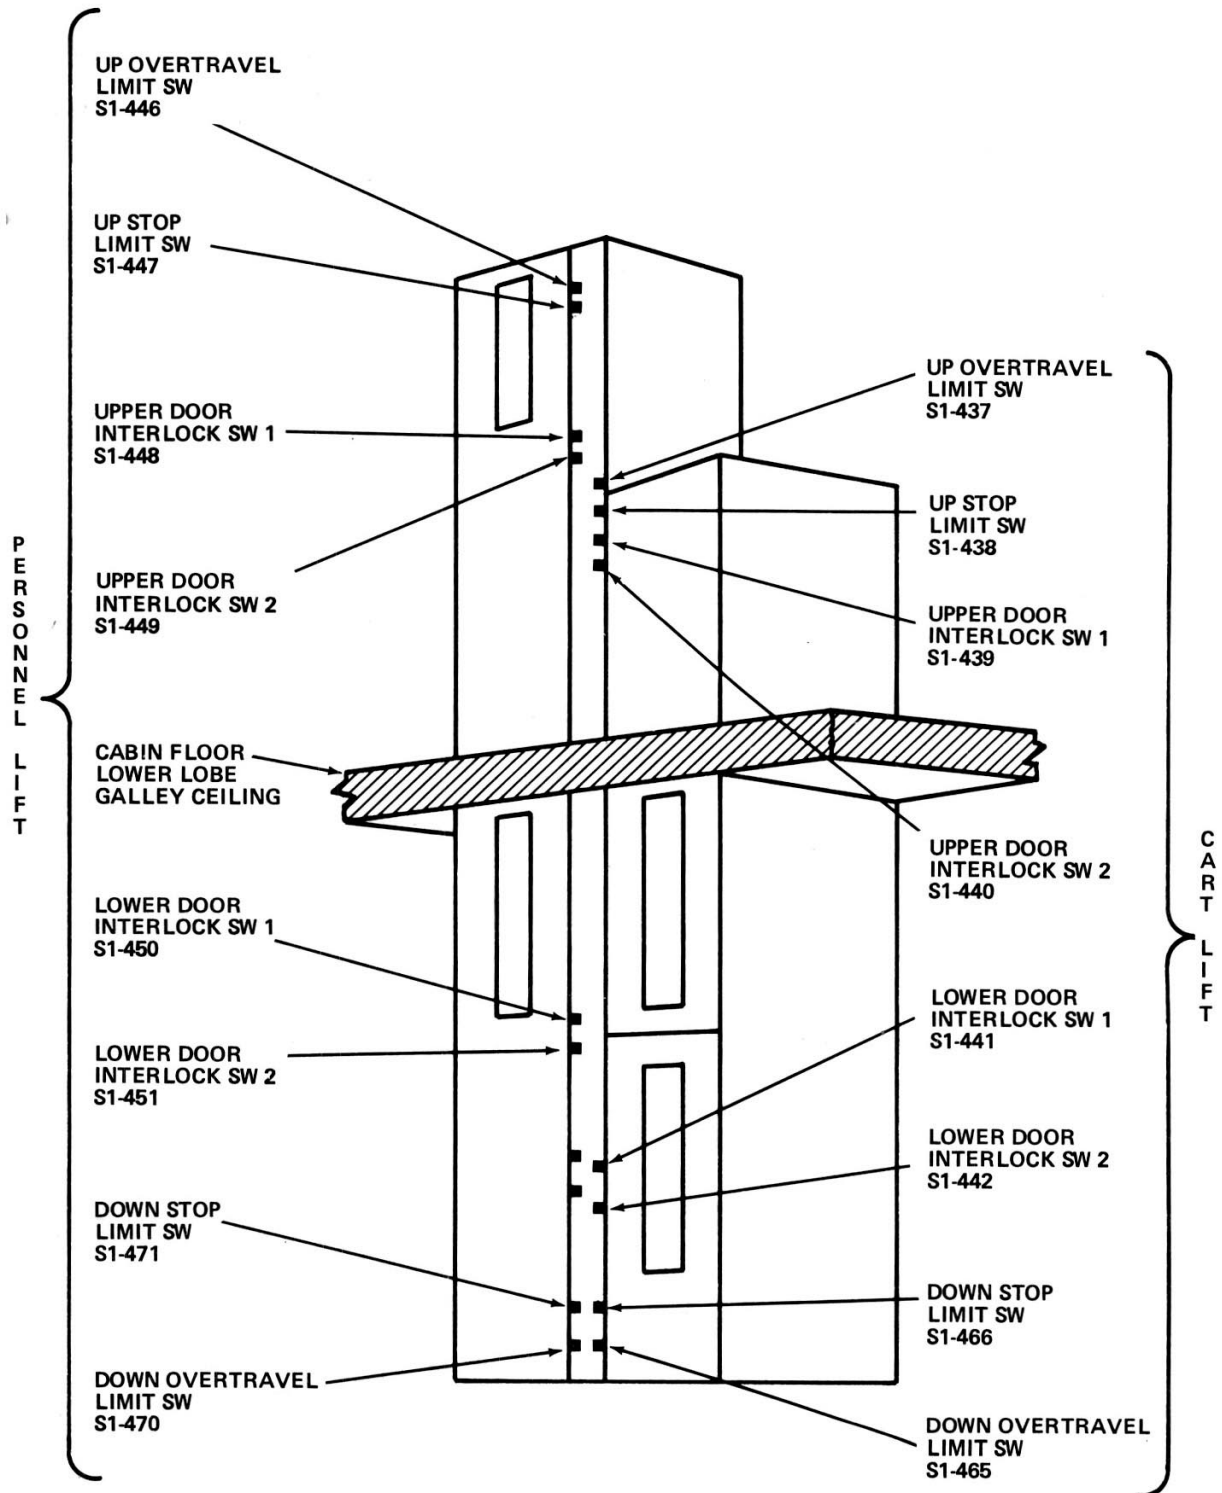
Figure 1.--Galley lift system with electrical switch locations.

Limit Switches - The range of travel of the lifts is controlled by limit switches installed within the wire duct attached to the forward side of one of the vertical lift tracks. There are two sets of two limit switches for each lift; one set located in the service center and one set in the lower galley. One switch is a normal stop switch and the other limit switch is for overtravel in the event the normal switch fails to operate. The limit switches are actuated by a cam plate mounted on the side of the lift. The cam plate has a machined offset to prevent actuation of the overtravel limit switch unless the normal switch fails to operate. In addition to the limit switches, mechanical stops are installed in the vertical lift tracks to stall and shut off the gear motors if both limit switches malfunction. (See figure 1.)

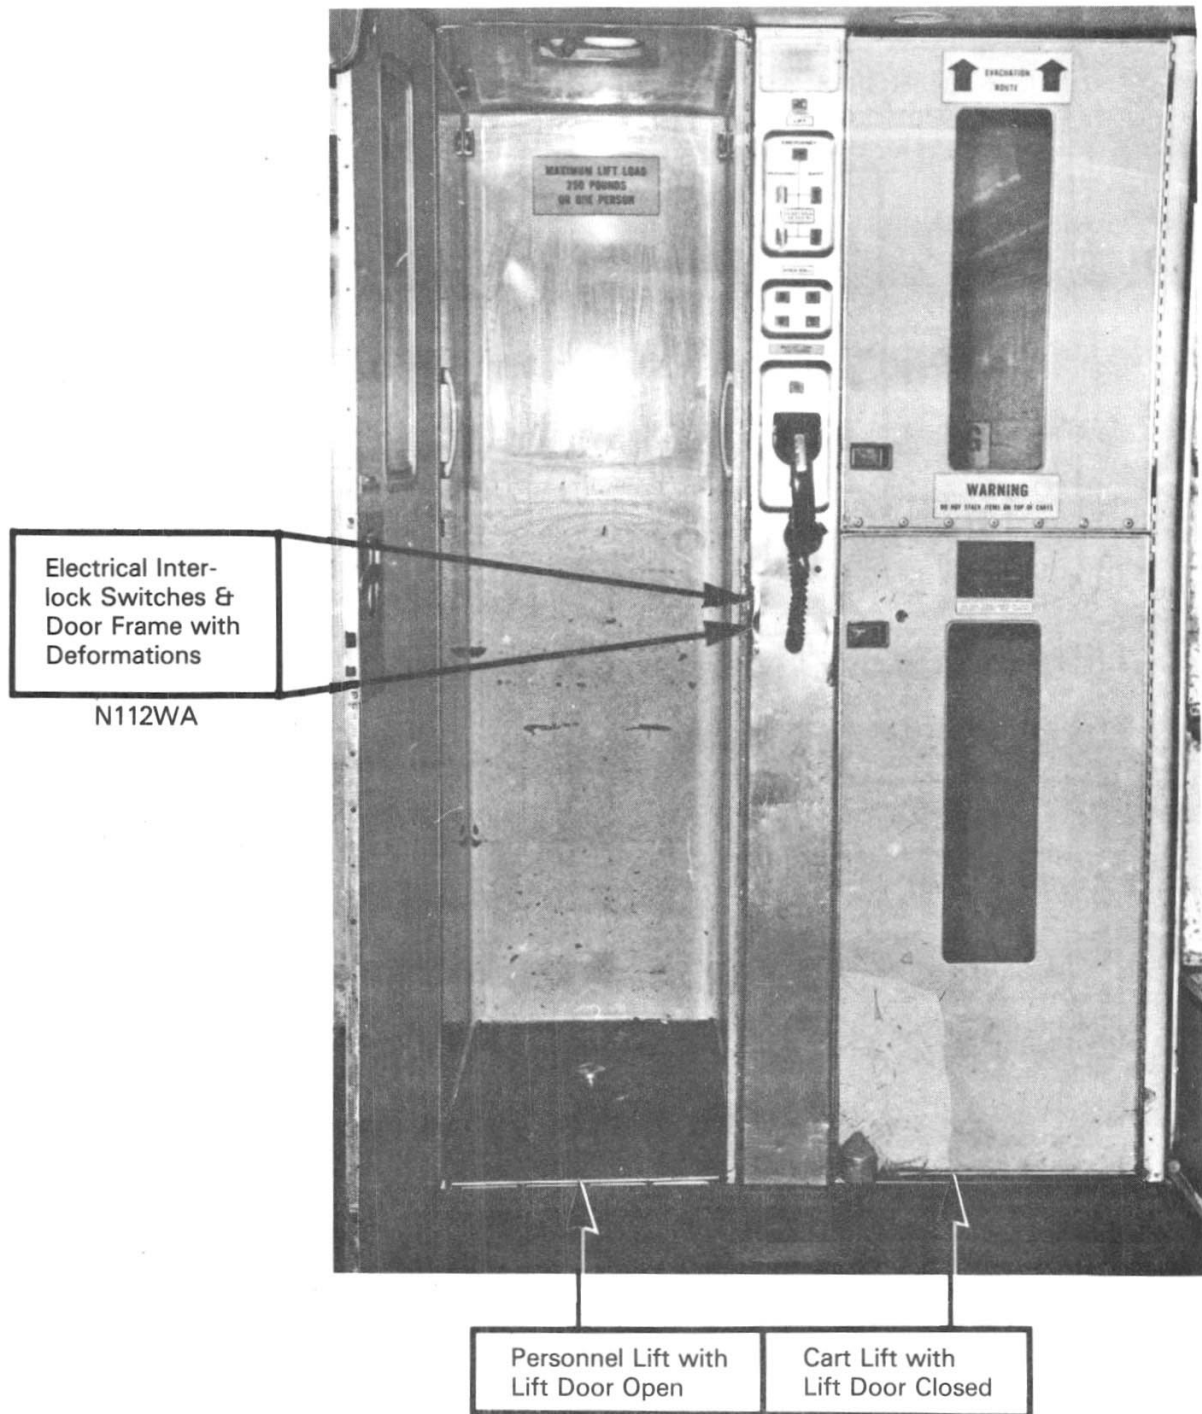
Figure 2.--Personnel and cart lifts.

The lower galley personnel lift door frame was deformed and battered in the area where the electrical interlock switches are mounted (see figure 2). The uppermost electrical interlock switch on the lower galley personnel lift door, S1-450 (see figure 1), was found with the switch roller assembly twisted and the roller striker arm jammed in the depressed (switch closed) position. The damage to the lower galley lift door frames was the result of repeated bumping by food and liquor carts.

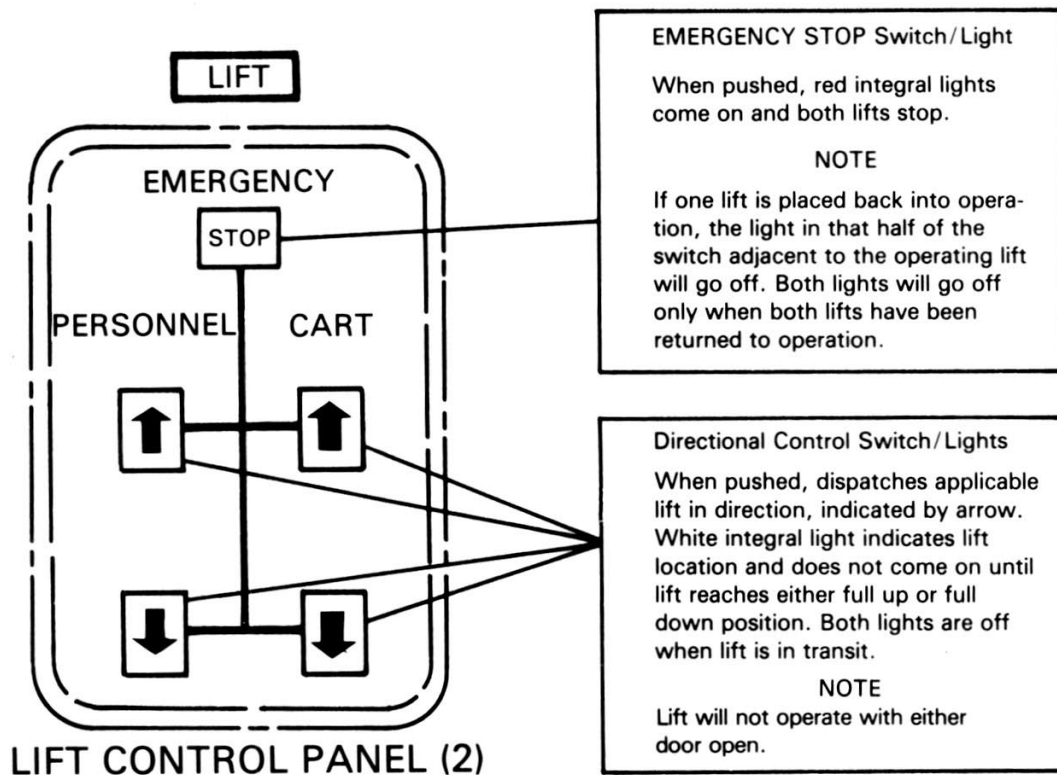
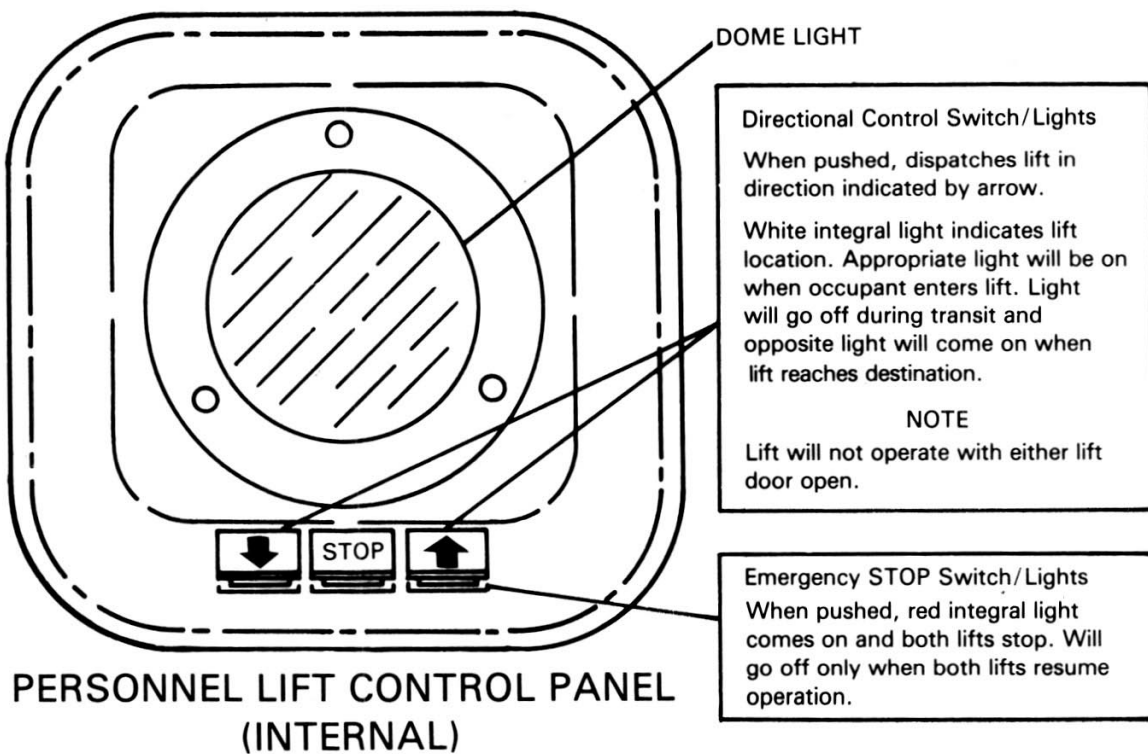
Figure 3.--Galley lift controls and indicators.

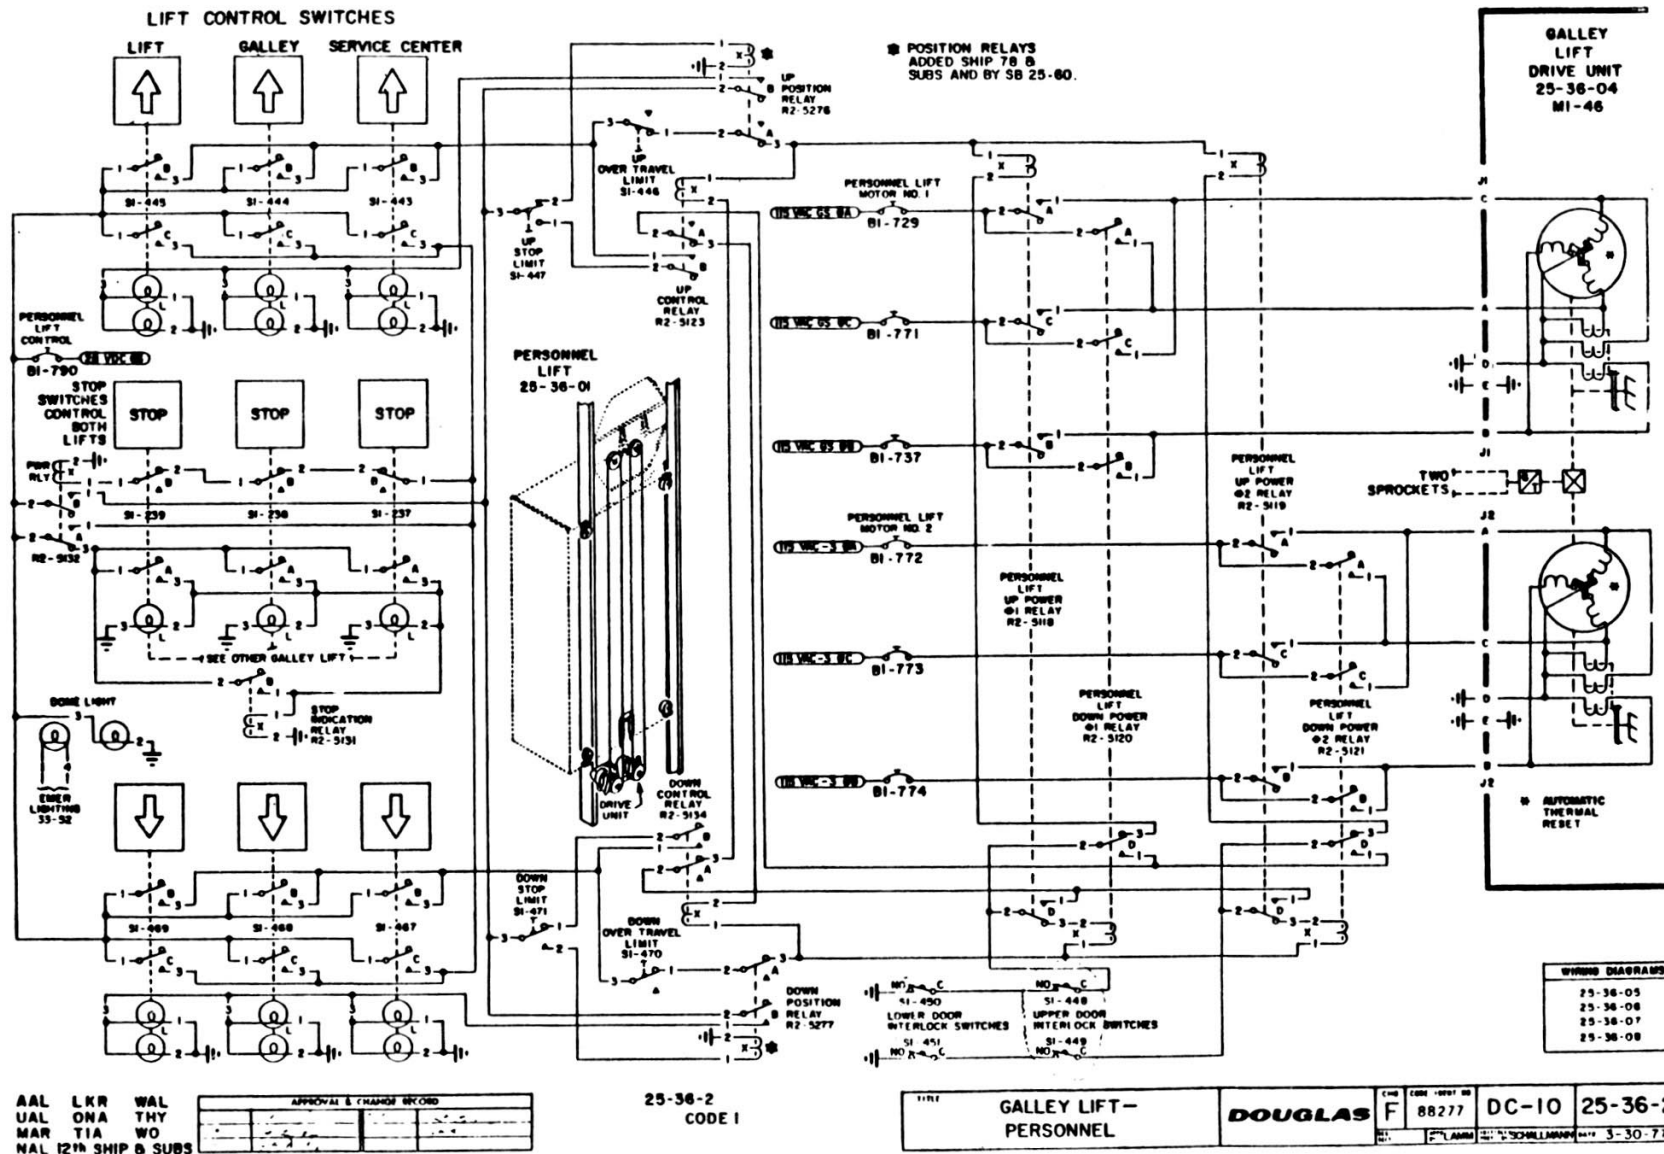
Figure 4.—Electrical diagram of galley personnel lift system.

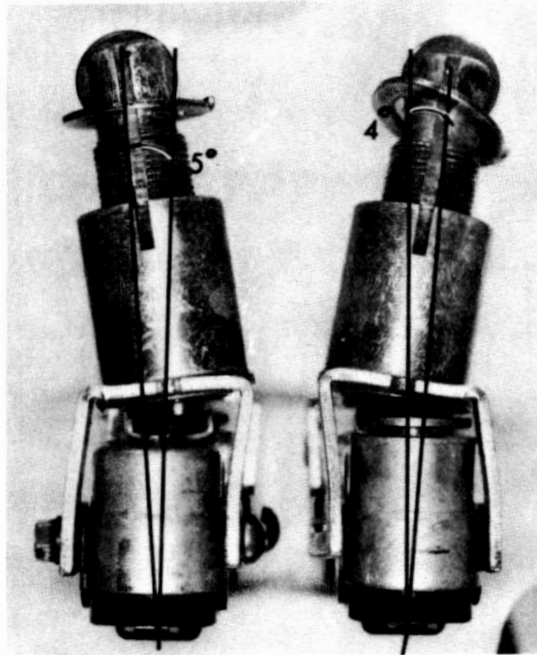
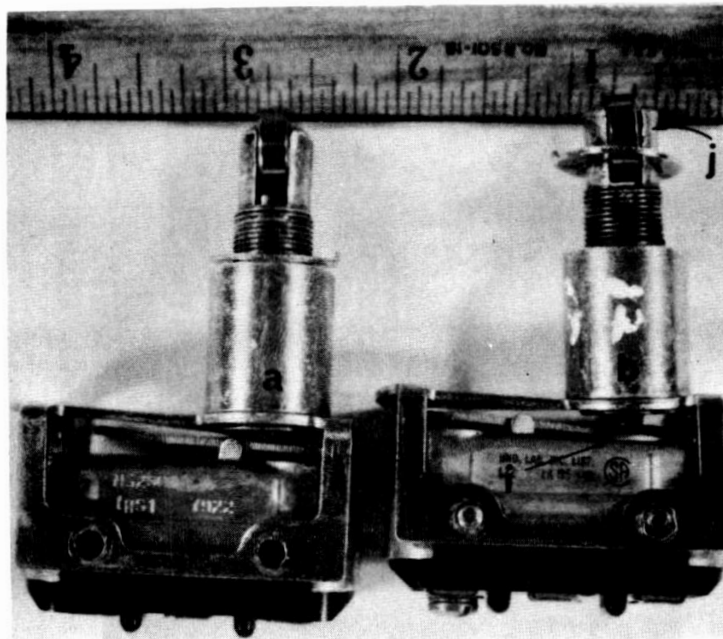
Examination of the two personnel lift door interlock switch assemblies in the lower galley disclosed that the support brackets were bent. The bends were in a rearward direction and were 5° from centerline for the upper switch (S1-450) and 4° from centerline for the lower switch (S1-451). (See figures 5 and 6.)

Figure 6.--Side view of S1450 (a) and S1-451 (b) switch assemblies, showing degree and directions of bending.
