Uncontained engine failure, Air Florida Airlines Inc., McDonnell-Douglas DC-10-30CF, N101TV, Miami International Airport, Miami, Florida, September 22, 1981

AIRCRAFT ACCIDENT REPORT

**AIR FLORIDA AIRLINES, INC.
McDONNELL-DOUGLAS, INC.,
DC-10-30CF, N101TV
MIAMI INTERNATIONAL AIRPORT
MIAMI, FLORIDA
SEPTEMBER 22, 1981**

NTSB-AAR-82-3

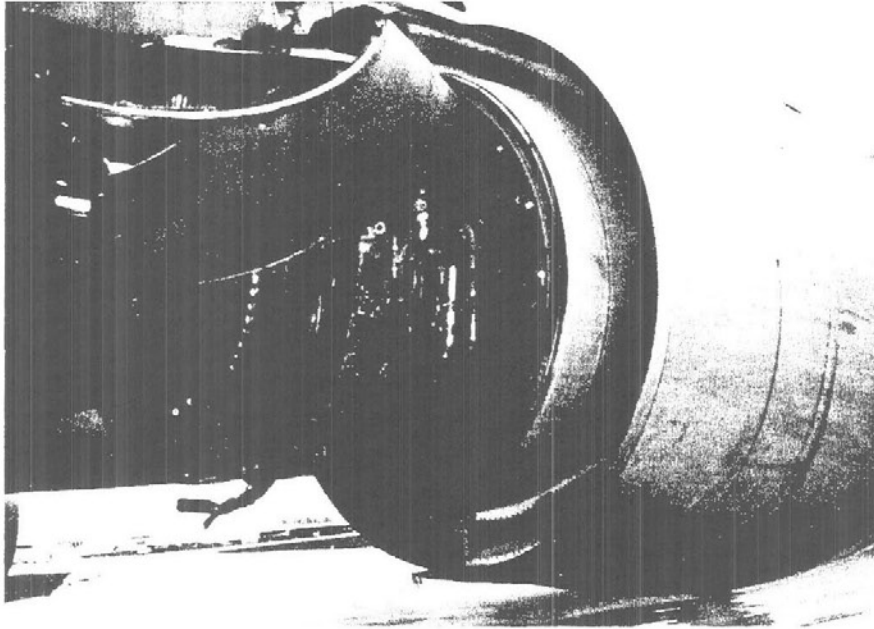
The low pressure turbine (LPT) casing, the stage 1 low pressure turbine rotor and the exhaust cone also separated from the engine. The exhaust cone was found on the runway. The low pressure turbine rotor had fragmented, and rotor fragments were found lodged in the right wing leading edge slat area, the left wing trailing edge flap area, and on the airport surface south of the centerline of runway 9L. One piece of the turbine rotor was found about 2,500 feet south of the runway centerline. The aircraft sustained about 30 penetrating strikes from high energy engine debris. Virtually all of these strikes were inboard of the No. 3 engine and aft of the plane of rotation of the failed stage 1 low pressure turbine rotor. (See figure 2.)

Figure 1.--Damaged No. 3 engine.

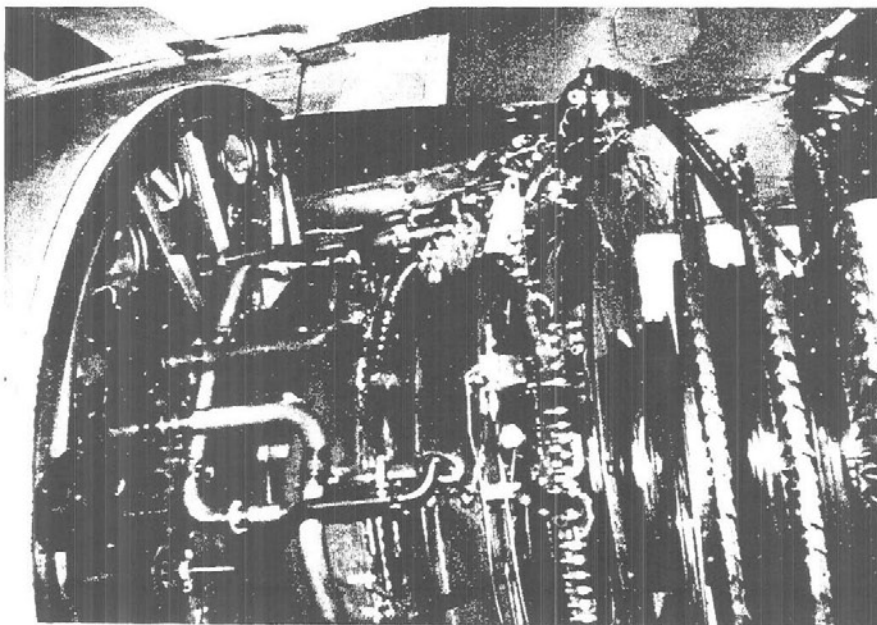
Figure 2.--Low pressure turbine section and missing stage 1 low pressure turbine disk.

Examination of the low pressure turbine rotor showed that the stage 1 low pressure turbine rotor had separated from the stage 2 low pressure turbine rotor and was missing. The stage 1 and 2 low pressure turbine rotors are attached to each other by 60 bolts. These bolts attached the aft spacer arm of the stage 1 low pressure turbine rotor disk to the rotating air seal and forward spacer arm of the stage 2 low pressure turbine rotor disk. The rotating air seal is a circular metal seal with 60 bolt tabs and fits between the forward and aft spacer arms of the two disks when the bolts are in place. All the bolt tabs on the rotating air seal of the stage 2 low pressure turbine disk through which the stage 1 to 2 connect bolts are inserted and fastened were bent forward. Five bolt hole tabs were broken off through the bolt holes and the flange was cracked in four places. The forward face of the seal's flange exhibited severe heat discoloration and there was a circumferential band of metal smears outside of the bolt holes. These smears varied in width from 0.189 to 0.375 inch. Two bolt holes had heavy side fretting on their forward face. The right hand side of the bolt tabs--viewed from the aft of the bolt tabs looking forward--had varying amounts of impact damage, some with smooth impressions.

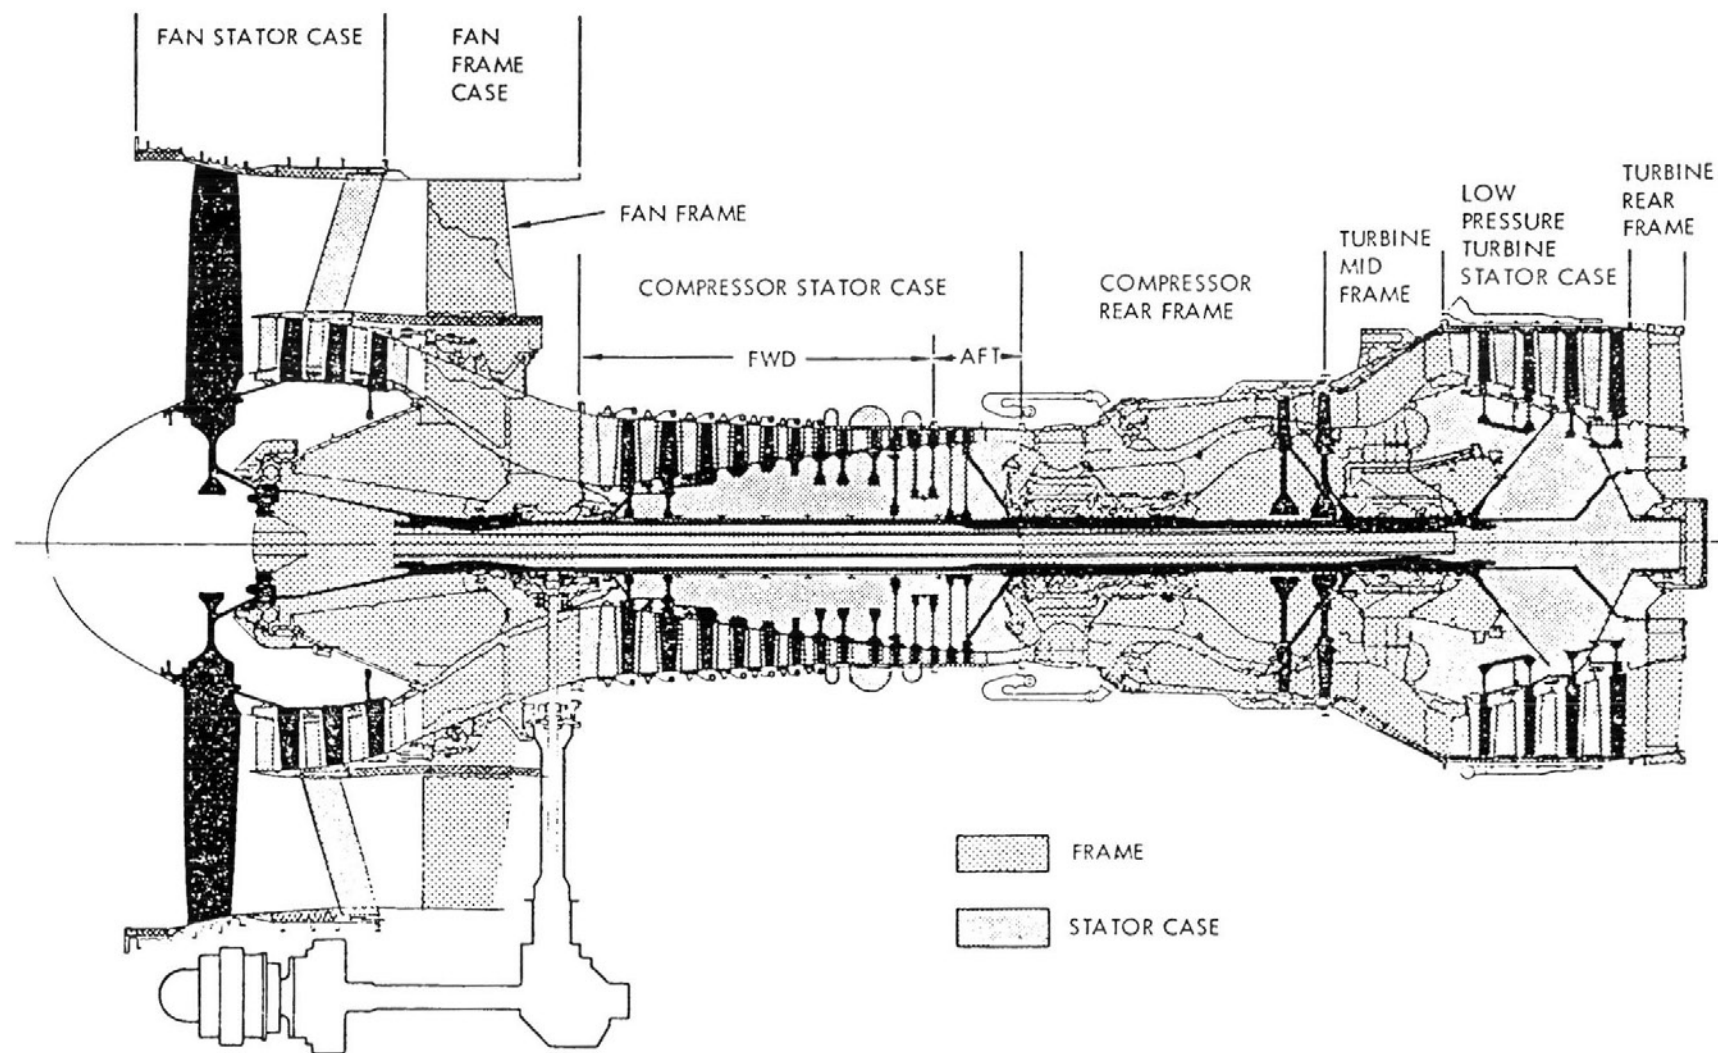
The examination showed that the major damage to the engine was incurred aft of the high pressure turbine section. The low pressure turbine stator assembly case had separated circumferentially along the flange attaching its forward end to the turbine mid-frame housing. This separation, located at engine station (ES) 294, was just forward of the plane of rotation of the stage 1 low pressure turbine rotor. The stator case separated fore and aft along the top of the engine; it tore horizontally above its outboard split flange and the forward one-third of the inboard split flange had separated. The stator assembly case had split into three large segments and numerous smaller segments which separated from the engine and fell to the runway. (See figure 3.)

Figure 3.--CF6-50/-45 frames and stator assemblies.

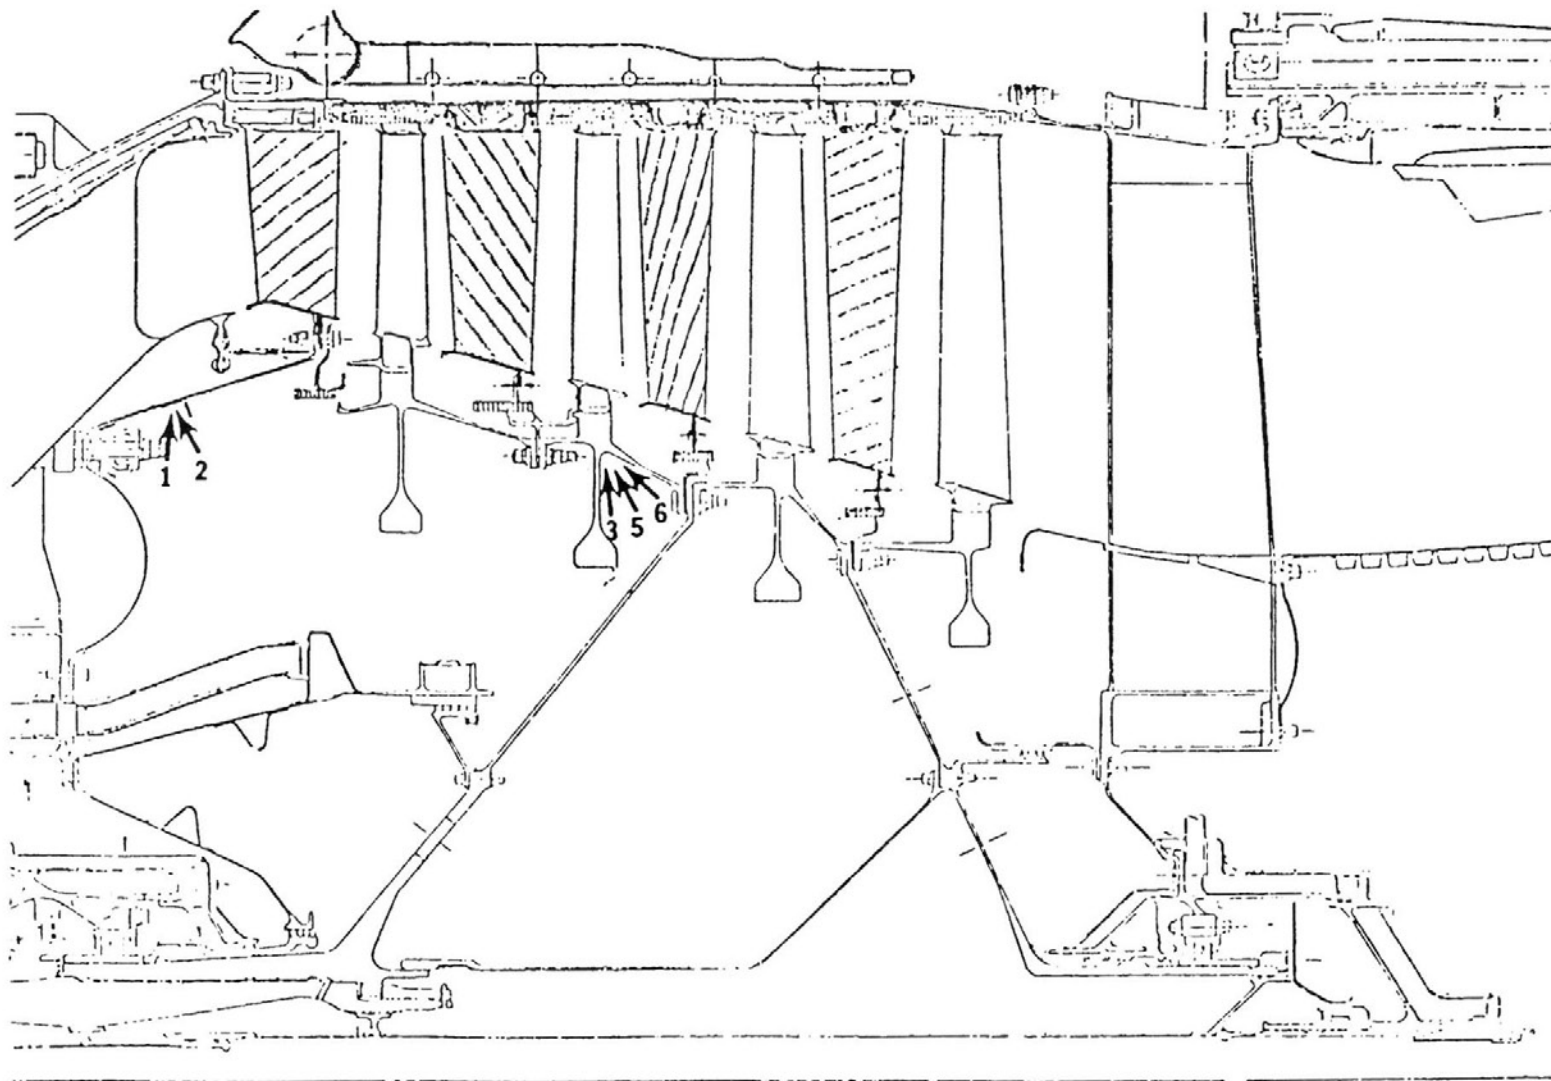
Figure 4

Six additional pieces of ferro magnetic material were found: one piece was found on the runway; three pieces were found in the low pressure turbine stage 2 rotor cavity; and two pieces were found in the low pressure turbine's stage 1 toroid cavity. EDAX analysis identified the material as M-50 alloy steel. All six pieces were severely battered and oxidized. Five of the six pieces were measured for thickness. One piece was too battered for thickness determination. The thickness of one piece ranged from 0.140 to 0.150 inches; one piece was 0.148 inches thick; and three pieces were 0.149 inches thick. (See figure 4.)

These six pieces were compared to a typical CF6-50 No. 5 roller bearing inner race which is manufactured from M-50 alloy steel. The specified thickness for this inner race is 0.146 inches to 0.148 inches. In addition, two of these six pieces had

Sketch of the low pressure turbine portion of CF6-50 engine S/N 455-123. After the low pressure turbine failure of this engine, six pieces of foreign material were recovered and submitted for examination. For identification purposes these six pieces were arbitrarily assigned numbers - #1 thru #6. Pieces #1 and #2 were found near the turbine mid frame stiffener (see arrows #1 and #2). Pieces #3, #5, and #6 (see arrows #3, #5, and #6) were found in the cavity formed by the Stage 2 low pressure turbine disk and the forward low pressure turbine shaft. Piece #4 was recovered from the runway near the location where the engine failure occurred.
