NATIONAL TRANSPORTATION SAFETY BOARD

AIRCRAFT ACCIDENT REPORT

**AIR FLORIDA, INC.
BOEING 737-222, N62AF
COLLISION WITH 14TH STREET BRIDGE,
NEAR WASHINGTON NATIONAL AIRPORT
WASHINGTON, D.C.
JANUARY 13, 1982**

NTSB-AAR-82-8

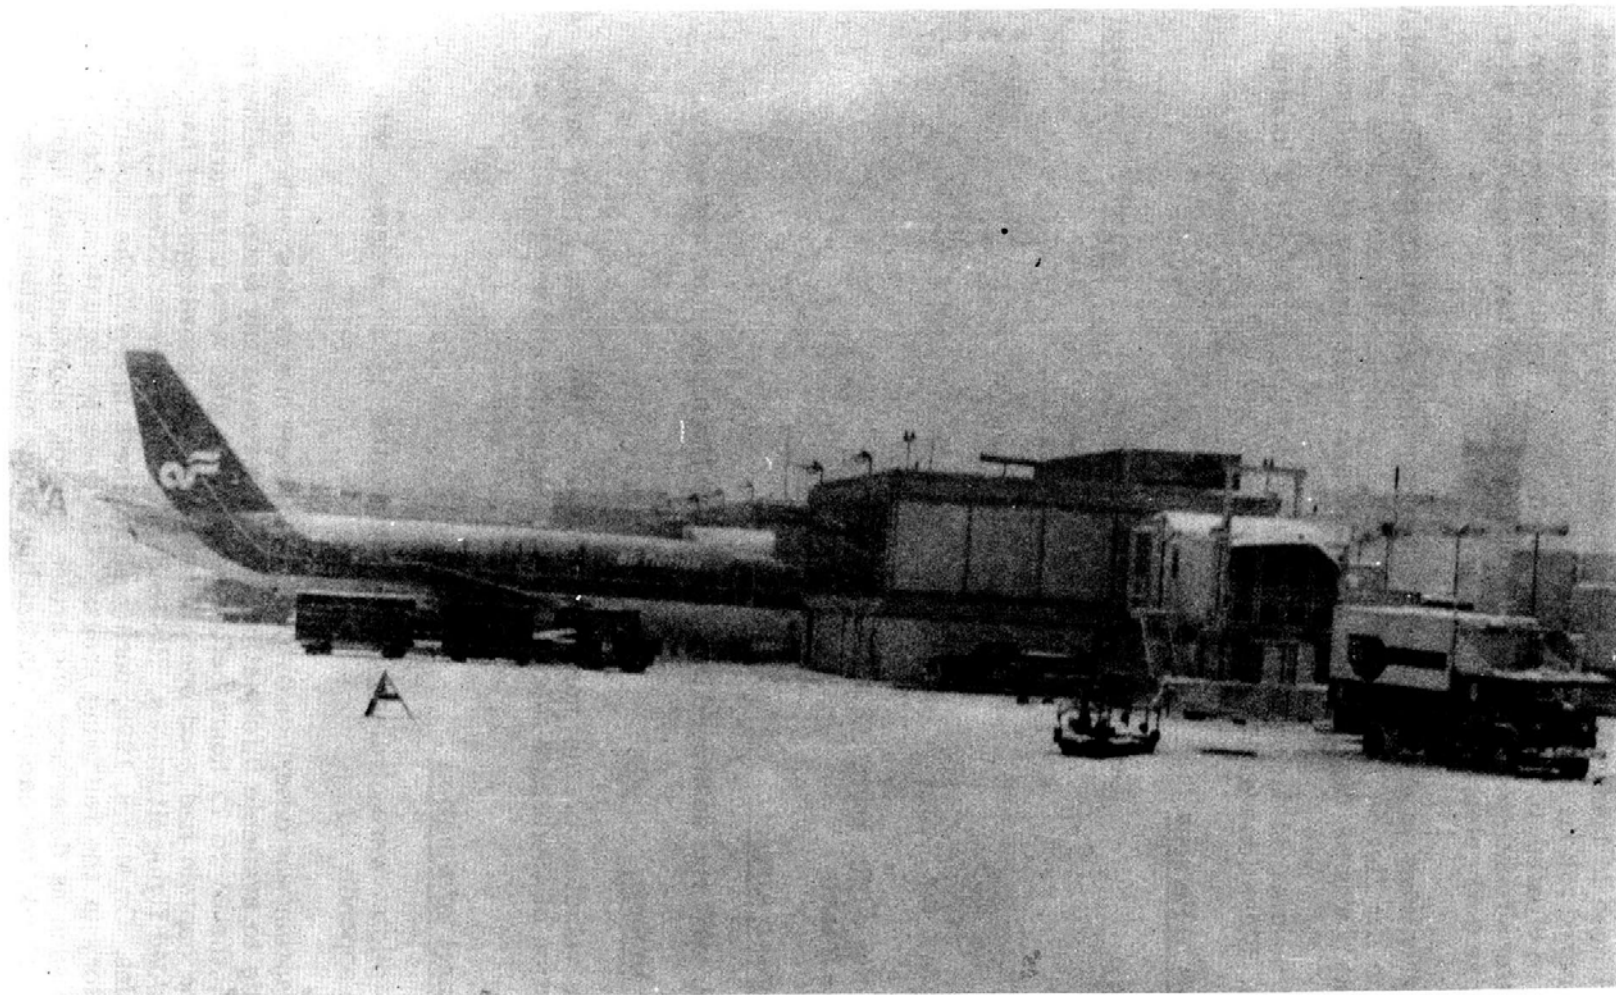
Figure 3.—Flight 90 between 1519 and 1524.

Between 1519 and 1524, a passenger on an arriving flight holding for gate space near Flight 90 saw some snow accumulated on the top and right side of the fuselage and photographed Flight 90. (See figure 3.)

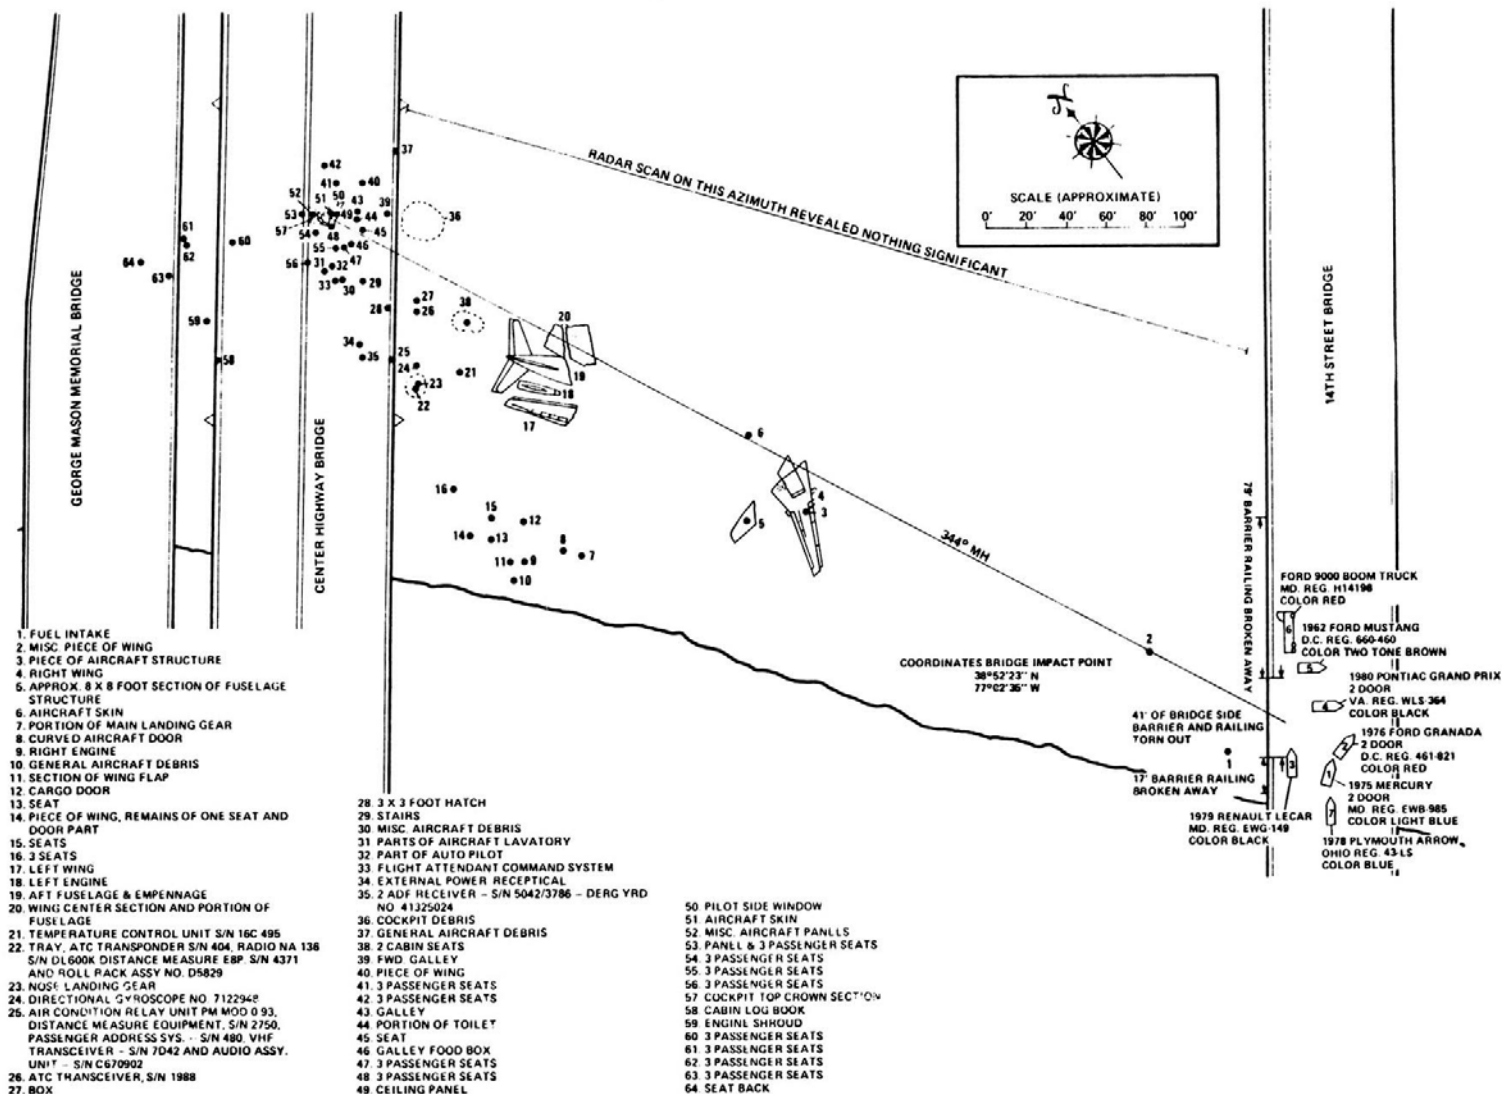
Figure 4. -- Position of Wreckage in the Water.

As the aircraft descended, the right wing was structurally damaged when it hit the boom truck, and shortly thereafter, the aircraft struck the steel barrier and railing on the west side of the 14th Street Bridge at an elevation of about 37 feet mean sea level. Fragments of the right wing remained on the bridge. The remainder of the wreckage sank in the Potomac River in about 25 to 30 feet of water. The wreckage area was confined to the south side of the river between the 14th Street Bridge and the Center Highway Bridge of the George Mason Memorial Bridge. (See figure 4.)

After initial impact, the aircraft broke into several major pieces. The fuselage broke into four major pieces which included: (1) nose section with cockpit; (2) fuselage section between nose section and wing center section; (3) fuselage-to-wing intersection; and (4) aft body structure with empennage attached. The wing structure was separated into three major pieces which included: (1) left wing outboard of the No. 1 engine, including all associated flight control surfaces; (2) wing center section, lower surface, including wing lower surface stubs between the No. 1 engine mounts and the No. 2 engine mounts; and (3) right wing outboard of the No. 2 engine with the outboard 20 feet mostly disintegrated. The left main landing gear was separated from the wing, and the right main gear remained attached except for the wheels and oleo piston. The nose landing gear and its attaching structure were separated from the nose section. Both engines and their pylon structures were separated from the wings. There was no evidence of fire on any of the recovered structure.

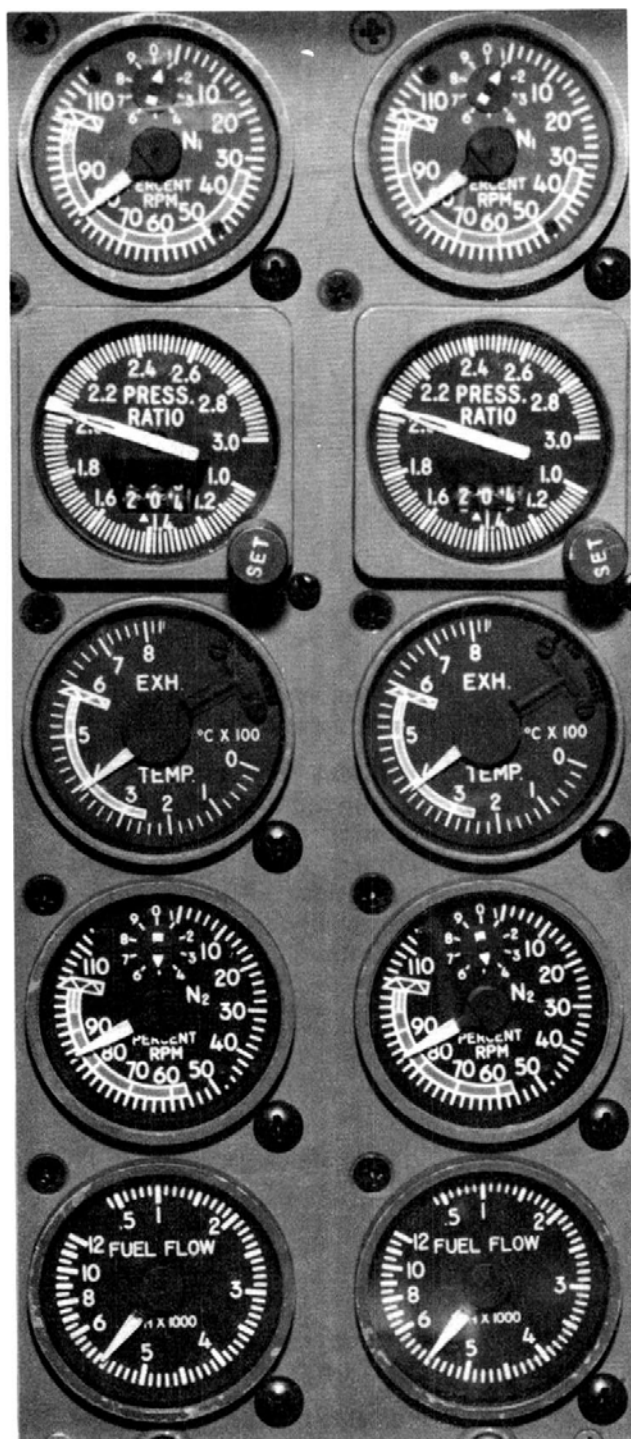
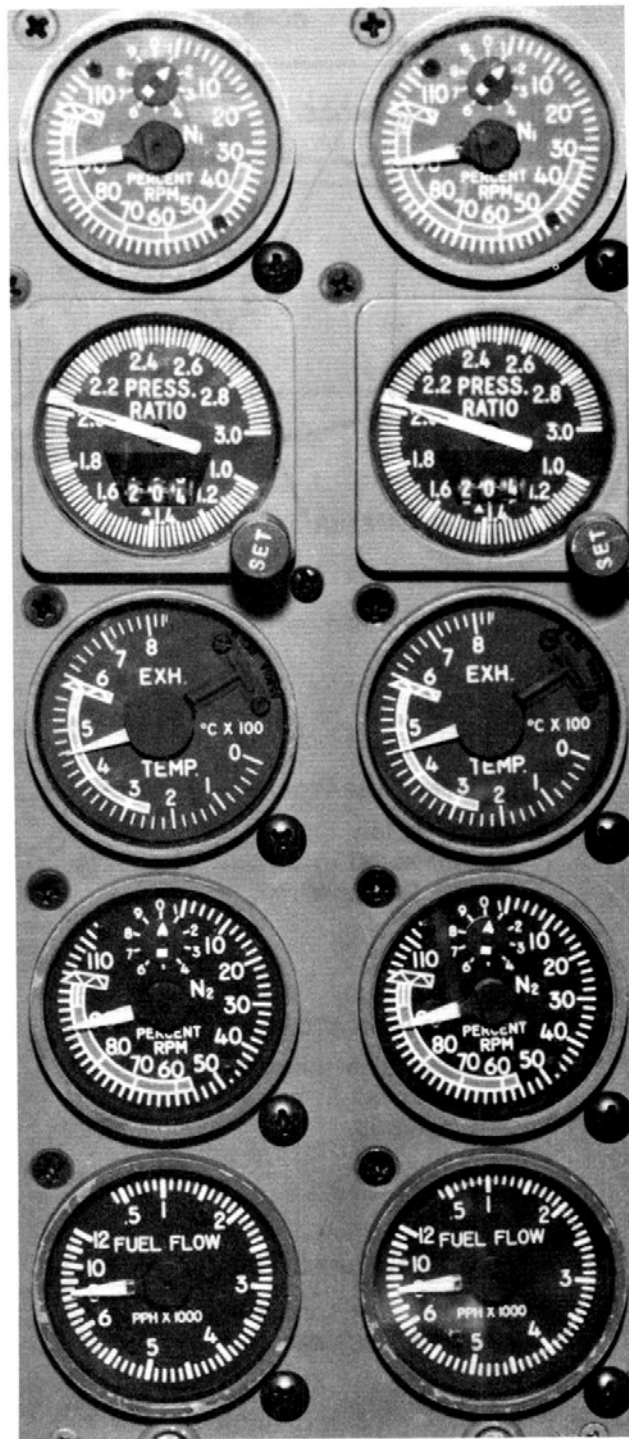
Figure 6.—Comparison of Instrument Readings -- 1.70 EPR vs. 2.04 EPR.

Engine Instrument Indication:
1.70 EPR P_{t2} probe blocked
Engine anti-ice-Off

Engine Instrument Indication:
2.04 EPR
Normal Operation

With the engine operating, a false indication of the actual EPR can be indicated in the cockpit when ice blocks the inlet probe. Under this condition, the P_{t_2} probe is vented to the nose cone pressure through a siphon-break hole in the sense line. The interior of the engine nose cone is vented to the engine inlet static pressure, which is lower than the engine inlet total pressure normally sensed by the P_{t_2} system. Under severe icing conditions, if the engine inlet anti-icing air bleed system is shut off and the normal P_{t_2} sensing port is blocked with ice, the P_{t_2} sensor will sense the lower pressure at the vent port in the nose cone. The cockpit indication may become slightly erratic as icing begins to block the probe and will indicate a significantly higher reading when ice fully blocks the probe. Tests have demonstrated that with a blocked probe at takeoff, engine power can indicate an EPR of about 2.04 with the engine actually operating at an EPR ratio of 1.70. Under these circumstances, a pilot would unknowingly attempt takeoff at a considerably lower thrust than desired. However, the pilot has available other indications of engine operation displayed in the cockpit, such as a lower N_1 , N_2 , EGT, and F/F consistent with the reduced engine thrust. (See figure 6.)

Should the pilot activate the engine inlet anti-icing system with a blocked probe, he would immediately notice a substantial drop in the indicated EPR, incorrectly indicating a low engine thrust as long as the normal P_{t_2} sensing port remains blocked. This results from the introduction of engine anti-icing air flow into the nose cone and resultant increase in the pressure in the interior of the nose cone. This pressure is higher than that which would be sensed at the normal P_{t_2} port. Falsely low indicated EPR's have been detected by pilots when they found that they were unable to set takeoff power without exceeding redline N_1 , N_2 , and EGT.
