**Runway excursion, World Airways, Inc., Flight 30H, McDonnell Douglas DC-10-30 CF, N113WA, Boston-Logan International Airport, Boston, Massachusetts, January 23, 1982**

WORLD AIRWAYS, INC., FLIGHT 30H  
MCDONNELL DOUGLAS DC-10-30CF, N113WA,  
BOSTON-LOGAN INTERNATIONAL AIRPORT  
BOSTON, MASSACHUSETTS  
JANUARY 23, 1982

NTSB-AAR-82-15

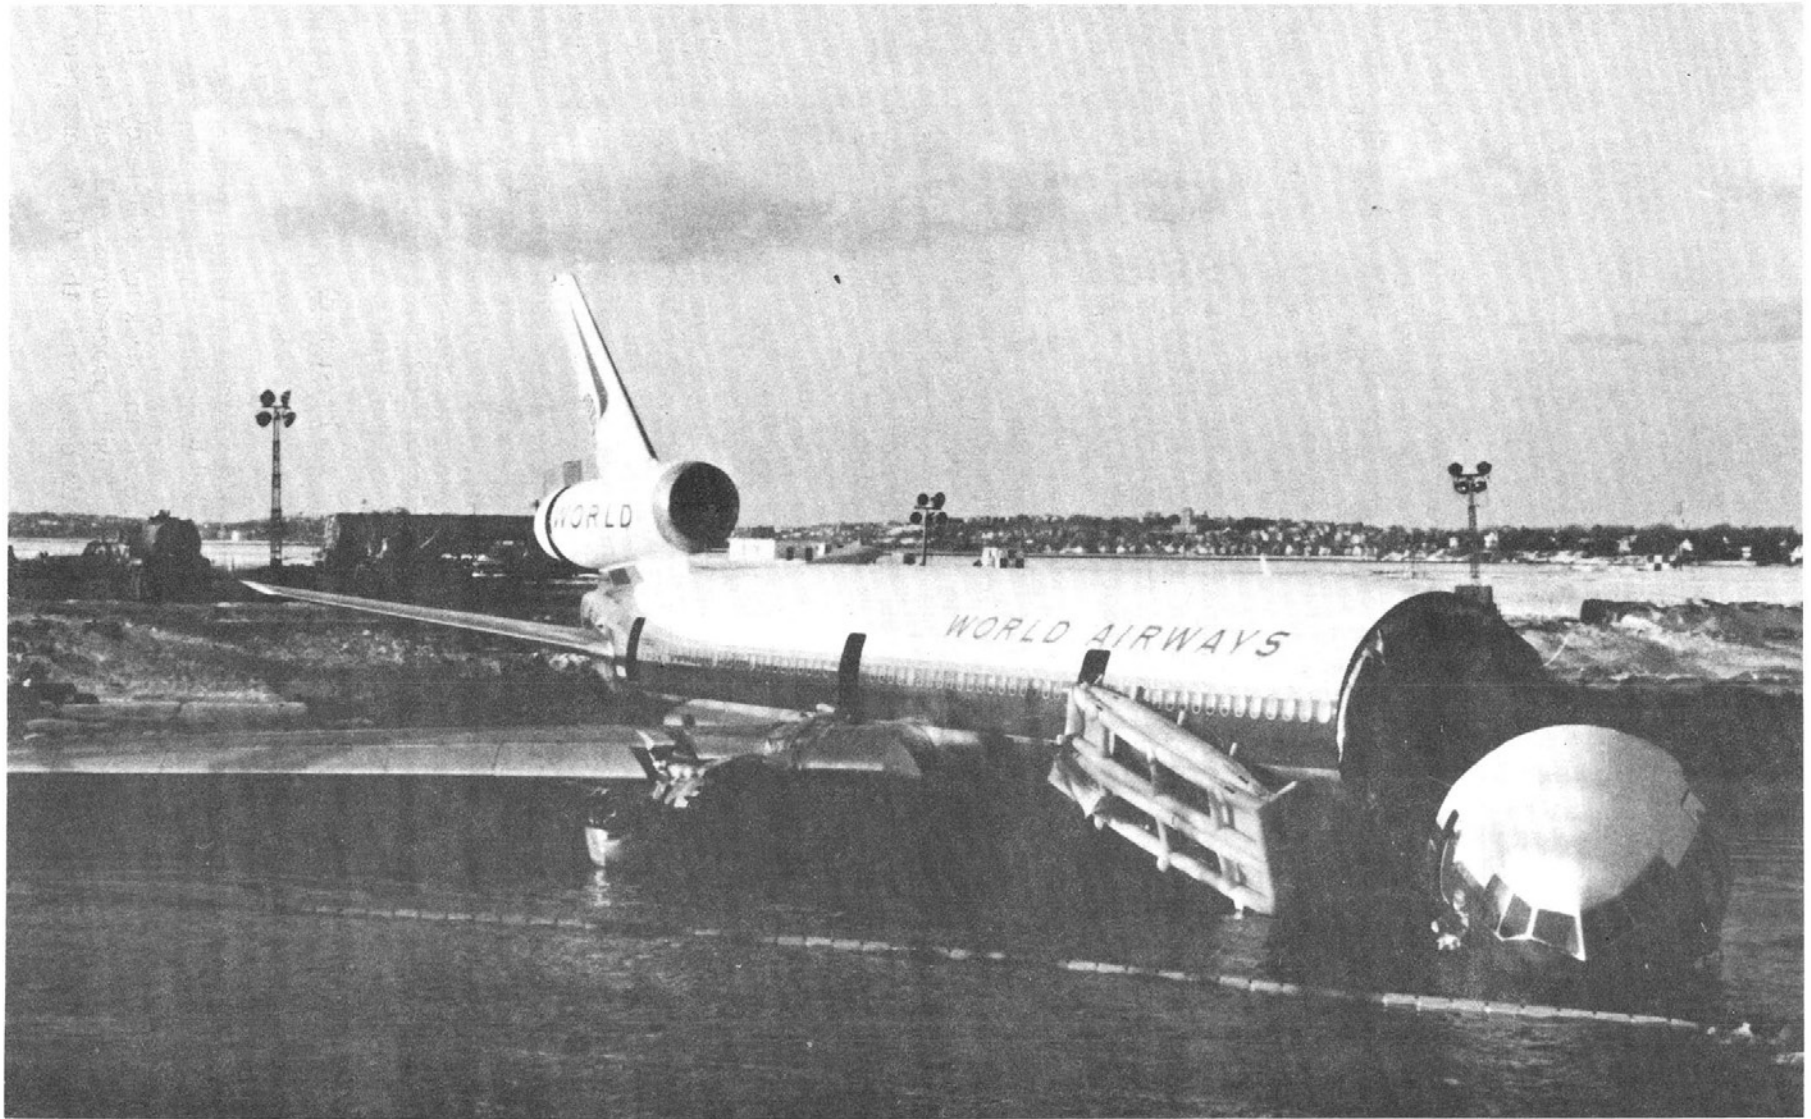
Figure 1.--Flight 30H as it rested in Boston Harbor.

The airplane came to rest immersed in water up to the wings at high tide and in a slightly nosedown attitude. The nose section, which included the cockpit area and first row of main cabin passenger seats, separated from the fuselage along a fracture line from fuselage station (FS) 370 to 475. The nose section remained attached to the main fuselage structure by control cables and electrical wire bundles. The pressure bulkhead at FS 275 had been crushed aft at the fuselage bottom centerline. The main cabin floor beams from FS 392 to FS 475 failed with a progressively downward displacement of each floor beam. The aft edge of this floor section was hanging down at a 45° angle. The cabin

seat tracks in this area had fractured into short sections. The fractures were clean and bright, with the fractured surfaces about 45° to the local surface. There was no evidence of compression buckling or previous cracking. The first row of passenger seats, which consisted of a left side module of three seats, a center seat module of two seats, and a right module of three seats, had separated from the floor structure as the result of the seat track fragmentation. The three seat modules were installed in the immediate area of the nose-section/main-fuselage separation. The pressure bulkhead at the forward end of the nose wheel landing gear well had been crushed inward and aft. The shear web on the fore and aft nose landing gear support beams contained a 2-foot vertical fracture at the nose gear drag link support fittings. The fuselage attach fittings for the nose gear drag braces were torn from the fore and aft nose gear support beams, and the gear had folded aft while pivoting about the strut trunnion axis.
