Crash on takeoff in microburst, Pan American World Airways, Inc., Clipper 759, Boeing 727-235, N4737, New Orleans International Airport, Kenner, Louisiana, July 9, 1982

AIRCRAFT ACCIDENT REPORT

**PAN AMERICAN WORLD AIRWAYS, INC.,
CLIPPER 759, BOEING 727-235, N4737,
NEW ORLEANS INTERNATIONAL AIRPORT
KENNER, LOUISIANA
JULY 9, 1982**

NTSB/AAR-83/02

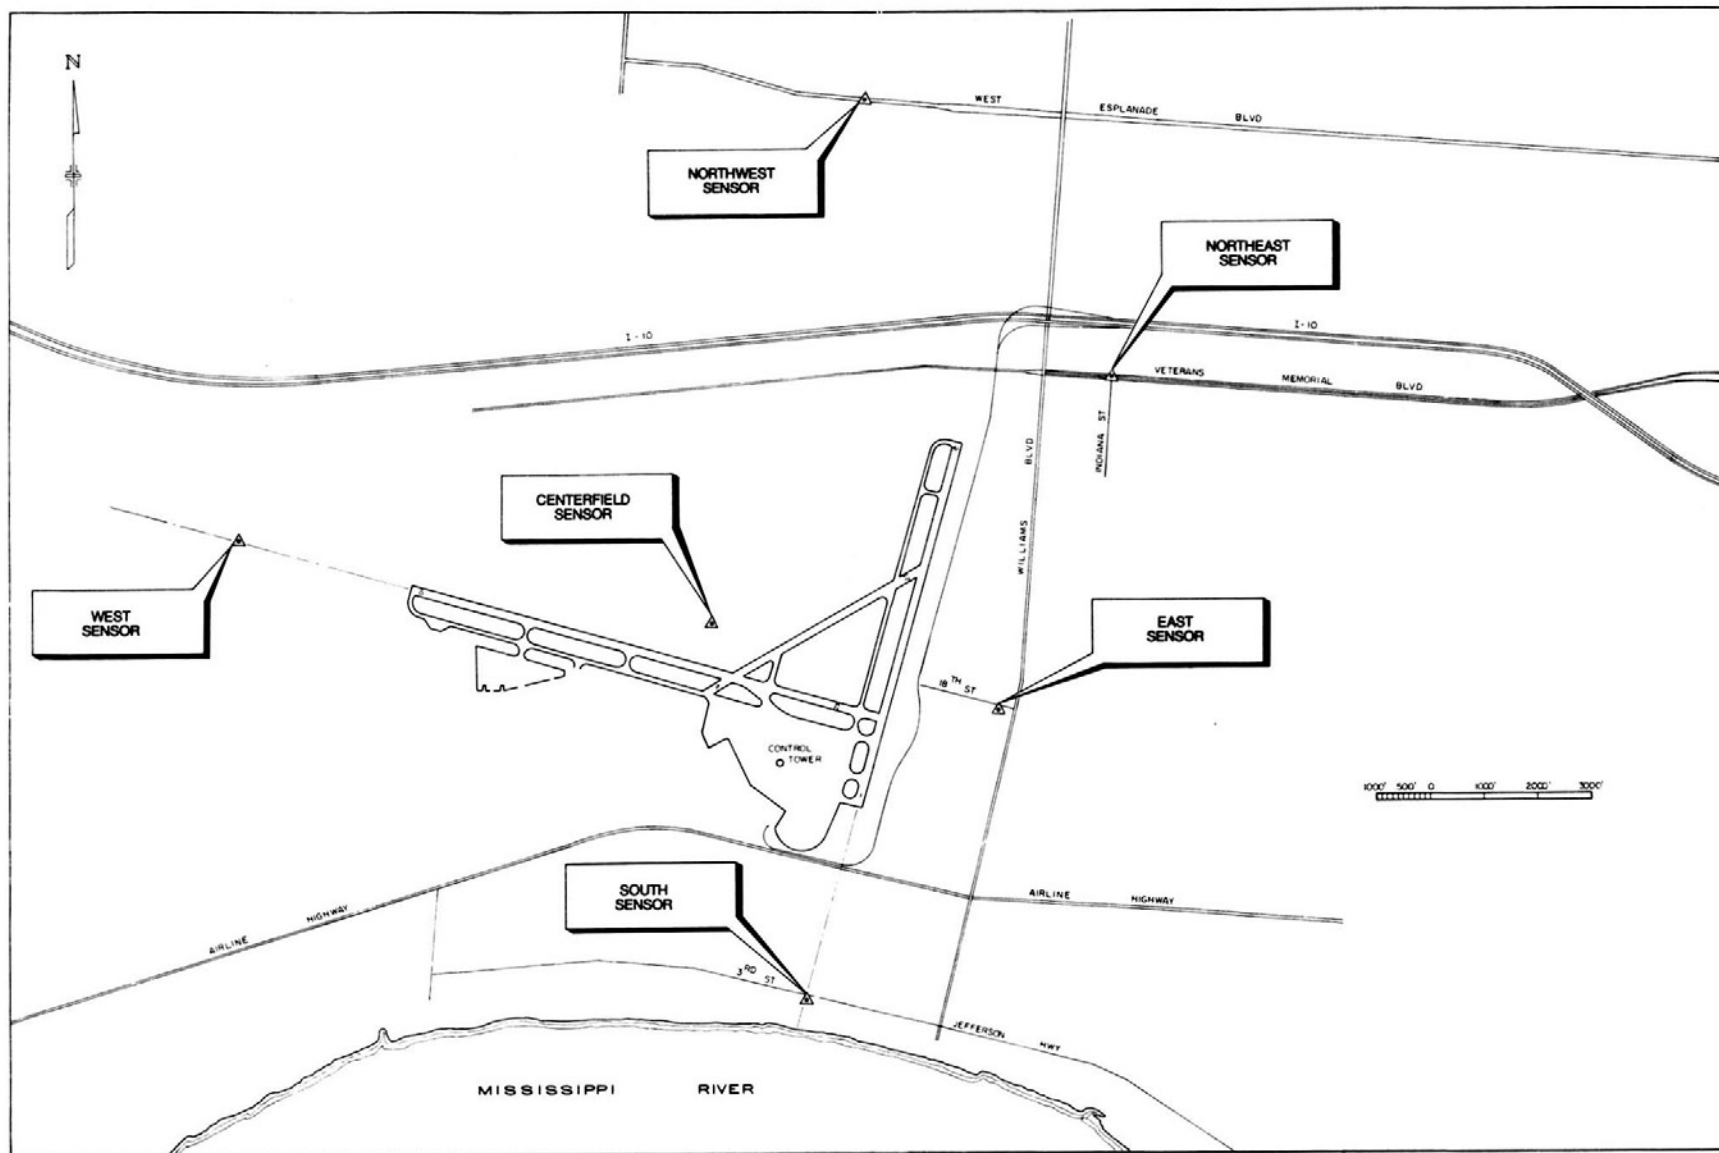
Figure 1.--Low Level Wind Shear Alert System
at New Orleans International Airport.

wind sensors is about 3 kms.^{13/} Examination of the locations at New Orleans showed that, except for the spacing between the northwest sensor and the centerfield sensor (3.1 kms), the four other sensors were within 3 kms of the centerfield sensor. The manager testified that while uniformity of spacing between sensors is desirable, the location of these instruments is dictated by other factors. The sensors should be located where they will not be affected by terrain, trees, or other obstacles. In order to provide advance warnings to pilots, they should be located so that they can detect wind shears associated with weather systems which are moving toward the airport; therefore, in many cases they have been located outside the airport's boundaries. The FAA's program manager testified that although there were trees located to the north, east, and south of the east sensor, the sensors at New Orleans International Airport were located in accordance with established criteria and that there were no obstacles near any sensor that could affect their readings. He also noted that since weather systems can approach the airport from any direction, all sensors in the system are considered critical.

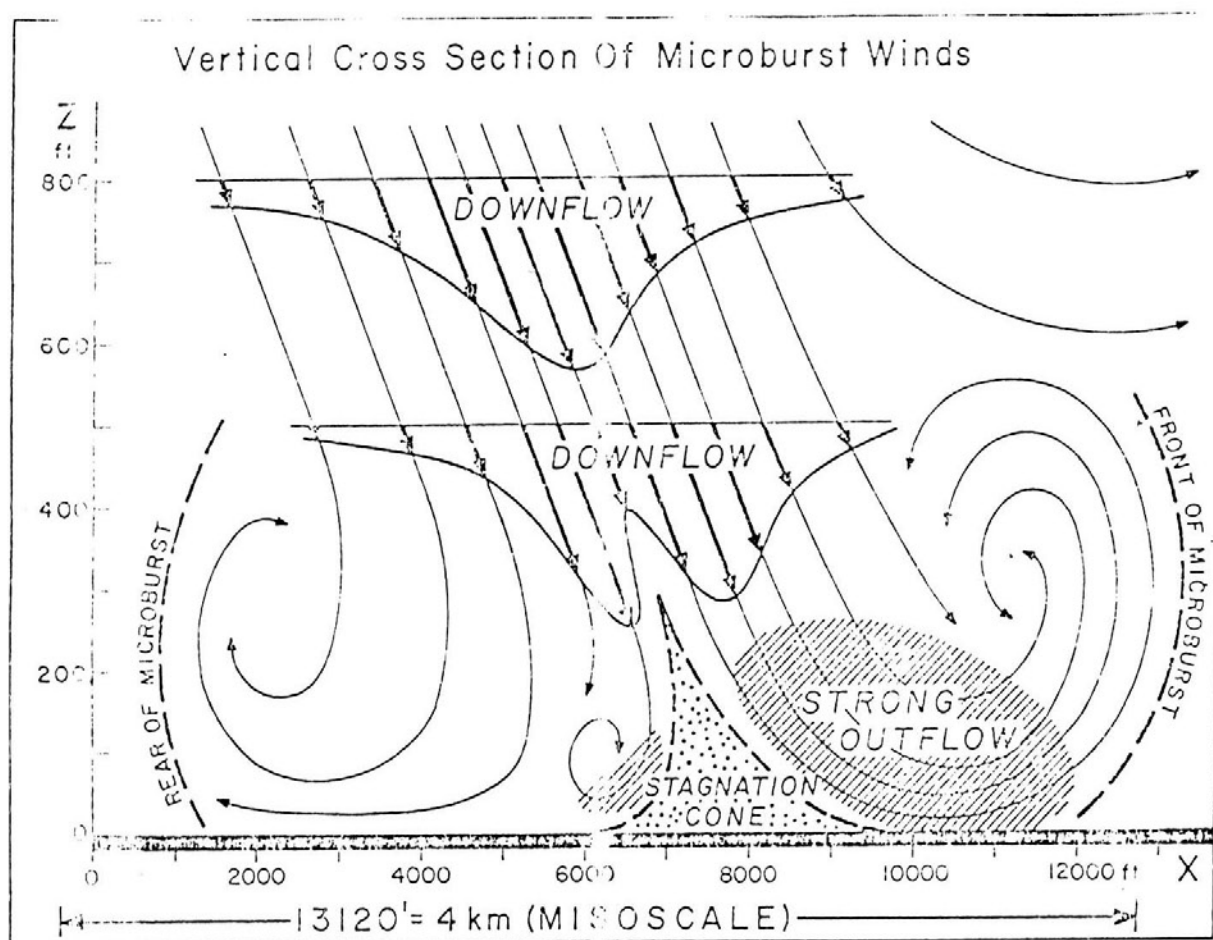
Figure 3.--Vertical cross-section of a microburst.
("Microburst Wind Shear at New Orleans International
Airport, Kenner, Louisiana, on July 9, 1982." p. 30, Dr. T. Theodore Fujita.)

The vertical velocities in 15 microbursts were measured by flying through their vertical shaft at heights of 2,000 feet AGL and 1,000 feet AGL. Airplane safety considerations precluded fly-throughs below 1,000 feet AGL. The co-director testified that "typically at 2,000 feet we are getting about 20 meters per second or 40 knots;

at 1,000 feet it was down to 10 meters per second, or 20 knots." The co-director testified that although they had made "observations" of vertical velocities below 500 feet and 200 feet AGL, it was premature to address these observations in a quantitative sense.

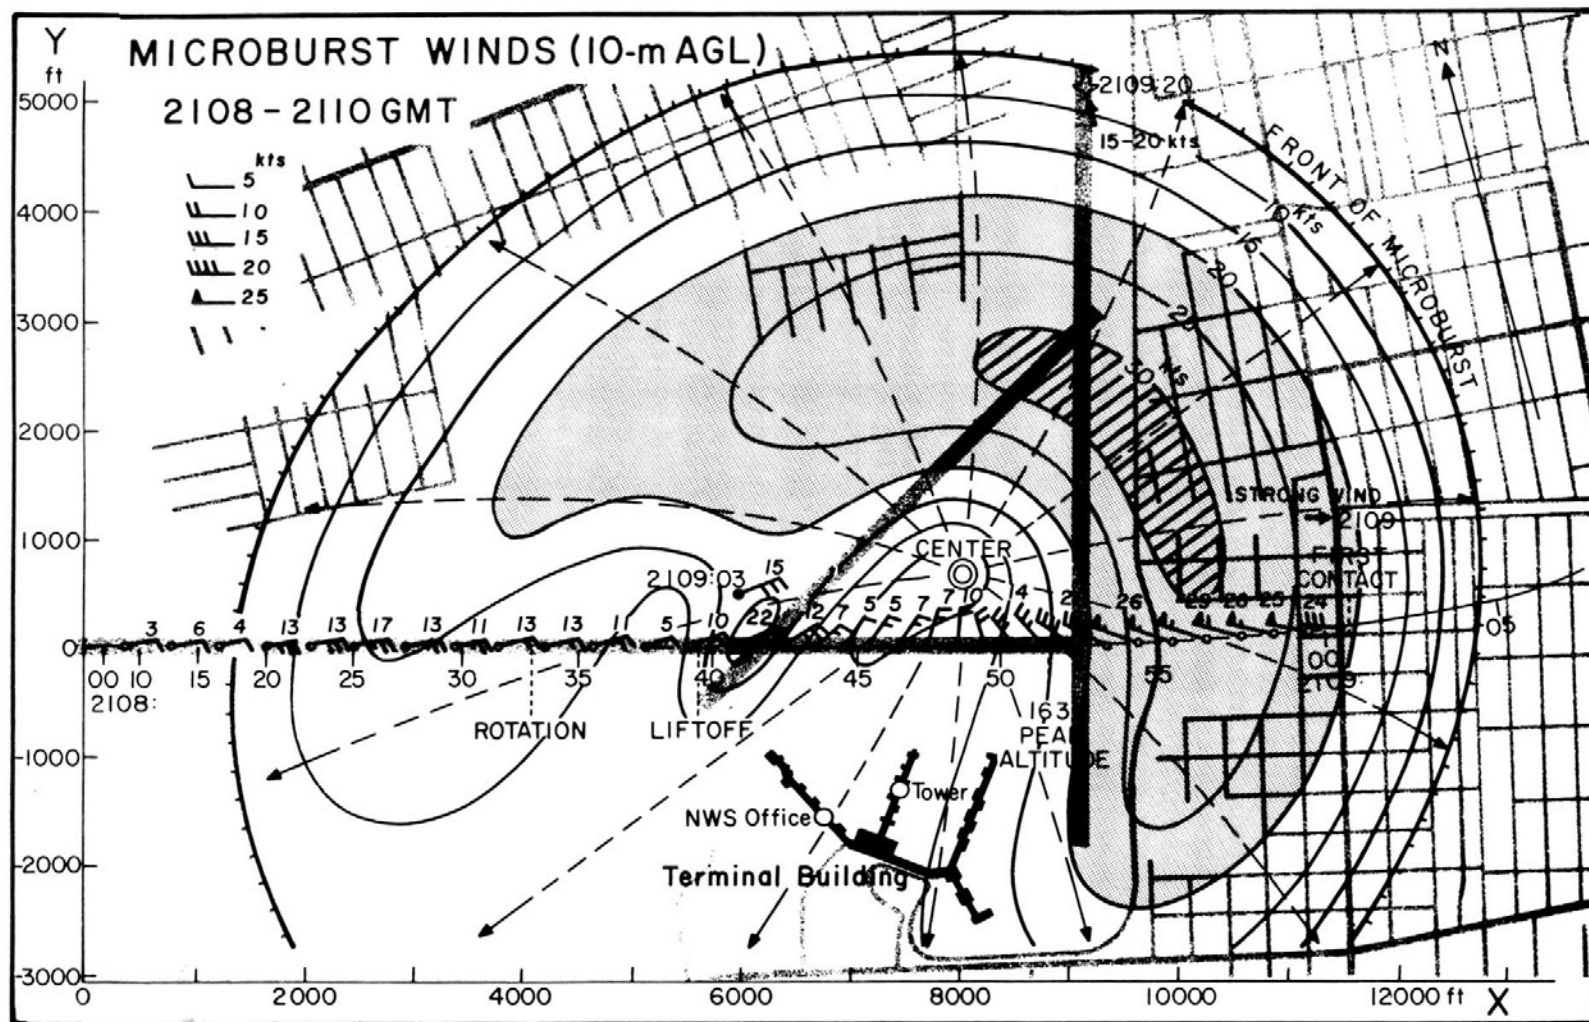
Figure 4.—Windfield of the microburst over the New Orleans International Airport (Moisant Airport) at the time of the accident. All wind speeds with barbs are reduced to the 30 ft (10 m) height above the runway with 0 to +1 ft elevation. Microburst was moving towards the northeast accompanied by strong west winds near the accident site and 15 to 20 knots southerly wind at the departure end of runway 19. (Page 28, "Microburst Wind Shear at New Orleans International Airport, Kenner, Louisiana, on July 9, 1982," Dr. T. Theodore Fujita.)

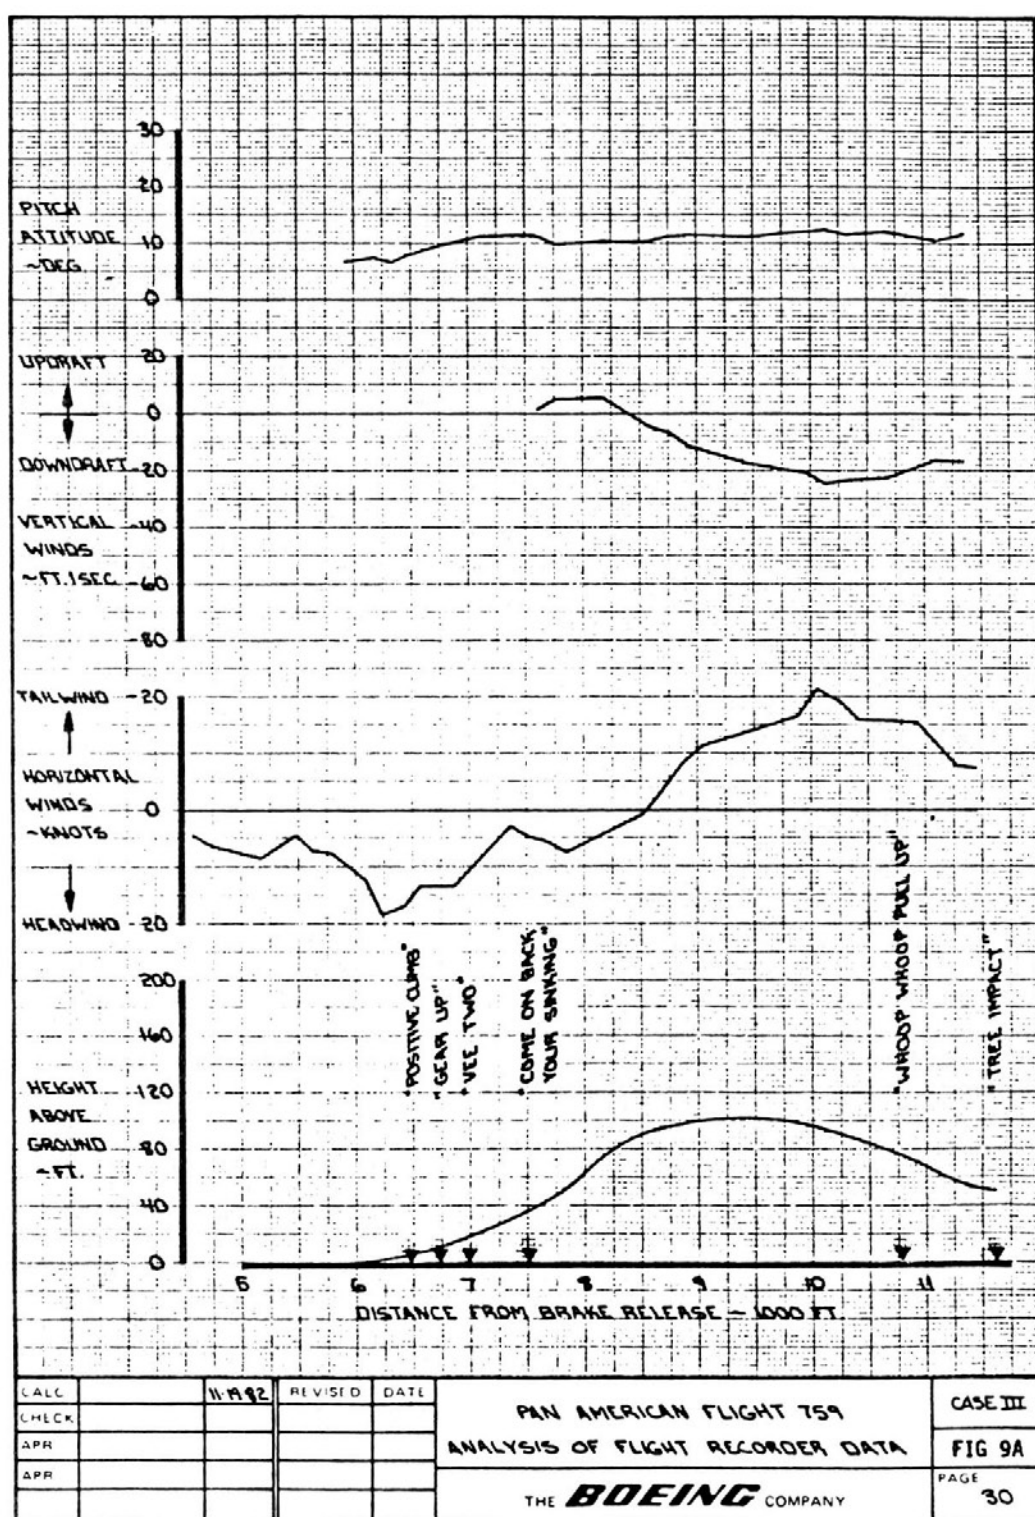
Figure 6.--Boeing's analysis of flight recorder data, case III.

The major difference between the derived windfields in the Boeing performance analysis and those reflected in the Pan Am and NOAA wind analyses was the wind speed of the downdraft at 100 feet AGL. In addition, the airplane pitch attitudes reflected in the Pan Am analysis were different from those shown in the Boeing analysis. In the Boeing performance analysis, the speeds of the horizontal and vertical wind components and their spatial relationship to each other were adjusted by assuming groundspeed time histories which insured that the airplane's flight met the constraints imposed by the physical evidence of the accident sequence. Airplane pitch attitudes were

derived from the airplane's measured performance parameters combined with the motion equation results for the assumed groundspeed profiles. No attempt was made to adjust the derived airplane pitch angles to produce a windfield that would fall within reasonable environmental parameters. Consequently, while the horizontal wind shear demonstrated in case III is reasonable, the 25 fps downdraft at 100 feet AGL is not; a 25 fps downdraft at 100 feet AGL would produce a diverging outflow on the order of 100 knots. It was obvious that surface winds of this magnitude did not occur during this accident.
