## Loss of control on takeoff, United Airlines Flight 2885, N8053U, McDonnell Douglas DC-8-54F, Detroit, Michigan, January 11, 1983

UNITED AIRLINES FLIGHT 2885,  
N8053U, McDONNELL DOUGLAS DC-8-54F  
DETROIT, MICHIGAN  
JANUARY 11, 1983

NTSB/AAR-83/07

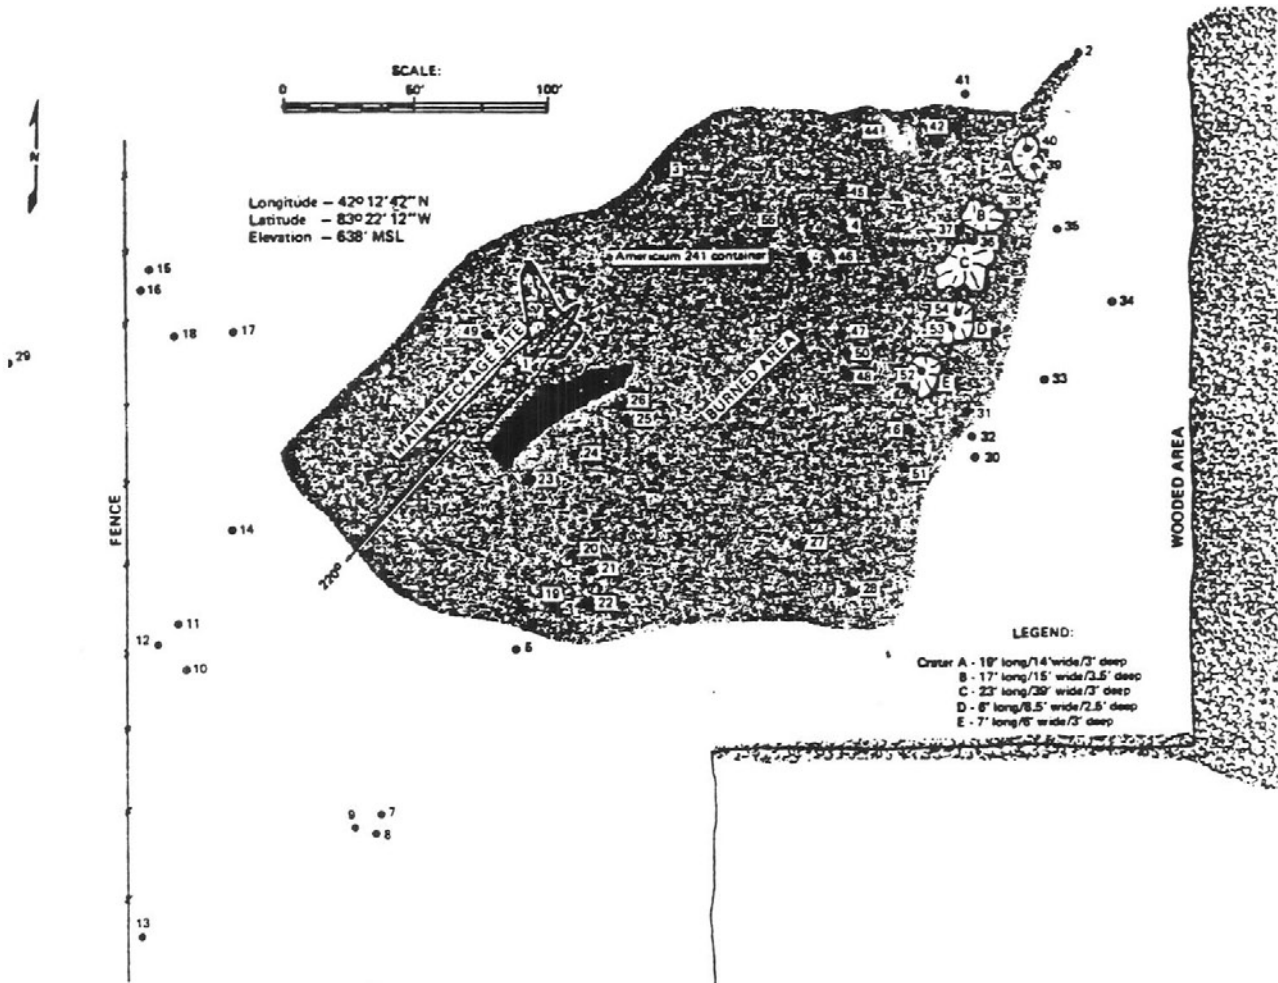
WRECKAGE DISTRIBUTION OF PARTS

The accident site was a freshly plowed farmfield within the airport boundary. The center of the impact area was located about 1,200 feet west (right) of the centerline and about 8,800 feet from the approach end of runway 21R. The wreckage pattern was roughly fan shaped, between 180-300 feet wide and 350 feet deep, from east to west. (See appendix D.) Five ground craters, indicating the impact of the airplane's four engines and nose, were found at the eastern edge of the wreckage site. The impact marks indicated that the airplane struck the ground about 70° - 80° nose down with about 200° right roll. Most of the wreckage was damaged by ground fire.

The largest piece of intact structure was a portion of the aft fuselage with the empennage assembly attached. All cargo tie down fittings (bear traps) had been sheared off in the forward direction. The rear cabin doors (left and right) were found intact, attached, and open. The aft fuselage pressure bulkhead was intact with no evidence of structural or fire damage.

1. 70' section of left fuselage and empennage assembly.
2. Pieces of red and clear glass (wingtip lighting).
3. No. 1 engine.
4. No. 2 engine.
5. No. 3 engine.
