Multiple engine failure, Eastern Air Lines, Inc., Lockheed L-1011, N334EA, Miami International Airport, Miami, Florida, May 5, 1983

AIRCRAFT ACCIDENT REPORT

**EASTERN AIR LINES, INC.,
LOCKHEED L-1011, N334EA
MIAMI INTERNATIONAL AIRPORT
MIAMI, FLORIDA
MAY 5, 1983**

NTSB/AAR-84/04

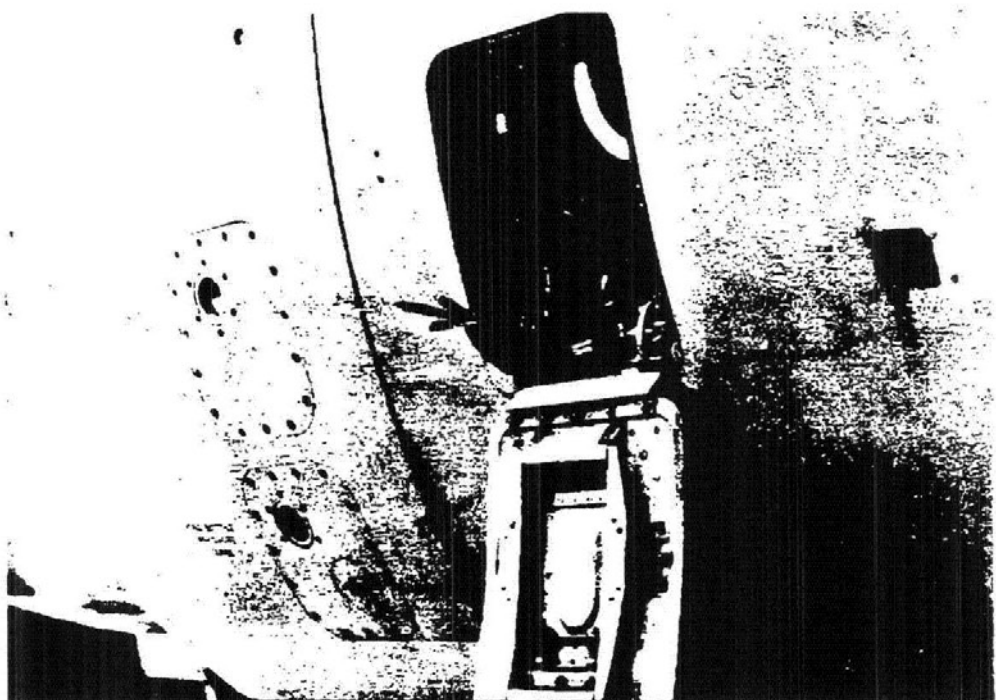
Figure 4.—Oil service door and chip detector location, engine No. 1.

He first went to engine No. 1, and he had to place his hand inside the oil service door 4 to 6 inches to reach the detector. He then removed the master chip detector from the engine. (See figure 5.) He stated that he could not simultaneously place his hand on the master chip detector and look at the detector, so he usually removed and replaced master chip detectors by feel. The mechanic said that he did not examine the replacement magnetic chip detectors to insure that the O-ring seals were installed. He said he had assumed that they were installed because the sealed plastic package had a serviceable parts tag, and because previous master chip detectors he had installed always had had O-ring seals installed. He inserted the replacement master chip detector in the No. 1 engine and then proceeded to the No. 3 engine where he repeated the procedure. He stated that he could not feel any difference between a master chip detector with O-ring seals and one without O-ring seals once the detector was installed in the engine. He then waited for the other mechanic to replace the master chip detector on the No. 2 engine.
