In-flight fire, Air Canada Flight 797, McDonnell Douglas DC-9-32, C-FTLU, Greater Cincinnati International Airport, Covington, Kentucky, June 2, 1983

AIRCRAFT ACCIDENT REPORT

**AIR CANADA FLIGHT 797
McDONNELL DOUGLAS DC-9-32, C-FTLU
GREATER CINCINNATI
INTERNATIONAL AIRPORT
COVINGTON, KENTUCKY
JUNE 2, 1983**

**NTSB/AAR-86/02
(SUPERSEDES - - NTSB/AAR-84/09)**

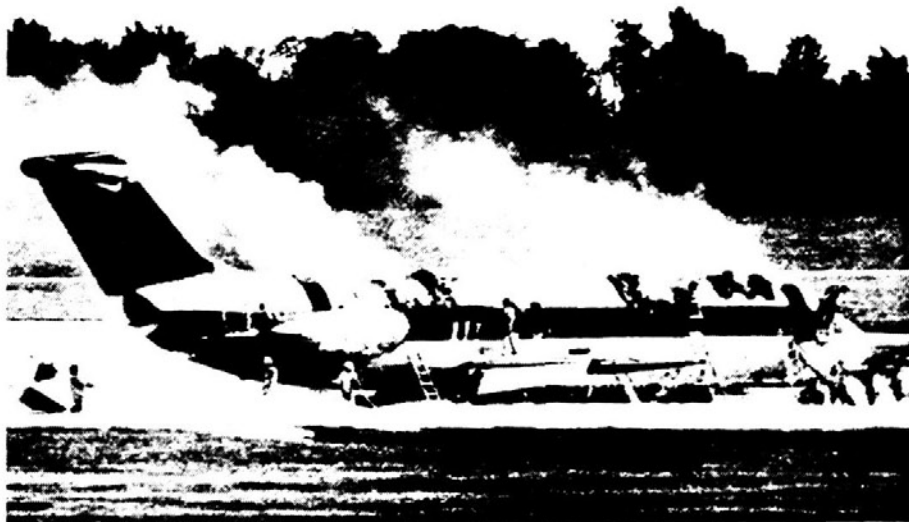
Figure 2.—Airplane after fire burned through top of fuselage.

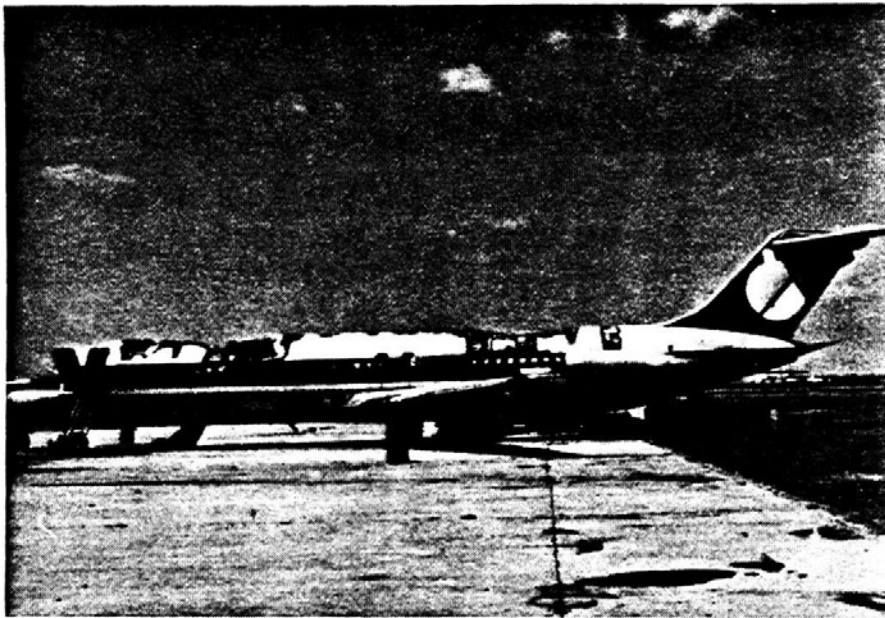
The cabin area of the upper fuselage down to below the level of the cabin windows was damaged heavily by fire; below that level the fuselage was relatively intact. The majority of the cabin windows were either missing or had partially melted out. (See figures 3 and 4.) Forward of the aft pressure bulkhead, the upper areas of the cabin windows were discolored and burned away in several locations. The fuselage skin above the left aft lavatory was intact, but a rectangular area corresponding closely to the shape of the lavatory had been discolored to dark brown and a large area of paint had been burned away. The rectangular area began above the engine pylon and extended to the top of the fuselage. (See figures 3 and 4.)

Figure 3.—Left side of the airplane.

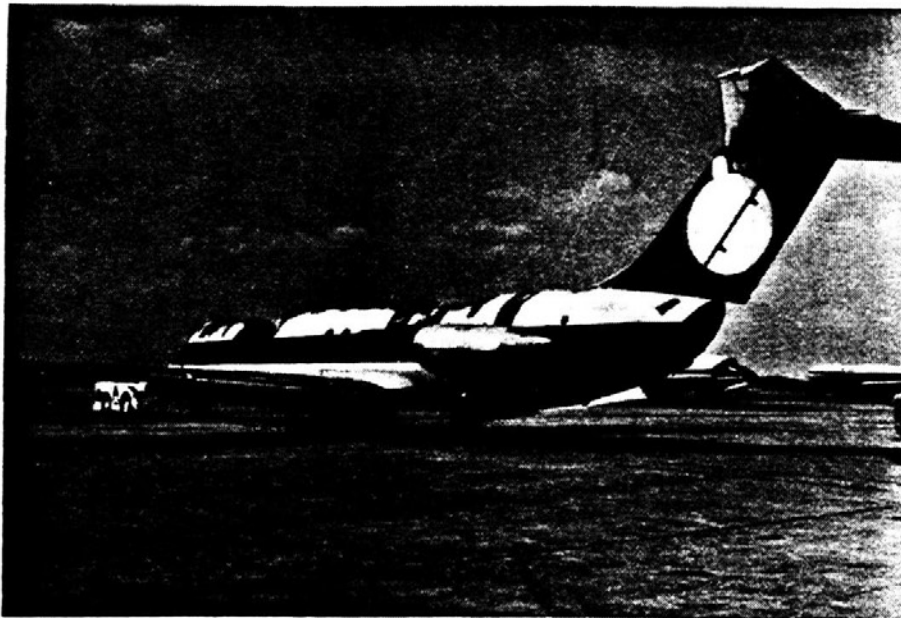
Figure 4.—Left side of the airplane, rear view, depicting rectangular burn pattern and soot trail.

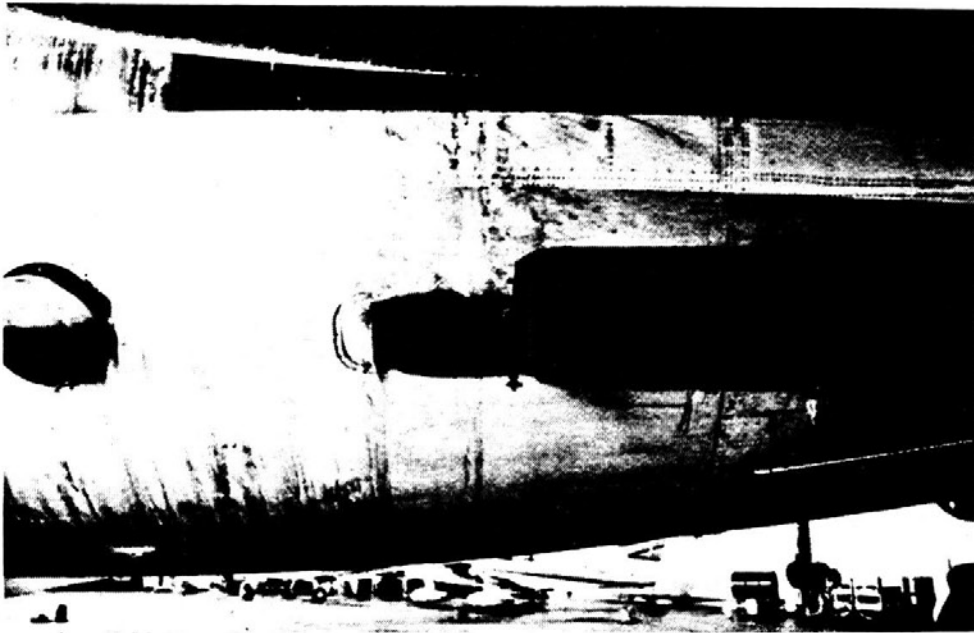
There were thick soot deposits along the lower side of the fuselage beginning at the cabin air outflow valve at FS 945 and from around the access door in the lavatory service panel at FS 965. The soot pattern trailed rearward along the airplane's side,

including the tailcone. The cabin air dump valve, at FS 920, was open, and light soot deposits trailed aft from around the edges of the valve. (See figure 5.)

Figure 5.—Soot trail deposits on left side of fuselage
at lavatory service panel and outflow valve.

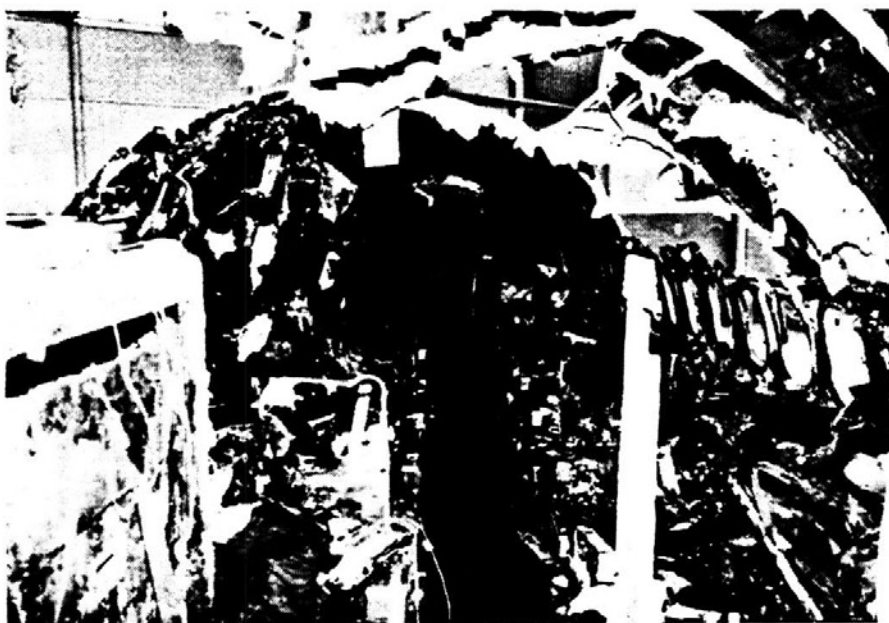
Except for the cabin floor and the aisle carpet, the entire passenger cabin back to the aft lavatory was either consumed or damaged by fire. The aisle carpet was covered by debris but had not been discolored or damaged by heat. Of the 100 passenger seats, only the seat frames and cushions of Nos. 12A and 12B remained intact. Seat Nos. 12A and 12B are adjacent to the left forward overwing emergency exit which had been opened during the passenger evacuation and had been used as access by firemen to apply water to the fire. The remaining seats were either completely or partially destroyed by the fire. (See figures 7 and 8.)

Figure 7.—Cabin interior viewed aft from the forward galley area.

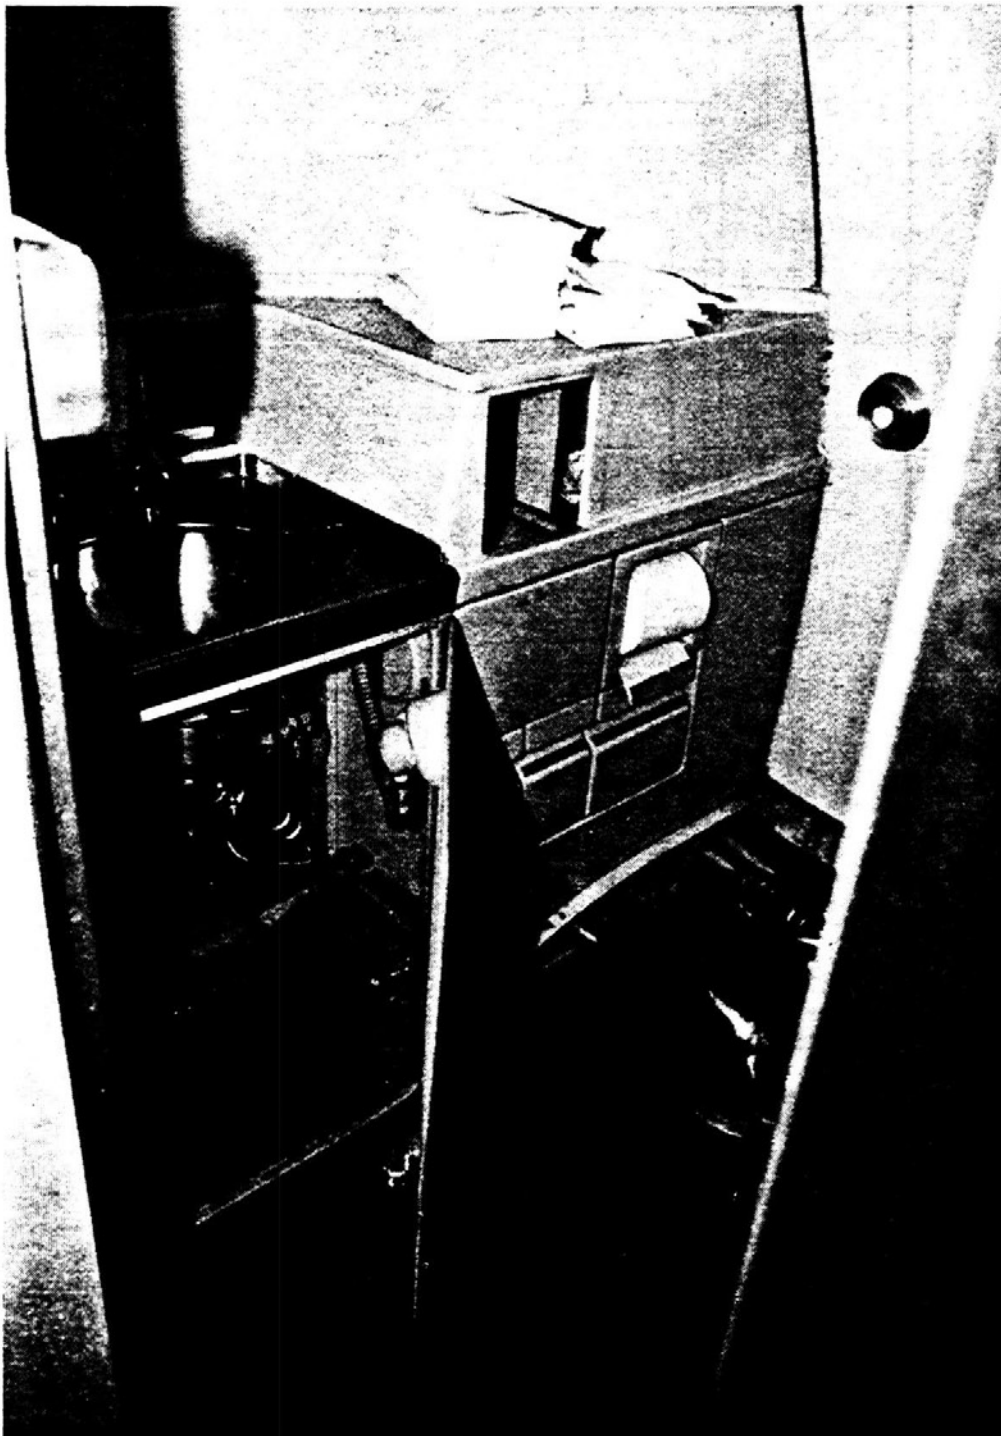
Figure 10.—Aft lavatory viewed toward aft and outboard wall.
Lavatory sink door is open exposing trash receptacle.
Toilet shroud has been removed showing the top of the
flush motor between the commode and forward wall of
the amenities section.

The aft lavatory was damaged extensively by fire and heat. Most of the lavatory's interior walls had been burned away. The entry door, which had been kept closed, was destroyed except within 16 inches of the floor. The aft pressure bulkhead and fuselage skin which comprised the outermost portion of the lavatory enclosure were intact, but were buckled and discolored to dark brown.

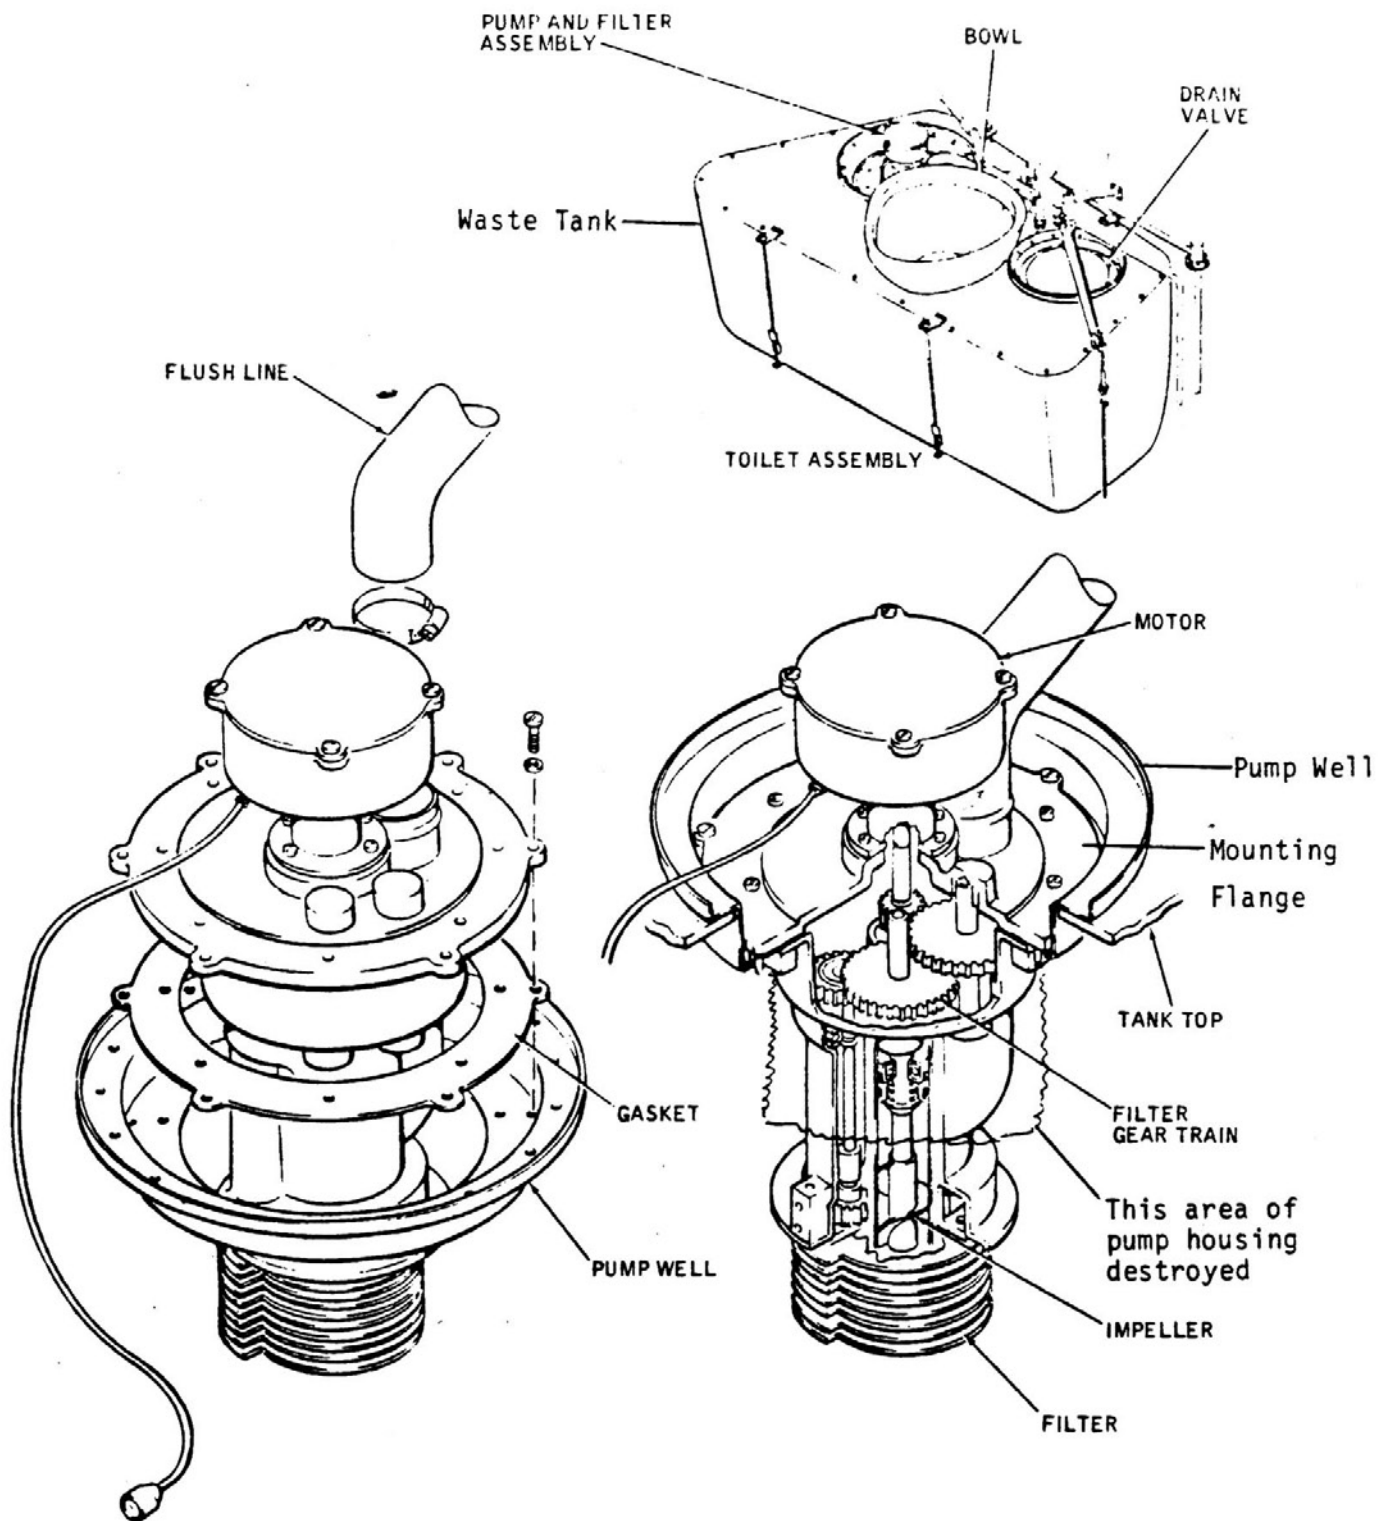
The flush motor was found attached to its mounting flange which was attached to the pump well. The flush motor assembly was found in approximately its normal position in the waste tank next to, but detached from, the flush pump and filter assembly. The motor housing was completely melted. Large concentrations of molten metal were found on the forward side of the mounting flange facing the toilet bowl, and on the aft side where the 3-phase electrical leads enter the motor housing. A portion of the wiring harness which supplies a.c. power to the flush timer, flush motor, and flush button was encased in the molten metal on the aft side of the motor. The rotor section of the flush motor was encased in molten metal above the field windings; however, the rotor did not appear to have been damaged extensively by heat. (See figure 11.)

Figure 11.—Lavatory pump and filter system.
