Runway Collision, Korean Air Lines, McDonnell Douglas DC-10-30, HL7339, Southcentral Air Piper PA-31-350, N35206, Anchorage, Alaska, December 23, 1983

AIRCRAFT ACCIDENT REPORT

**KOREAN AIR LINES
McDONNELL DOUGLAS DC-10-30, HL7339,
SOUTHCENTRAL AIR PIPER PA-31-350, N35206
ANCHORAGE, ALASKA
DECEMBER 23, 1983**

NTSB/AAR-84/10

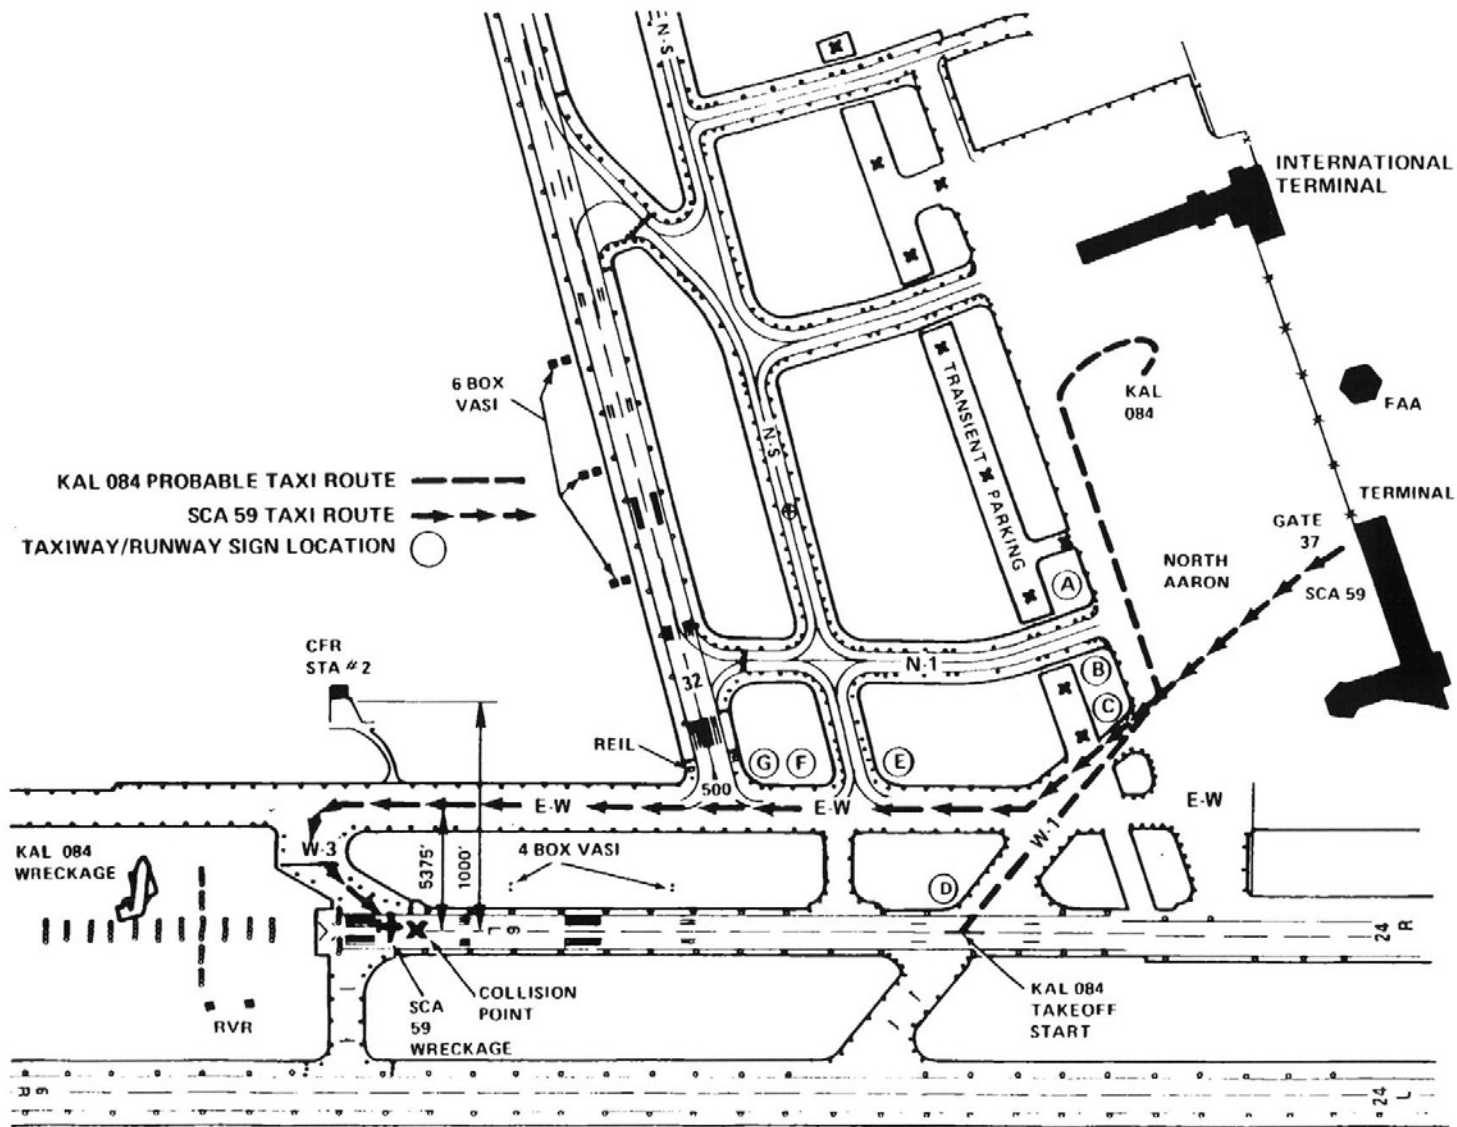
Figure 2.- Airplane taxi routes. Circled letters show locations of corresponding signs in figure 3.

SCA 59 arrived at the intersection of runway 6L and taxiway W-3 at 1344. KAL 084 started to taxi at 1355, 11 minutes after SCA 59 had completed taxiing. The Safety Board investigation team examined possible taxi routes used by KAL 084 to determine which route was most likely used. A transcript of recorded communications between Anchorage tower controllers and the pilots of both airplanes was zero-timed to the start of KAL 084's taxi. (See appendix D.) A SouthCentral Air Piper T1040 turboprop airplane was used and was taxied at a speed comparable to that of observed heavy turbojet aircraft. The transcript was read aloud as the airplane taxied from the parking ramp to the intersection of runway 6L/24R and taxiway W-1 and to runway 32 by various routes. A VHS audio and video record was made by the team member who occupied the copilot seat. The best correlations of time and position were accomplished using the following route (see figure 2):
