In-flight upset, China Airlines, Boeing 747 SP, N4522V, 300 Nautical Miles Northwest Of San Francisco, California, February 19, 1985

AIRCRAFT ACCIDENT REPORT

CHINA AIRLINES BOEING 747-SP, N4522V 300 NAUTICAL MILES NORTHWEST OF SAN FRANCISCO, CALIFORNIA FEBRUARY 19, 1985

NTSB/AAR-86/03

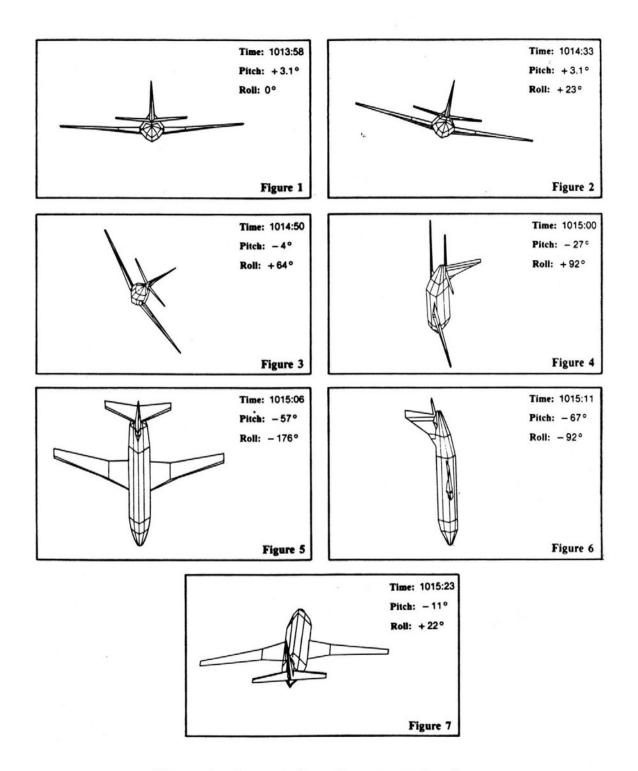
Figures 1.--Excerpts from Computer Animation.

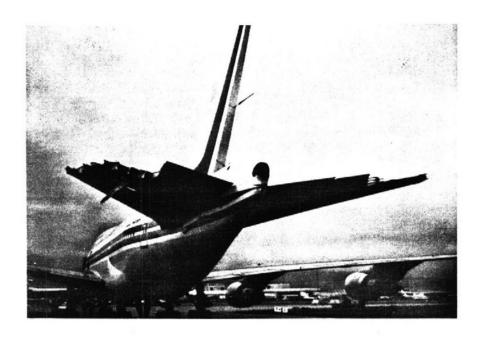
Empennage.--The major damage to the empennage was limited to the Auxiliary Power Unit (APU) compartment, the horizontal stabilizers, and elevators. The APU had separated from its mounts and was resting on the two lower tail cone access doors. The forward side of the APU fire bulkhead appeared to be deflected forward in the area adjacent to the two lower attachment fittings and the two lower support rods had buckled. In the area of the APU, there were several punctures in an outward direction on both sides of the tail cone.

Figure 8.-Photograph of Empennage.
