Crash short of runway in microburst, Delta Air Lines, Inc., Lockheed L-1011-385-1, N726DA, Dallas/Fort Worth International Airport, Texas, August 2, 1985

AIRCRAFT ACCIDENT REPORT

**DELTA AIR LINES, INC.,
LOCKHEED L-1011-385-1, N726DA
DALLAS/FORT WORTH -
INTERNATIONAL AIRPORT, TEXAS
AUGUST 2, 1985**

NTSB/AAR-86/05

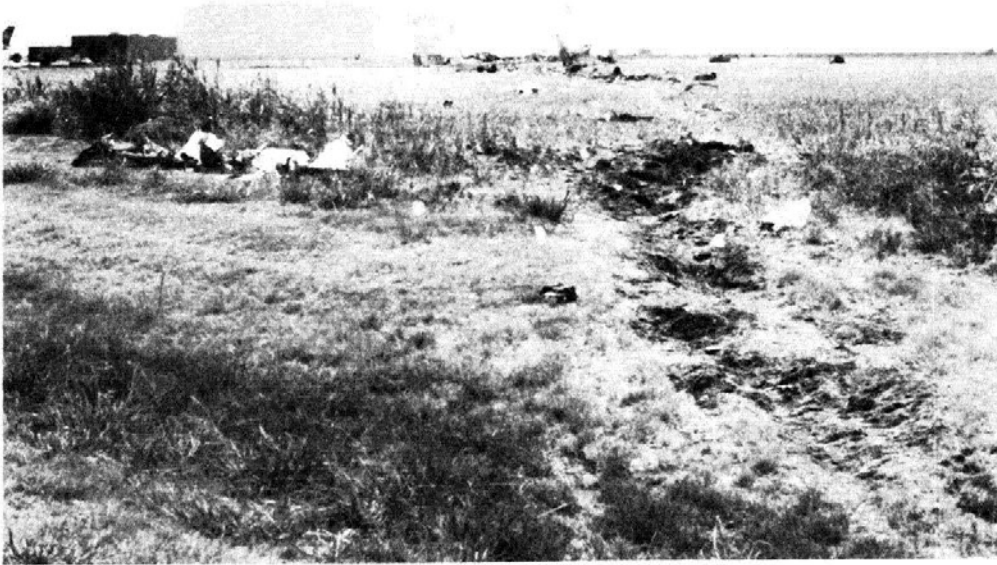
Figure 1.--Flight 191's ground track toward the water tanks.

The airplane grazed the north water tank and then impacted the south water tank--about 3,195 feet beyond initial touchdown--and broke apart. The fuselage, from the nose aft to fuselage station 1365 (FS 1365), was destroyed. Both wing sections outboard of the engine pylons separated during the breakup. The left wing came to rest in two inverted sections about 1,125 feet south of the south water tank. The wing sections and attached sections of the trailing edge flaps and leading edge slats were burned extensively. The outboard section of the right wing came to rest in an inverted position about 775 feet south of the south water tank. The No. 3 engine pylon was attached to the wing and the No. 3 engine was partially attached to the pylon. Both wings left a trail of wing components and burning fuel between the water tank and their final positions.

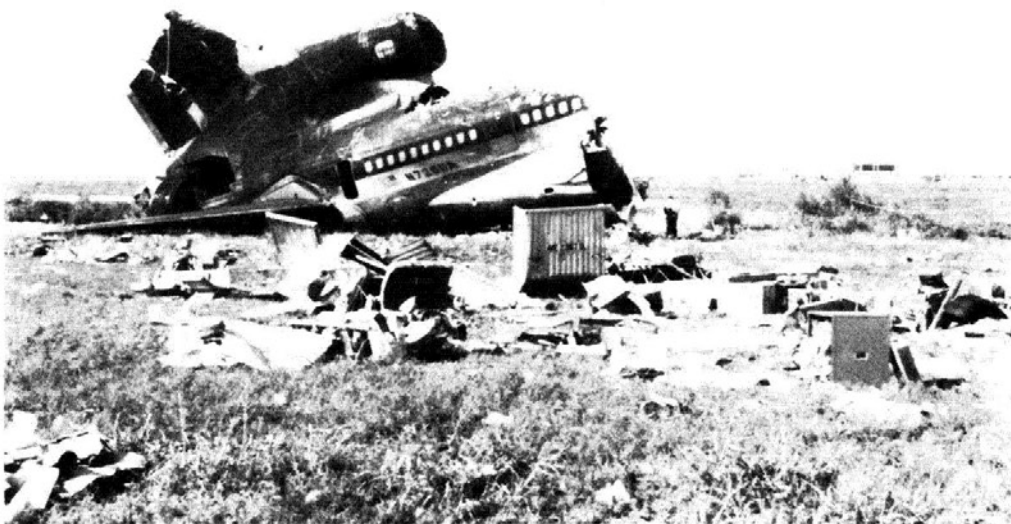
Figure 2.--The aft section of the airplane's fuselage.

The investigation team found the aft fuselage section containing the rear cabin and the empennage was in an upright position. Passengers and flight attendants reported that this section came to rest on its left side and was rolled to the upright position by wind gusts after the arrival of the rescue personnel. The section was relatively intact and included the No. 2 engine and associated ducting, the right stabilizer and elevator, and the base of the vertical stabilizer and rudder. The upper 12 feet of the vertical stabilizer and rudder had separated as a unit during the impact sequence and was found about 100 feet north of the aft fuselage section.

Except for the left cabin wall, which was missing, the remainder of the separated rear cabin section from row 40 aft to row 46 was relatively undamaged. Six passengers seated along the missing left cabin wall were killed. The remaining 16 occupants of this cabin section, including 2 flight attendants, sustained serious and minor injuries, and 2 passengers were not injured.

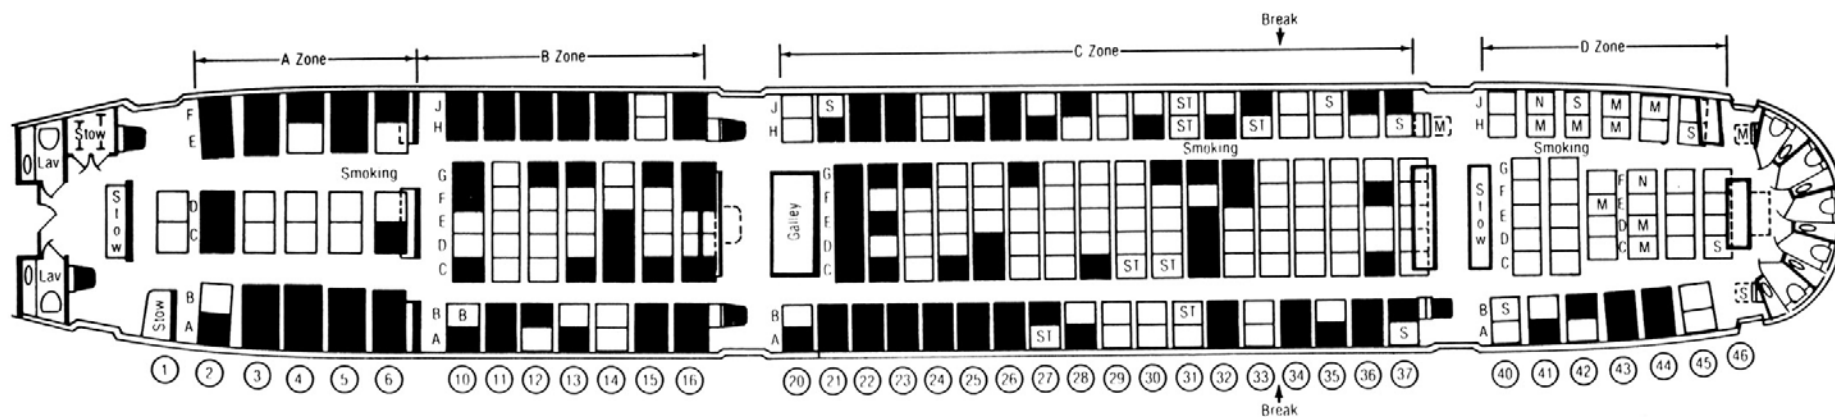
The rear cabin section came to rest on its left side. The survivors were either flung from the airplane in their seats or released themselves from their seats and exited at the forward end of the separated fuselage section or through the missing left wall. One flight attendant and three passengers could not escape from the cabin because of injuries and were removed by fellow passengers and rescue personnel. Two other flight attendants had only minor injuries and were able to escape unaided after shouting commands to the passengers to get out of the cabin. The flight attendant seated at the right rear (R-4) exit had difficulty releasing her seatbelt because the buckle was located on her left hip and her weight was on the buckle. The passengers and flight attendants were covered with fuel and some had fuel on their hands and in their eyes, which caused difficulties in climbing down the cabin to the hole created by the missing left cabin wall. Some persons were able to climb downward to the hole over seats while others fell the width of the cabin to the ground.

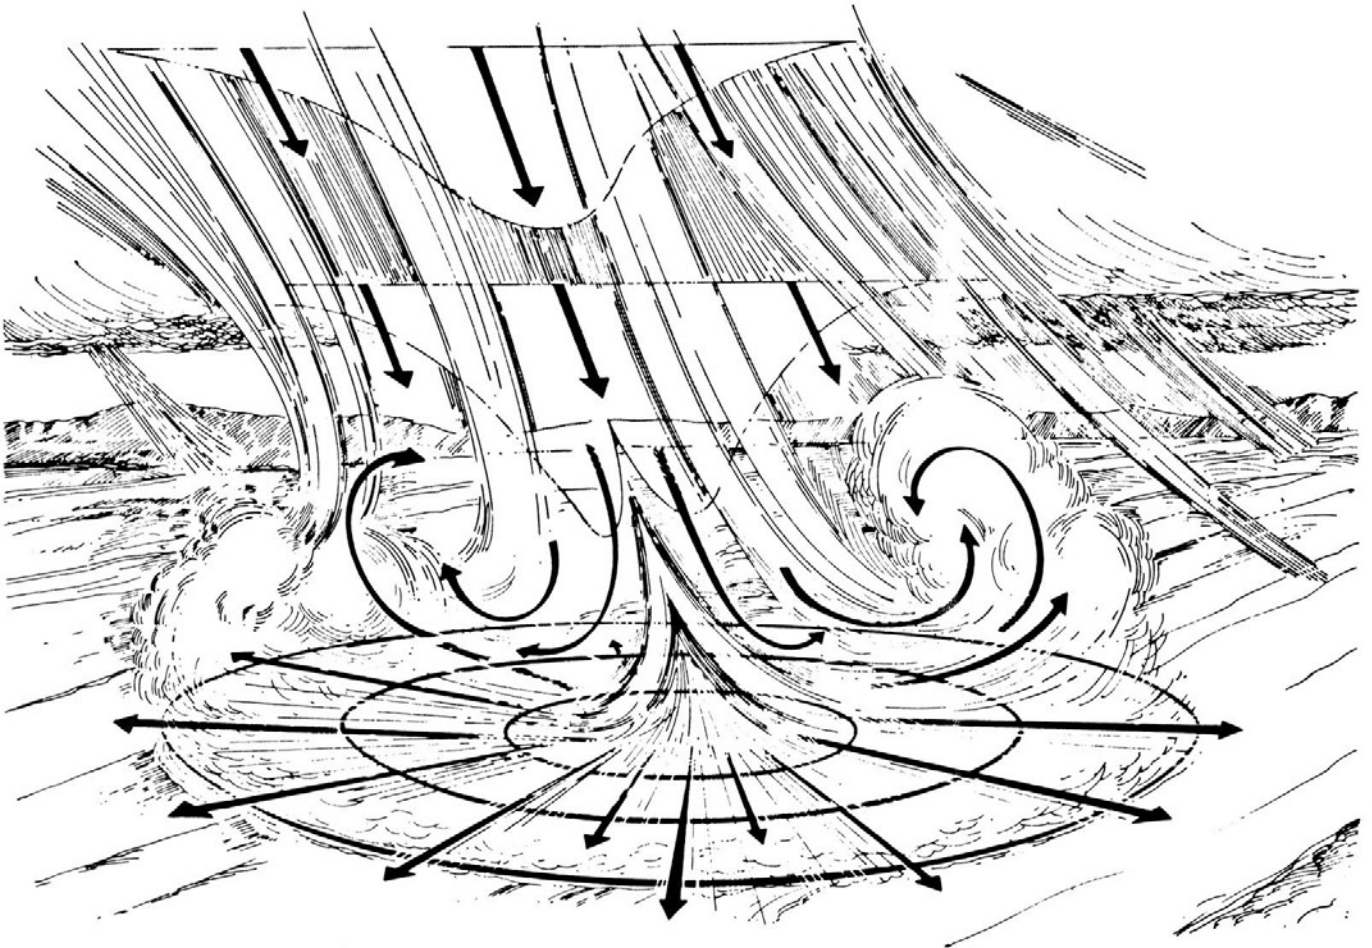
Figure 4.--Typical microburst wind field.

When a microburst is encountered during a landing approach, the airplane will typically experience an increasing headwind, a downdraft, and a decreasing headwind in rapid succession as it passes beneath the outflow and descending air column. The increasing headwind will be recognized as the indicated airspeed increases suddenly and the airplane tends to rise above the glidepath. However, this apparent increase in airplane performance is shortlived as the airplane enters the downdraft and encounters the decreasing headwind caused by the reversal in the direction of the outflow. The rapid reversal of wind direction and speed produces sudden changes in the airplane's angle of attack and airspeed, which may reduce the airspeed far below the initial stabilized airspeed. The reduced airspeed will result in reduced vertical lift, causing the airplane to accelerate downward. Furthermore, the airplane's longitudinal stability will cause the airplane to pitch nose downward as it attempts to reacquire its trim speed equilibrium. The extent to which the airplane's flight path changes depends upon the severity of the windshear and the pilot's reaction with flight controls and engine thrust. The microburst might also create horizontal vortices which produces sudden changes of vertical wind speeds to further upset the longitudinal stability and perhaps the lateral and vertical stability of the airplane, exacerbating the pilot's control task.

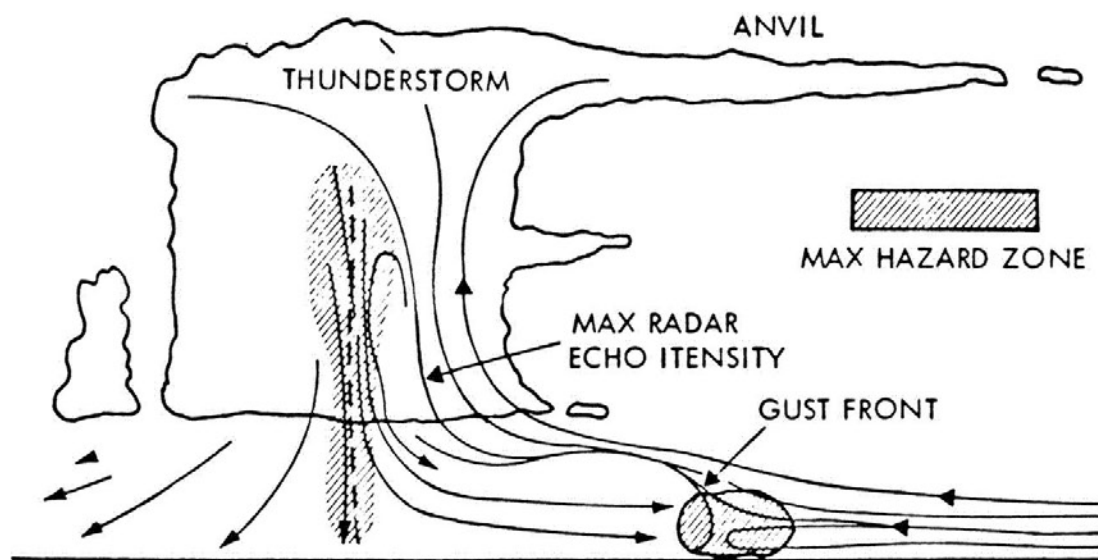
a. Thunderstorms. The winds around a thunderstorm are complex (Figure 1). Wind shear can be found on all sides of a thunderstorm cell and in the downdraft directly under the cell. The wind shift line or gust front associated with thunderstorms can precede the actual storm by 15 nautical miles or more. Consequently, if a thunderstorm is near an airport of intended takeoff or landing, low level wind shear hazards may exist.

FIGURE 1. THUNDERSTORM HAZARD ZONES

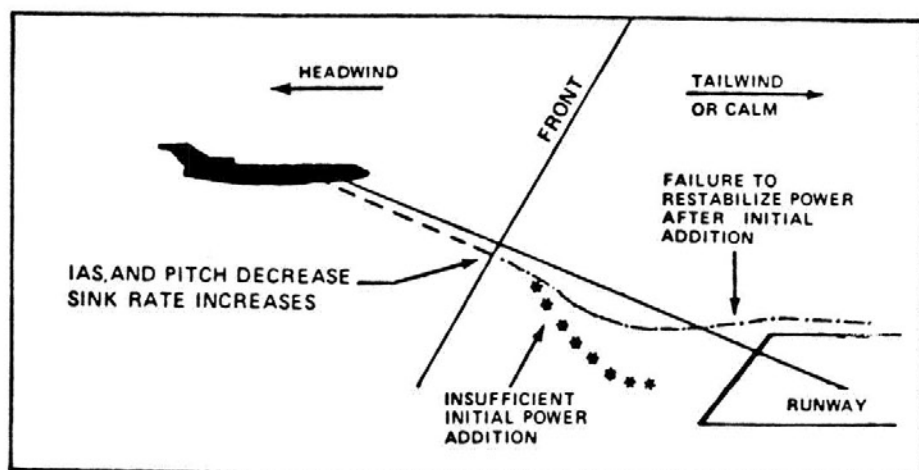
FIGURE 2. HEADWIND SHEARING TO TAILWIND OR CALM

(1) Consider an aircraft flying a 3° ILS on a stabilized approach at 140 knots indicated airspeed (IAS) with a 20-knot headwind. Assume that the aircraft encounters an instantaneous wind shear where the 20-knot headwind shears away completely. At that instant, several things will happen; the airspeed will drop from 140 to 120 knots, the nose will begin to pitch down, and the aircraft will begin to drop below the glide slope. The aircraft will then be both slow and low in a "power deficient" state. The pilot may then pull the nose up to a point even higher than before the shear in an effort to recapture the glide slope. This will aggravate the airspeed situation even further until the pilot advances the throttles and sufficient time elapses at the higher power setting for the engines to replenish the power deficiency. If the aircraft reaches the ground before the power deficiency is corrected, the landing will be short, slow, and hard. However, if there is sufficient time to regain the proper airspeed and glide slope before reaching the ground,

then the "double reverse" problem arises. This is because the throttles are set too high for a stabilized approach in a no-wind condition. So, as soon as the power deficiency is replenished, the throttles should be pulled back even further than they were before the shear (because power required for a 3° ILS in no wind is less than for a 20-knot headwind). If the pilot does not quickly retard the throttles, the aircraft will soon have an excess of power; i.e., it will be high and fast and may not be able to stop in the available runway length (Figure 2).

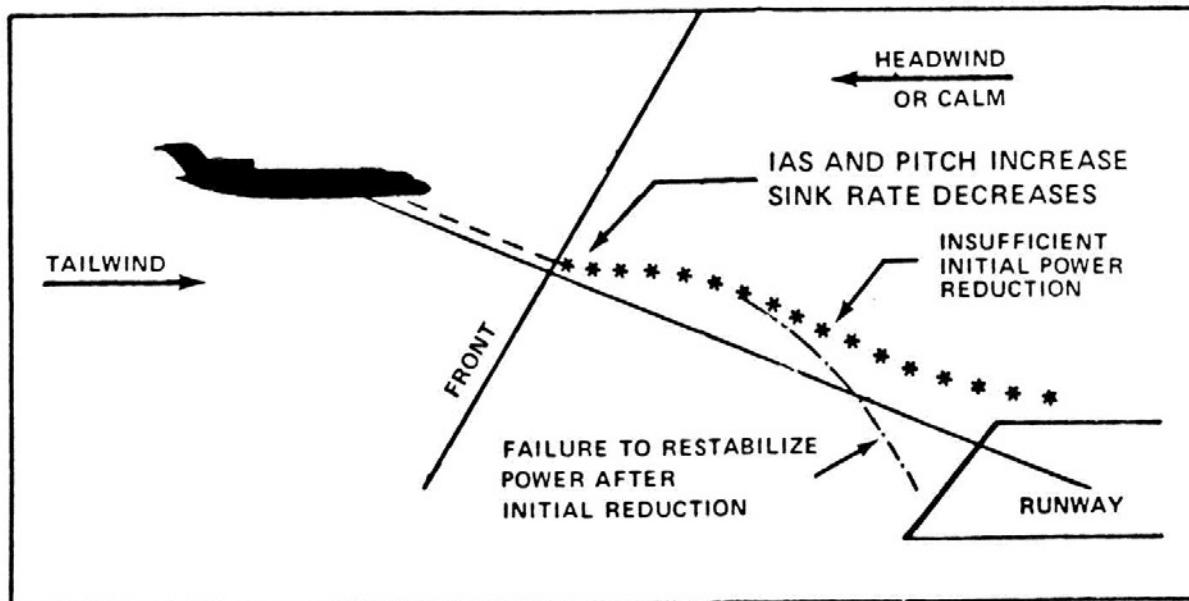
(2) When on approach in a tailwind condition that shears into a calm wind or headwind, the reverse of the previous statements is true. Initially, the IAS and pitch will increase and the aircraft will balloon above the glide slope. Power should initially be reduced to correct this condition or the approach may be high and fast with a danger of overshooting. However, after the initial power reduction is made and the aircraft is back on speed and glide slope, the "double reverse" again comes into play. An appropriate power increase will be necessary to restabilize in the headwind. If this power increase is not accomplished promptly, a high sink rate can develop and the landing may be short and hard (Figure 3). The double reverse problem arises primarily in downdraft and frontal passage shears. Other shears may require a consistent correction throughout the shear.

FIGURE 3. TAILWIND SHEARING TO HEADWIND OR CALM

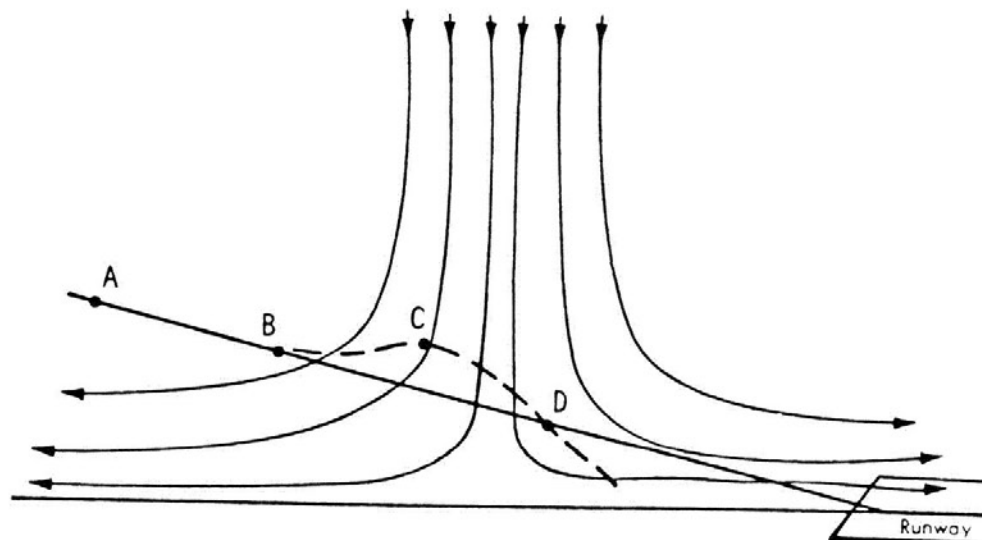
(3) The classic thunderstorm "downburst cell" accident is illustrated in Figure 4. There is a strong downdraft in the center of the cell. There is often heavy rain in this vertical flow of air. As the vertical air flow nears the ground it turns 90 degrees and becomes a strong horizontal wind, flowing radially outward from the center. Point A in Figure 4 represents an aircraft which has not entered the cell's flow field. The aircraft is on speed and on glide slope. At Point B the aircraft encounters an increasing headwind. Its airspeed increases, and it balloons above the glide slope. Heavy rain may begin shortly. At Point C the "moment of truth" occurs. If the pilot does not fully appreciate the situation, he may attempt to regain the glide slope and lose excess airspeed by reducing power and pushing the nose down. Then in the short span of time between Points C and D the headwind ceases, a strong downdraft is entered and a tailwind begins increasing. The engines spool down, the airspeed drops below V_{ref} , and the sink rate becomes excessive. A missed approach initiated from this condition may not be successful. Note that a missed approach initiated at Point C (or sooner) would probably be successful since the aircraft is fast and high at this point. Note also that the pilot of an aircraft equipped with a groundspeed readout would see the telltale signs of a downburst cell shortly after Point B; i.e., rapidly increasing airspeed with decreasing groundspeed.

FIGURE 4. DOWNDRAFT SHEAR

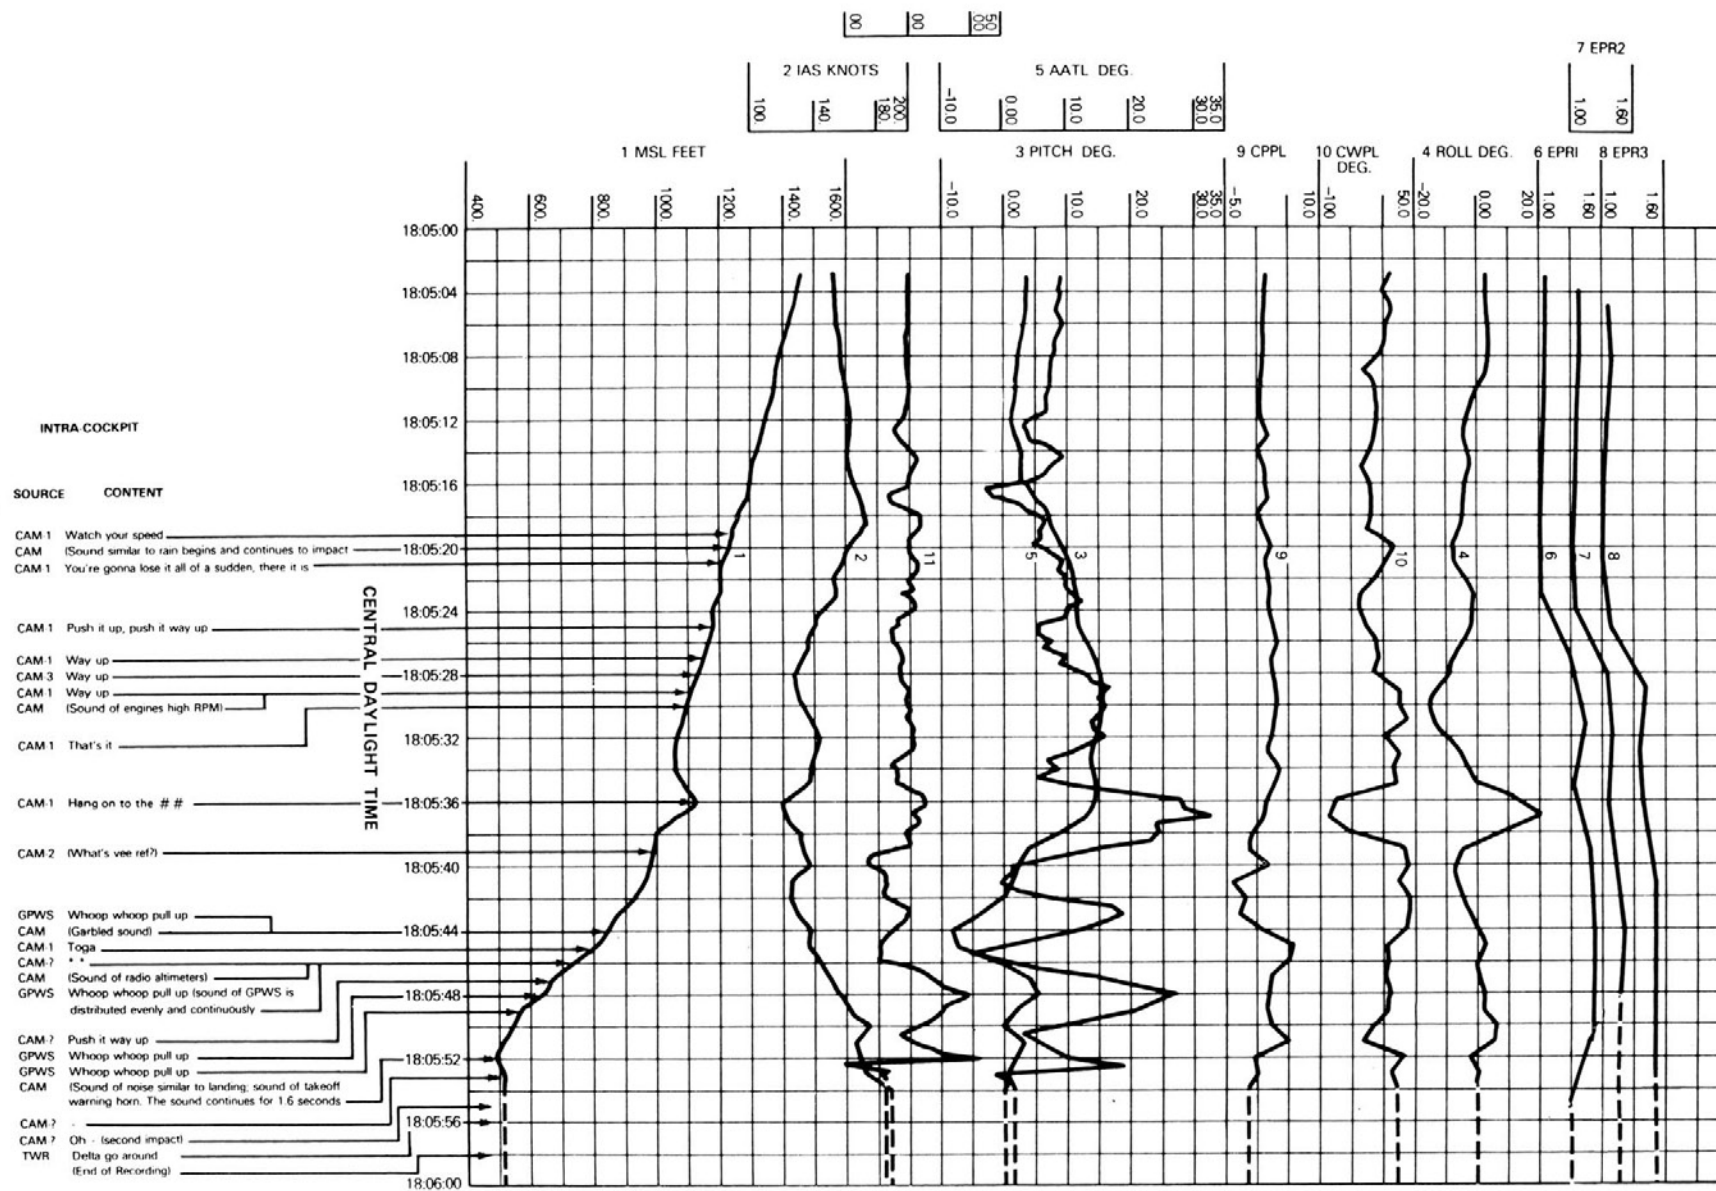
APPENDIX I DFDR/CVR INTEGRATED PLOT

DFDR/CVR CORRELATION
