Uncontained engine failure, Midwest Express Airlines, Inc., DC-9-14, N100ME, General Billy Mitchell Field, Milwaukee, Wisconsin, September 6, 1985

AIRCRAFT ACCIDENT REPORT

**MIDWEST EXPRESS AIRLINES, INC.,
DC-9-14, N100ME
GENERAL BILLY MITCHELL FIELD
MILWAUKEE, WISCONSIN
SEPTEMBER 6, 1985**

NTSB/AAR-87/01

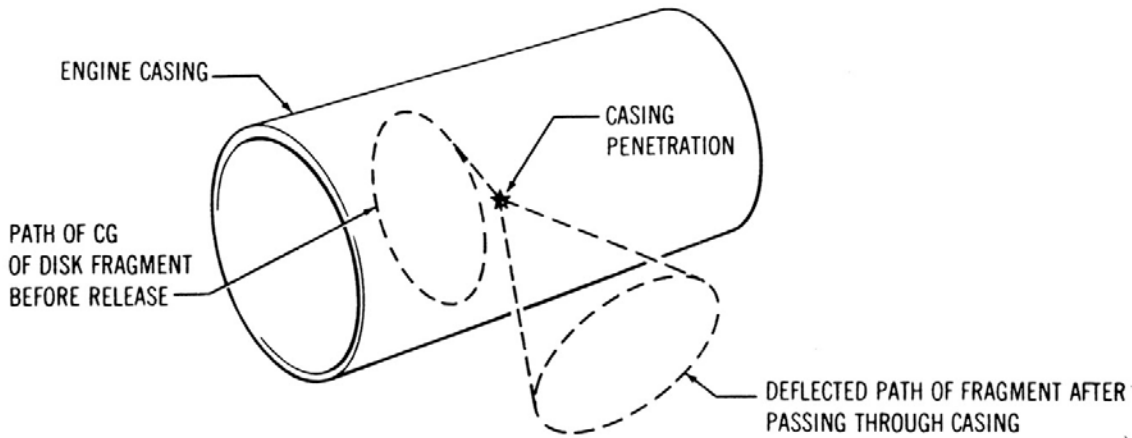
Figure 2.—Deflection path of uncontained engine parts.

Pratt & Whitney representatives testified at the public hearing that their experience had shown that the initial trajectory of uncontained rotating turbojet engine parts may be estimated by assuming that the parts (or fragments thereof) were initially ejected tangentially from their previous plane of rotation, through holes in the case and cowling. This is consistent with the aforementioned research findings. The initial trajectory path may be estimated by aligning a straight object, such as a broomstick, through the hole in the engine case from which the parts were ejected, to the outer diameter of the spacer or rotor that failed (the "broomstick" method). Pratt & Whitney

reported that its previous service history of uncontained compressor spacer failures in JT8D-7 and JT8D-1 engines revealed that in incidents where the fuselage was penetrated by ejected spacer pieces, the holes in the fuselage were nearly directly in line with the penetrations of the engine case and tangent to the outer edge of the failed rotating part.

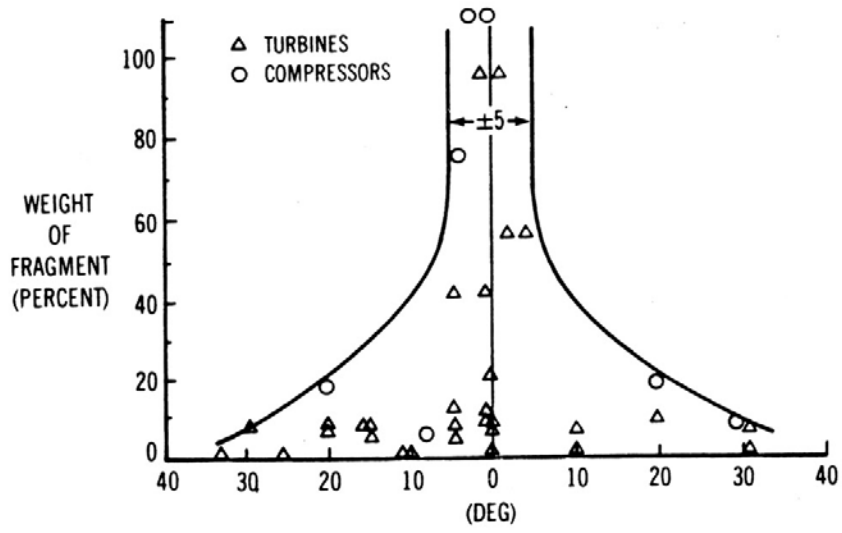
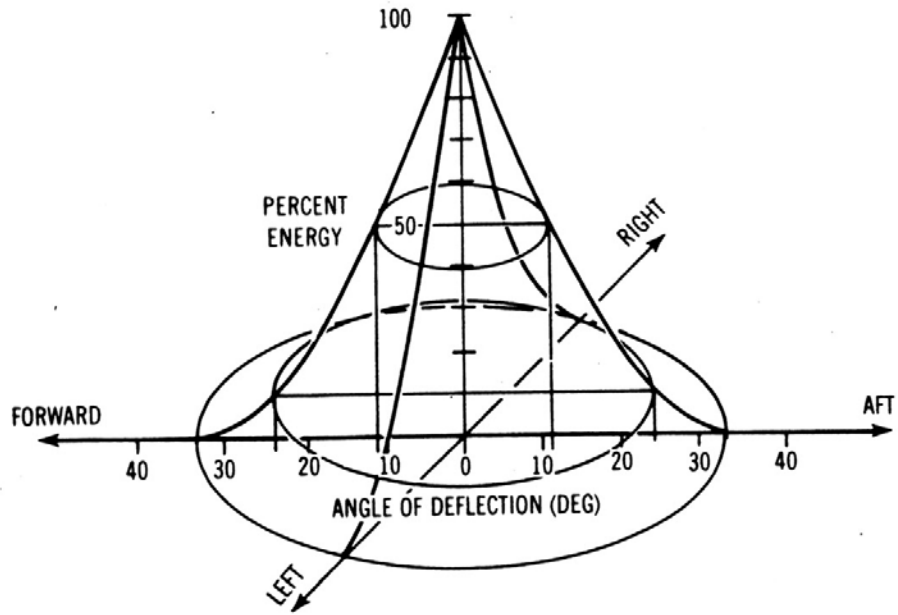
Figure 3.--Dispersion of uncontained engine parts.

The recovered spacer and compressor blade parts were measured to determine drag reference areas, using a factor of 0.635 ^{20/} to allow for tumbling of parts. Thus, the drag reference areas for the largest spacer part, weighing 1.03 pounds; a smaller spacer part, weighing 0.07 pound; and a compressor blade piece, weighing 0.035 pound were determined to be 0.138, 0.03, and 0.019 square foot, respectively. A flat plate drag coefficient of 1.0 was assumed. For the purpose of determining potential tangential velocities, initial ejection speeds between 0 and 800 feet per second (fps) were considered. (Pratt & Whitney determined that the rim tangential velocity of the operating high pressure compressor spacer had been 800 fps.)

The heaviest part would have been most sensitive to the exit velocity and angle. The lighter parts would have been more sensitive to wind factors. It was found that the predicted central point of ground impact would have been about 400 feet rearward and 200 feet left of the aircraft at the time the parts were ejected from the right engine, assuming that the parts were ejected while the airplane was about 450 feet above the ground, left of the runway centerline and at 168 knots. The calculated ejection point was consistent with the point at which parts were determined to have been ejected, based upon the timing of the "clunk" on the CVR tape; the correlation of FDR, CVR, and recorded radar data; and the locations of the recovered engine parts.

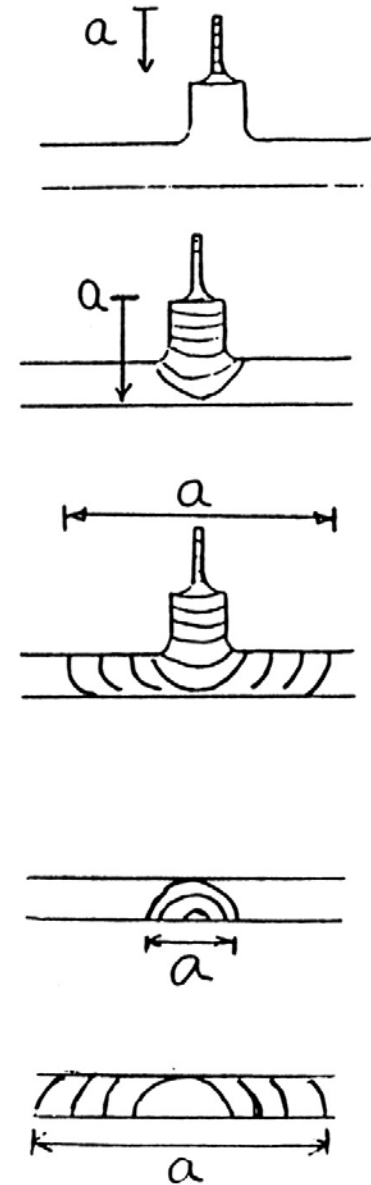
Figure 4.--Cyclic spin test results.

- o CYCLES FROM INITIATION TO THROUGH CRACK - 25,000 CYCLES (TYP)

- o CYCLES FROM THROUGH CRACK TO RUPTURE - 1000 CYCLES (TYP)

Based upon an analytical model developed from the 1980 cyclic spin pit data, Pratt & Whitney concluded that, at approximately 3,000 test cycles before (imminent) rupture of a 7-8 stage spacer, a fatigue crack initiating in a knife edge would have extended to a length of at least 0.20 inch. A crack of this size would extend through the knife edge and into the pedestal in either the 7-8 or 9-10 stage spacer. Pratt & Whitney calculated a crack growth rate equation for a 9-10 stage spacer based on the 7-8 stage data and the known differences in operating temperatures and stress. The calculation indicated that a knife edge crack would be 0.33 inch in length about 3,000 (test) cycles before rupture of the 9-10 stage spacer.

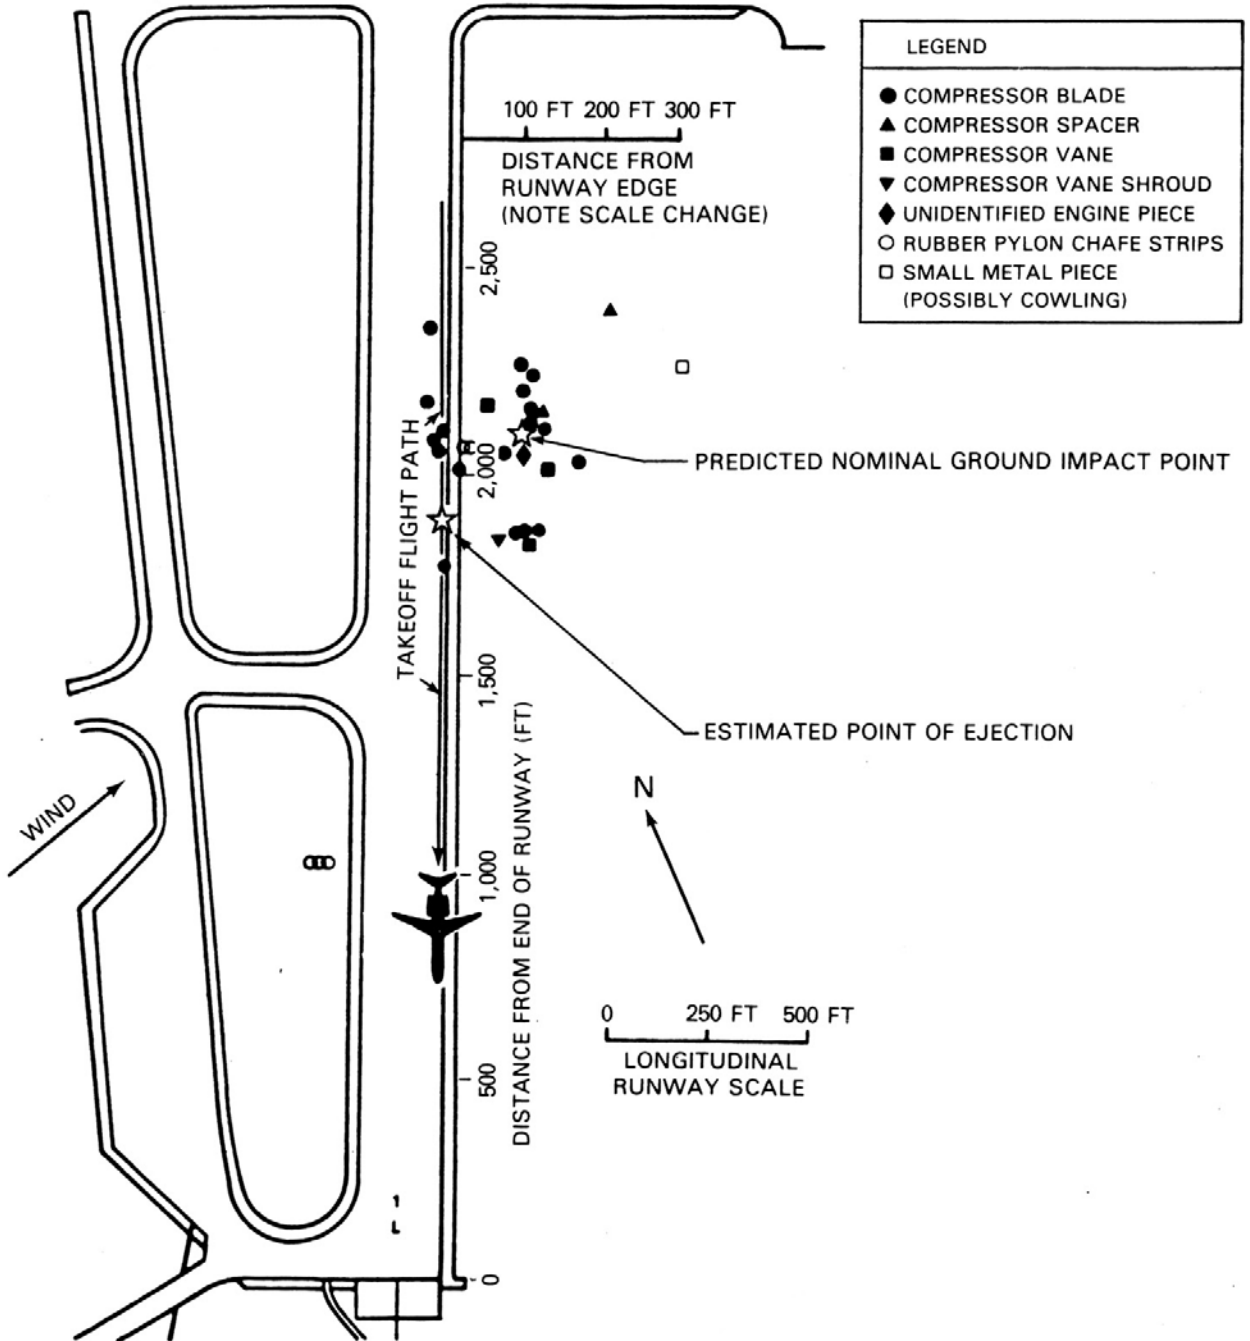
Figure 6.—Calculated nominal ground impact point and actual locations of engine debris adjacent to runway 19R.

Calculations showed that, from the point at which spacer parts were actually ejected from the right engine, the distribution of the parts found near runway 19R was as predicted for undeflected parts exiting the right engine. (See figure 6.) The ejection paths of a few spacer pieces and compressor blades pieces could not be resolved because those parts were not found. However, based on the paths of the recovered debris, the Safety Board concludes that part of the spacer was probably ground into tiny, harmless pieces during the rupture and that part of the unaccounted for spacer pieces and blades might have been missed, despite a thorough search for engine debris in the grass adjacent to the runway.

Calculations showed that the deflection of engine parts by the engine casing or cowling would have resulted in the absorption of energy of the deflected parts, thereby reducing the velocity substantially and limiting the potential to produce any damage of consequence to the fuselage or to the control systems. For example, engine containment tests have shown that ejected engine debris which is deflected more than 33° loses virtually all of its energy.

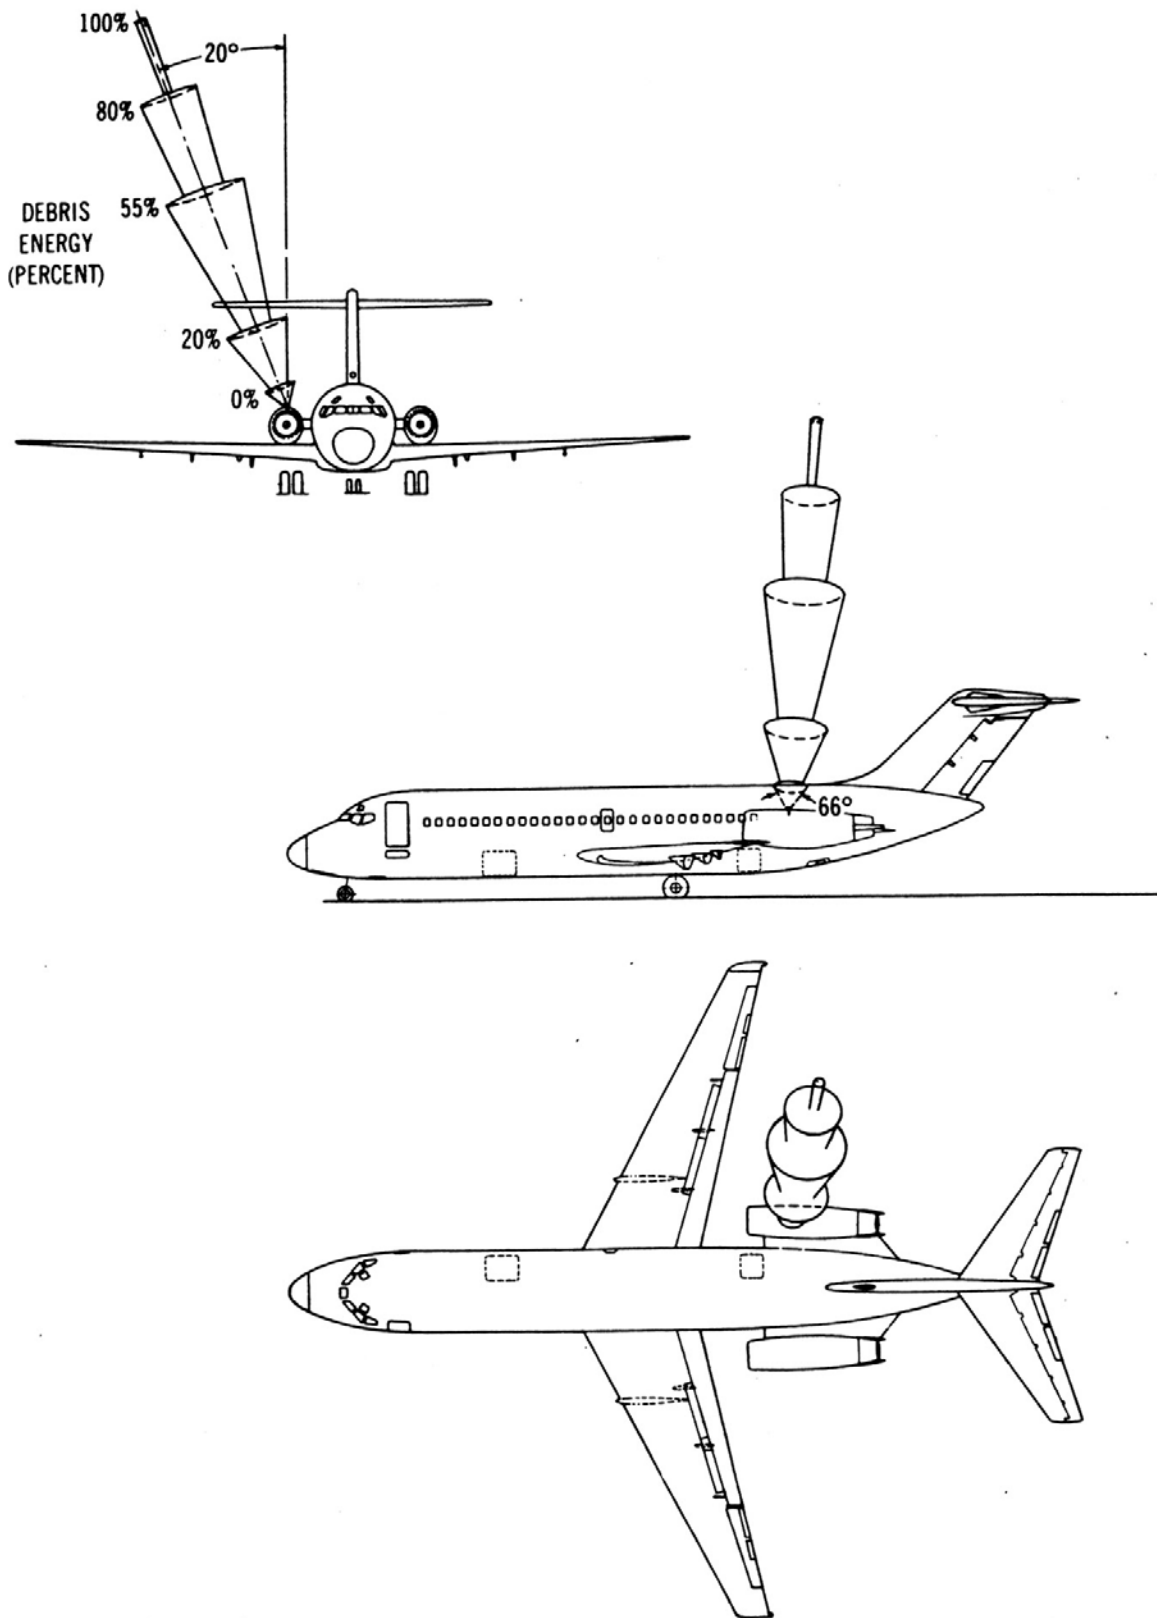
Figure 7.--Three-view drawing of a DC-9 series 10 airplane with various debris patterns and corresponding percentage of energy loss.

Figure 7 shows that undeflected parts are initially ejected in a direction approximated by the broomstick method; in this case, 20° outboard of vertical (away from the airplane fuselage) with high energy and speed. To have struck the Midwest Express fuselage, the parts would have had to have been deflected in excess of 65° and thus virtually all energy would have been lost.
