Crash on takeoff, Northwest Airlines, Inc., McDonnell Douglas DC-9-82, N312RC, Detroit Metropolitan Wayne County Airport, Romulus, Michigan, August 16, 1987

AIRCRAFT ACCIDENT REPORT

**NORTHWEST AIRLINES, INC.
McDONNELL DOUGLAS DC-9-82, N312RC
DETROIT METROPOLITAN WAYNE COUNTY AIRPORT
ROMULUS, MICHIGAN
AUGUST 16, 1987**

NTSB/AAR-88/05

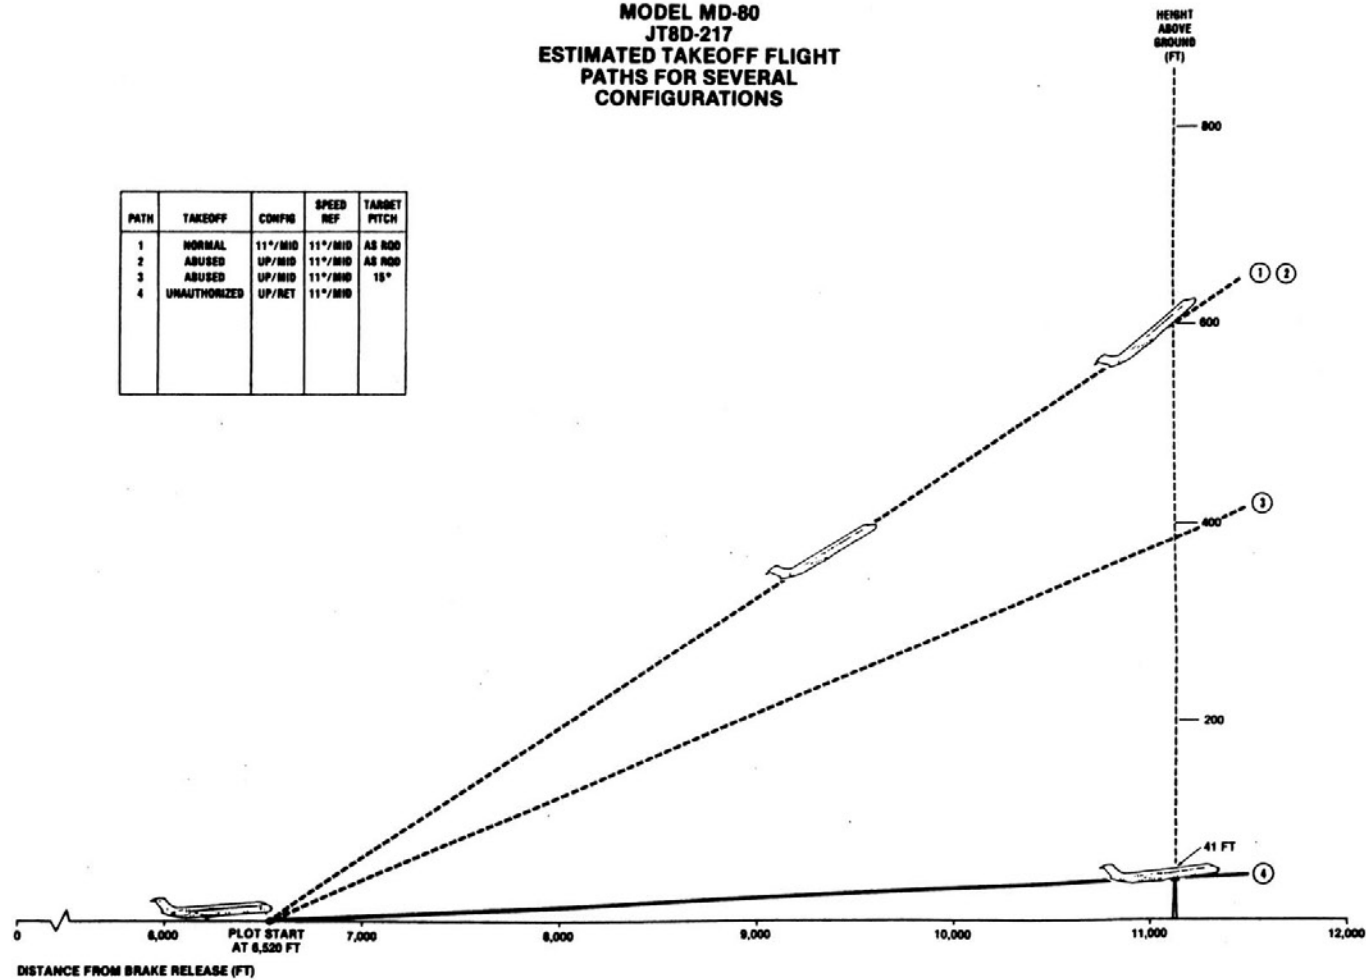
Figure 2.--Model MD-80, JT8D-17.
Estimated takeoff flightpaths for several configurations.

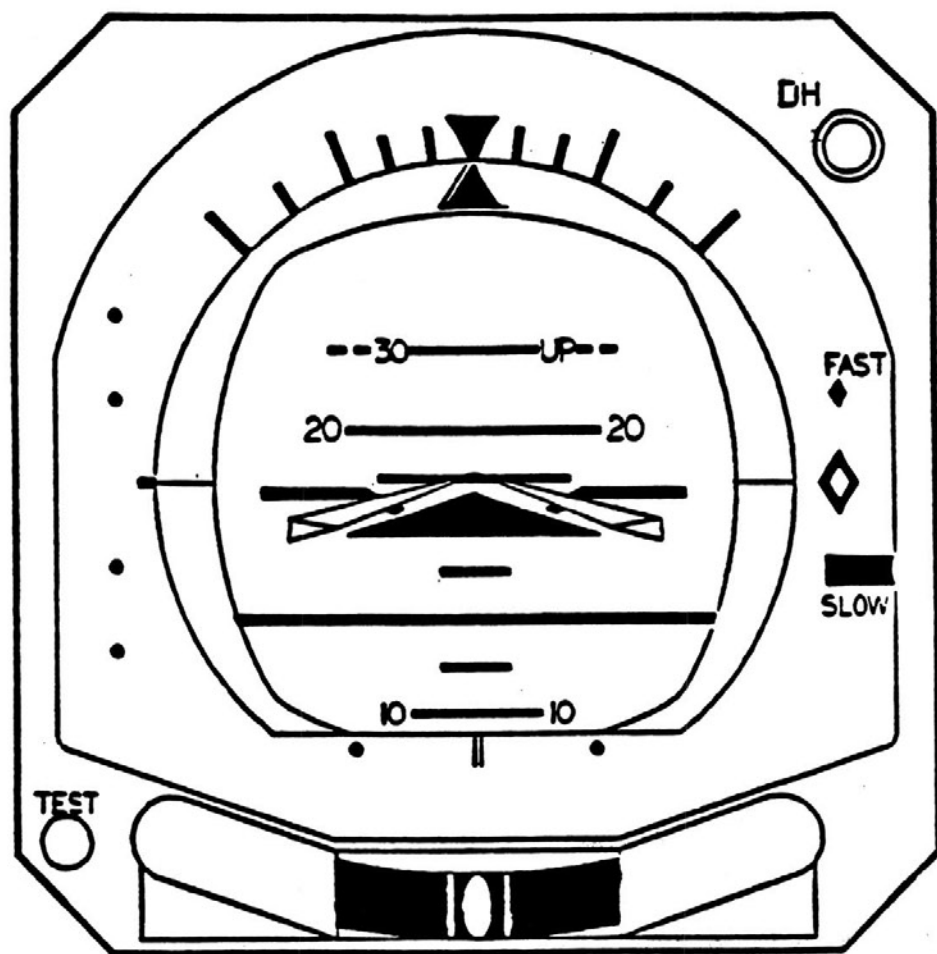
Figure 3.—Displays theoretical pitch attitude information presented by the ADI and the F/D command bar for the conditions existing 65 seconds after the start of the takeoff roll and after the F/D has entered the go-around mode. Roll attitude information and command bar roll guidance information is not displayed.

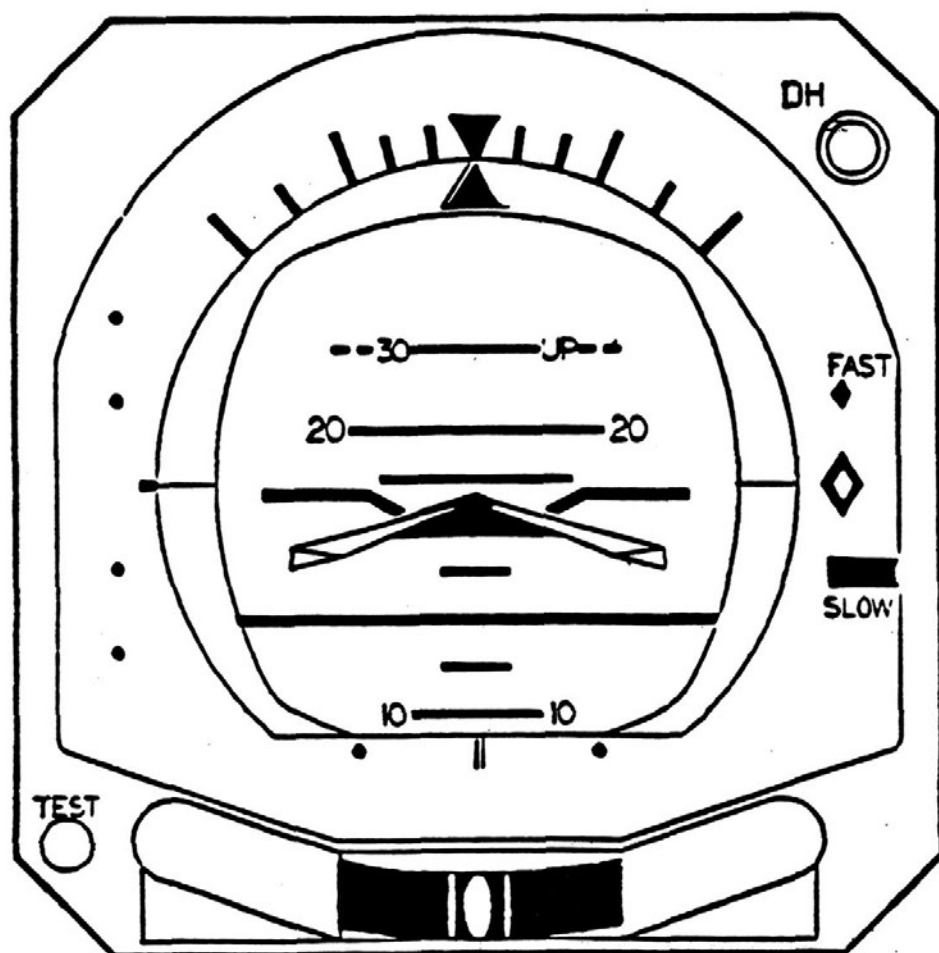
Figure 4.--Displays theoretical pitch attitude information presented by the ADI and the F/D command 65 seconds after the start of the takeoff roll with the F/D in Takeoff mode. Roll attitude information and command bar roll guidance is not displayed.
